To:	Steve Brown Waterloo	From:	Carrie Curtis and Trevor Chandler Waterloo
File:	Silver Lake Environmental Assessment Addendum 161413464	Date:	August 17, 2017

**Reference: Surface Water Resources Status Memo
 Hydrology, Hydraulics and Fluvial Geomorphology**

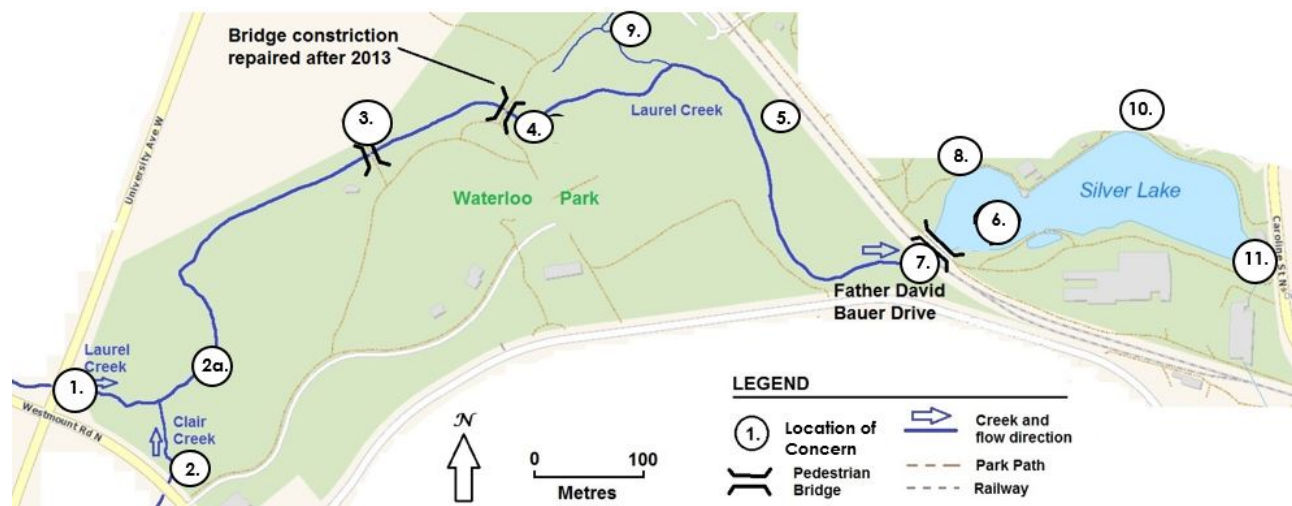
Figure 1: Areas of Concern Identified during the Field Work

The site reconnaissance, completed May 26, 2017, revealed that many of the same conditions exist from the 2013 assessment, with the additional complexity of the added culvert/bridge structure and LRT tracks. Sediment has continued to accumulate within the Lake and the accumulation has extended into the newly installed triple box culvert for the rail crossing.

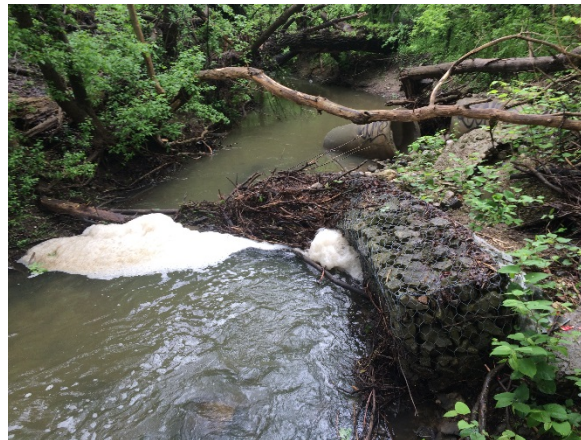
Bank erosion has undermined a concrete stormwater outfall (approx. 1000 mm dia.) and associated gabion bank protection (Photo 1). The site is located approximately 20 m downstream of the Westmount Road culvert along the right (downstream-facing) bank (Figure 1). The erosion at this site is assumed to be recent as it was not identified in previous reporting.

Photo 1. Eroded bank, Clair Creek at Westmount Rd. N.

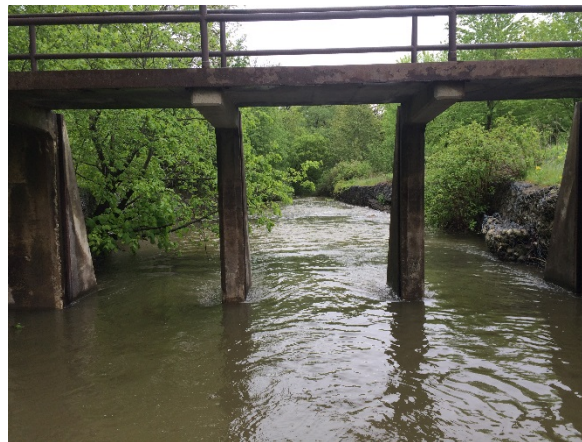
A concrete dam reported as a "historic dam" (MTE 2013) was observed again in 2017 (Figure 1). The historic dam, which also functions as a pedestrian bridge, consists of three concrete openings that are each 2 m wide. The channel width is 6 m and the flow is constricted through the opening (Photo 2). There is a deep scour pool (water depth >1.5 m) immediately downstream of the dam/constriction.

Photo 2. Historic dam, Laurel Creek.

Removal of the historic dam was considered to offer minimal benefits (MTE, 2013), although doing so would restore (increase) channel width, which would improve flow conveyance and reduce erosion potential. Based on the 2017 field assessment of this site, the recommendation to remove or modify the historic dam to restore channel width is considered appropriate.

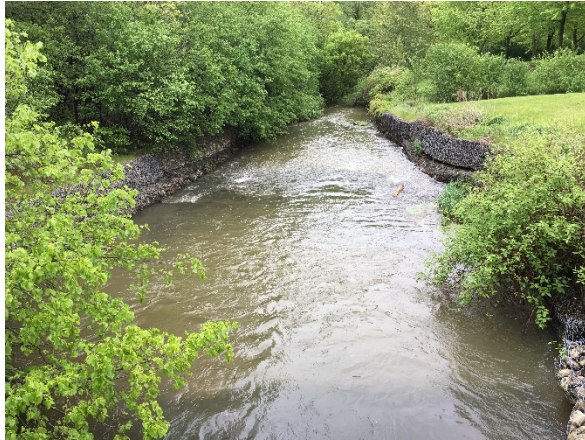
Gabion baskets line both sides of Laurel Creek and extend downstream from the historic dam for 70 m. The gabions were likely necessary to protect the banks from erosion caused by the dam and flow constriction. The gabions are up to 2.5 m in height, resulting in locally entrenched conditions, which further aggravates erosion. Sections of the gabion along the right bank are sagging/collapsing (Photo 3). Gabions on both banks at the dam structure are failing as well (Photo 4).

Photo 3. Gabions downstream of historic dam.

Removal of the gabions and reshaping of the banks would improve stream conditions and the riparian buffer, and should occur in conjunction with the removal of the dam (MTE, 2013). Removal of the historic dam would alleviate the constriction and erosion potential, and bank protection would likely not be required. Based on the 2017 field assessment of this site, this restoration approach is considered appropriate and is recommended

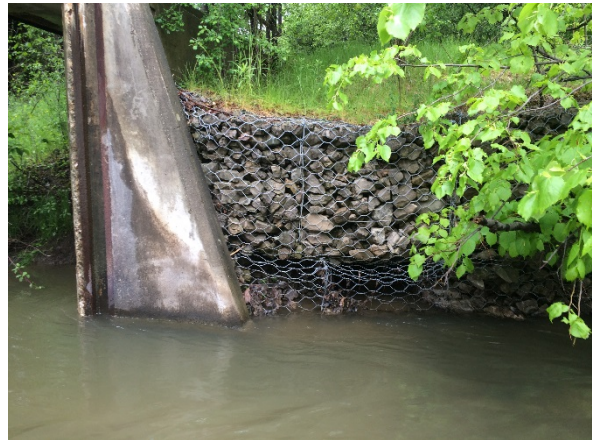
Photo 4. Failing gabions at historic dam

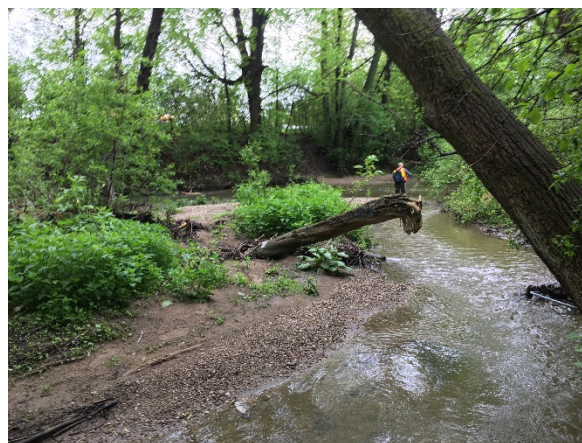
A large mid-channel bar was observed in 2017 at Site 3, at a sharp bend in the channel (Figure 1). The bar was not indicated in previous reporting and likely developed recently (Photo 5). Restorative measures are not considered necessary as the bar does not appear to be affecting Park infrastructure and the creek may restore itself without intervention. This site should be monitored and restored if bank erosion poses a permanent hazard to infrastructure or channel stability.

Photo 5. Mid-channel bar deposition.

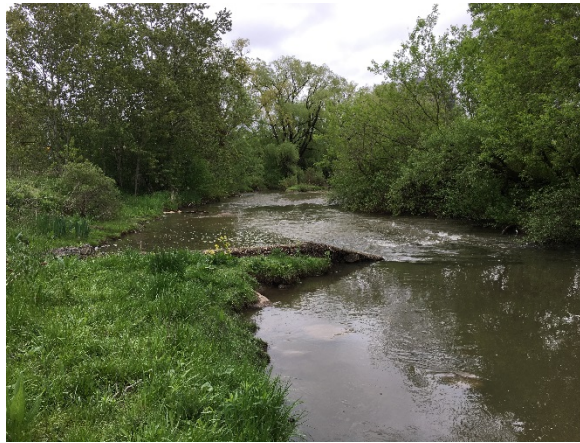
Concrete was observed in the channel at the location of a former weir (Figure 1; Photo 6). The 2013 report by MTE recommended that the concrete be removed, and the adjacent banks reshaped to transition the creek upstream and downstream of the existing weir location. These modifications were recommended to improve stream conditions (flow conveyance) at this location. The 2017 field assessment indicated that the weir remnants created a local constriction and that its removal, as previously recommended would relieve this constriction.

Photo 6. Remnant concrete weir structure.

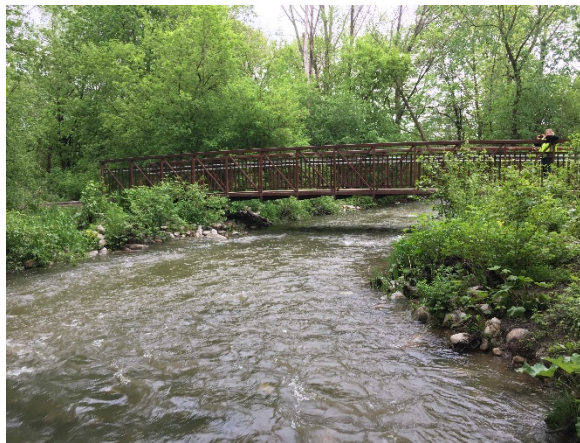
One of the pedestrian bridges across Laurel Creek was identified as an erosion site (MTE, 2013). The field inspection of this bridge in 2017 indicated that it has been modified (widened) to remove the constriction and no longer affects channel stability (Photo 7). No restoration is required at this site.

Photo 7. Appropriately-sized pedestrian bridge.

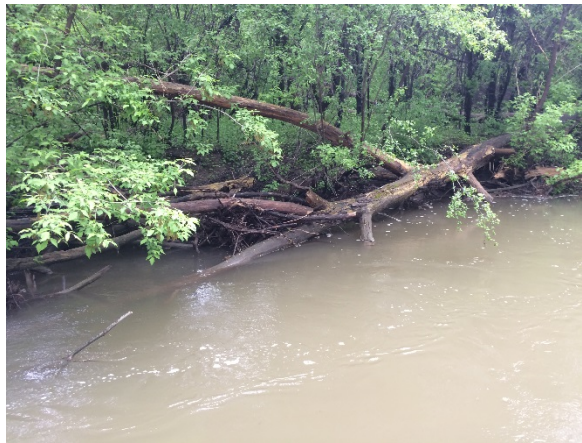
Large woody debris was observed at several sites along the creek, and was causing localized bank erosion (MTE,2013). Woody debris was observed in 2017 but was not considered to be causing bank erosion or channel disturbance (Photo 8). No woody debris was observed in the narrow (2 m) openings at the historic dam. Based on the field inspection in 2017, only a few local points require action to address large woody debris at this time, although monitoring should continue.

Photo 8. Woody debris along Laurel Creek.

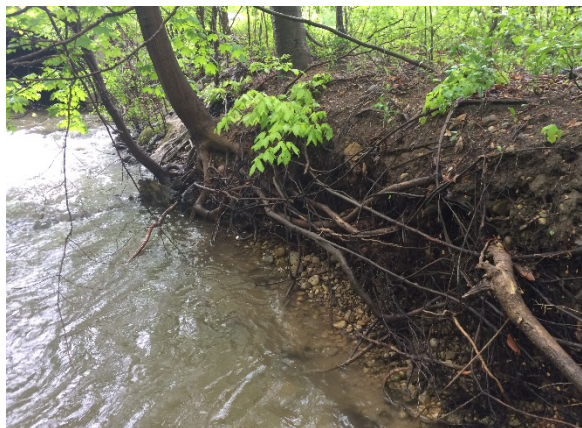
Bank erosion was observed in 2017 at several locations between University Avenue and the remnant weir structure at Site 4 (Figure 1), along the outside of bends and along straight sections of channel (Photo 9). Trees and other vegetation provide a dense root mat which appears to protect the banks

Photo 9. Tree roots protecting bank from scour.

in many areas. Channel modifications in areas of erosion are recommended to increase resistance to erosion (e.g., stone bank toe; vegetative plantings) and to reduce the erosive potential of the flow (e.g., structures to control flow vectors; improve channel-floodplain connection).

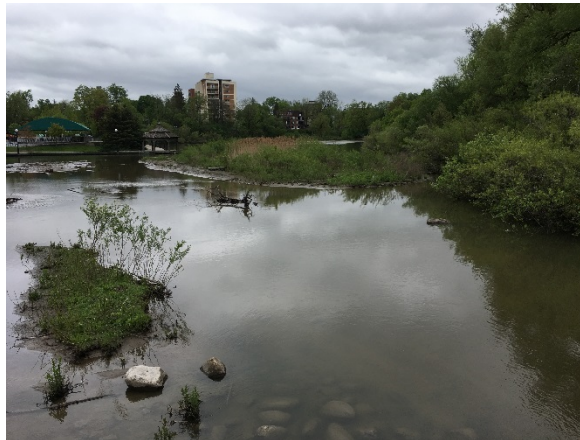
Extensive sediment deposition was observed in the upstream portion of Silver Lake (Figure 1). This material appeared to consist mainly of fluvial sand and silt that fall out of suspension as creek flows enter the lake (Photo 10). Controlling sedimentation will involve removing sediment (by dredging) and by preventing sediment from entering the lake (MTE, 2013). Several remedial measures have been recommended to reduce bank erosion upstream of Silver Lake and to modify Silver Lake to reduce or eliminate its capacity to retain sediment (MTE, 2013).

Photo 10. Bar deposition, upstream end of Silver Lake.

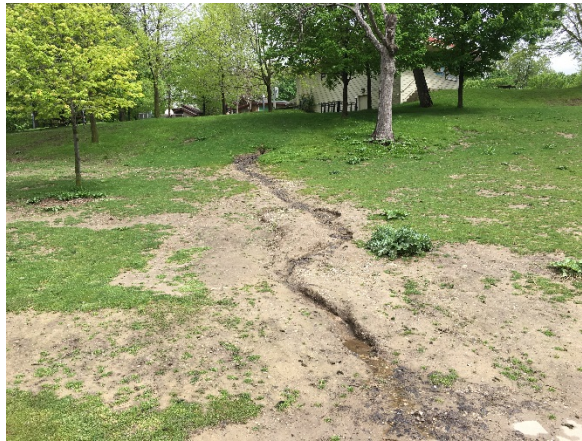
Overland flow over bare soil has caused surficial erosion and rill development on Park lands adjacent to Silver Lake. This erosion was not observed previously and contributes additional sediment to the lake (Figure 1; Photo 11). The site appears to have heavy foot traffic. Measures to reduce sediment loading from overland flow would likely involve a combination of reducing the force of the flows that cause erosion and to increase the resistance of the ground surface to erosion.

Photo 11. Rill development on Waterloo Park lands.

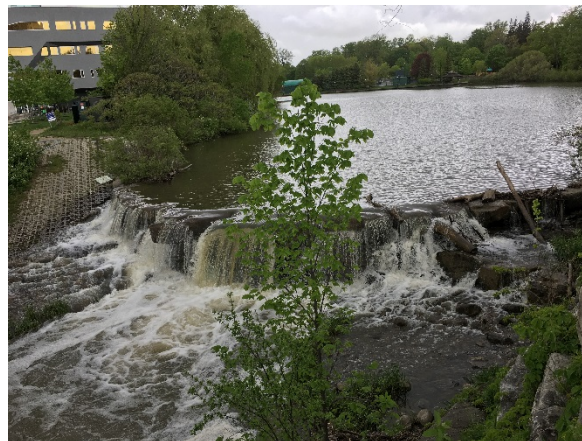
A minor leak was identified at the armourstone outlet structure and the road/access ramp was cracked (MTE, 2013; Figure 1). The outlet structure and access ramp were inspected in 2017 and are in poor condition and need repair (Photo 12) if the outlet is to continue in its present function.

Photo 12. Armourstone outlet structure, Silver Lake.

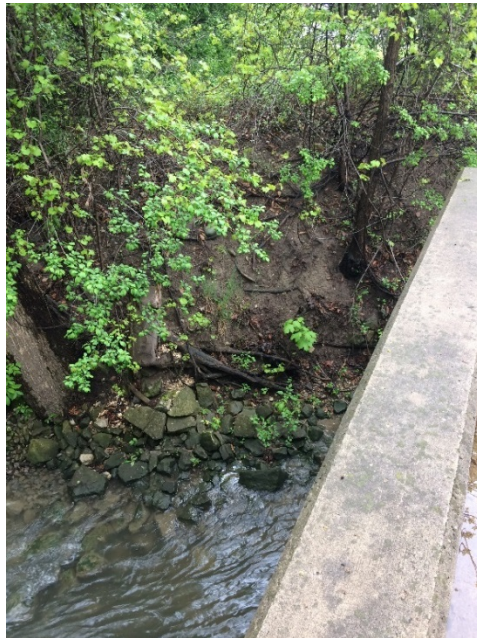
Erosion behind the headwall at the University Avenue crossing.

Photo 13. Bank erosion at Laurel Creek at University Avenue.

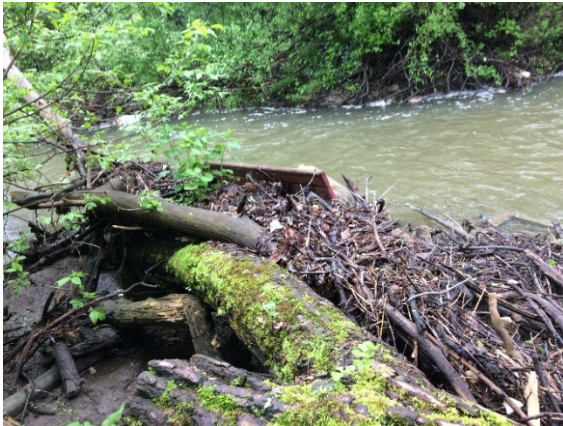
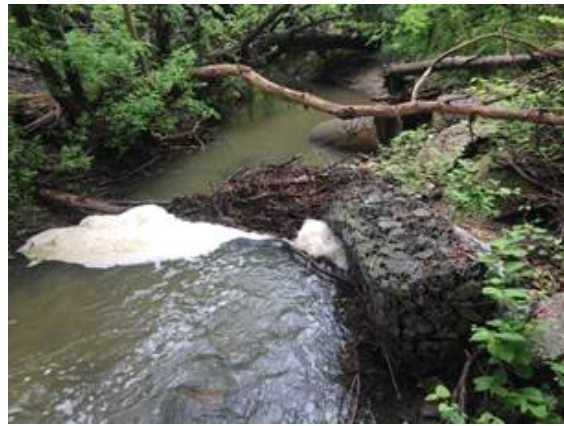
Significant erosion immediately downstream of Westmount Road along the Clair Creek tributary. In addition, there is significant debris accumulation within the creek.

Photo 14. Debris accumulation – Laurel Creek.

Photo 15. Debris accumulation – Clair Creek.

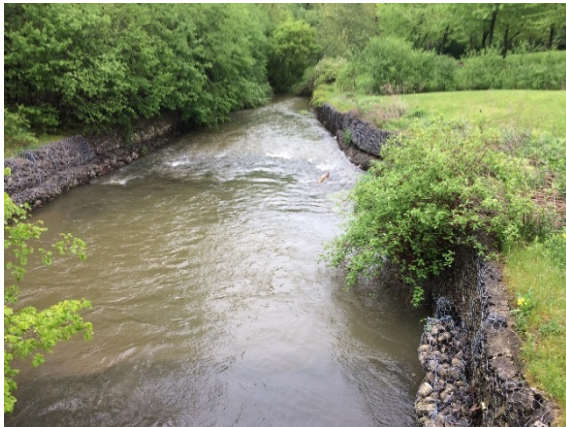
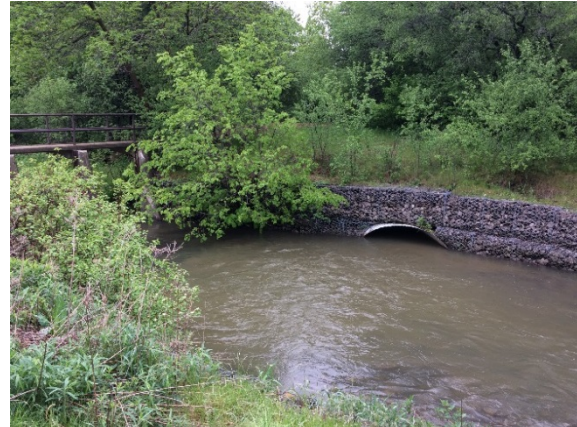
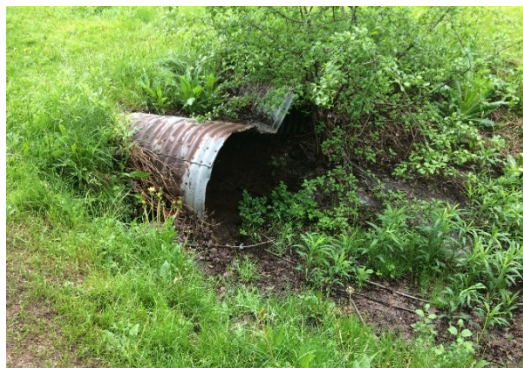
Undermining of gabion wall near the pedestrian crossing and overflow culvert near the former band shelter as identified in previous reports. The overflow channel is also damaged and of reduced capacity in its current condition.

Photo 16 Undermined gabions.

Photo 17. Undermined gabions.

Photo 18 Overflow culverts near historic dam

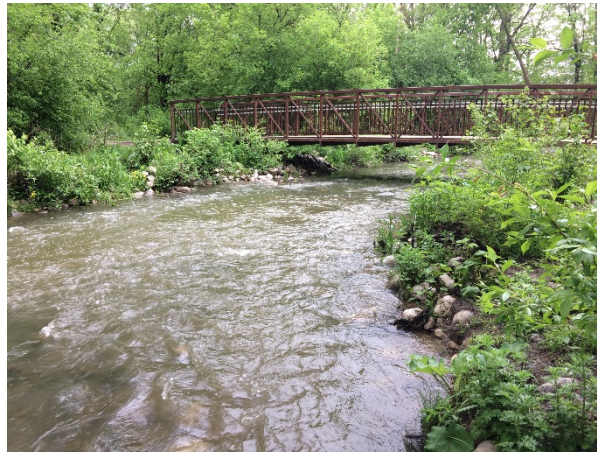
The primary pedestrian crossing between the east and west sides of the park was replaced following the 2013 MTE Report as recommended. This new crossing appears to be functioning appropriately with stable banks and no signs of erosion. The former structure in this location was often washed out due to its lack of capacity.

Photo 19. Appropriately-sized pedestrian bridge.

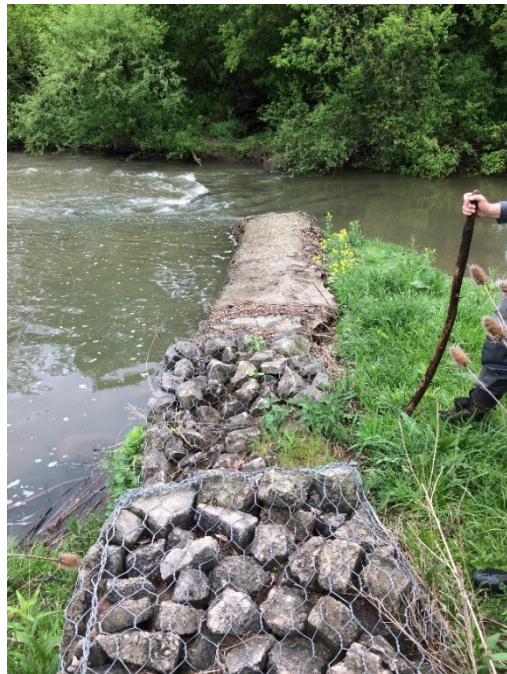
Remnants of the former dam remain in the same damaged condition as identified in the 2013 MTE Baseline Report. This was recommended for removal in the previous report.

Photo 20. Remnant weir structure, Laurel Creek.

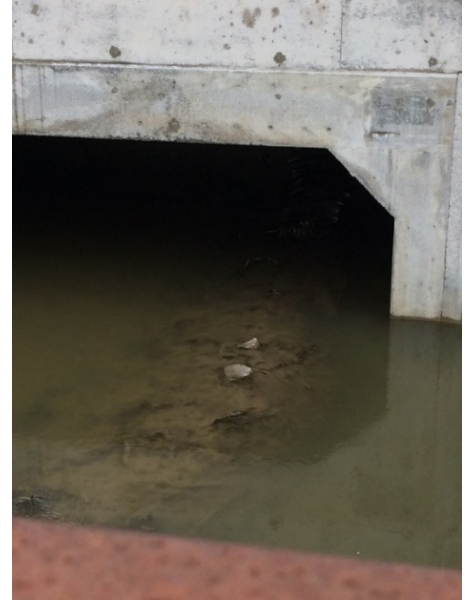
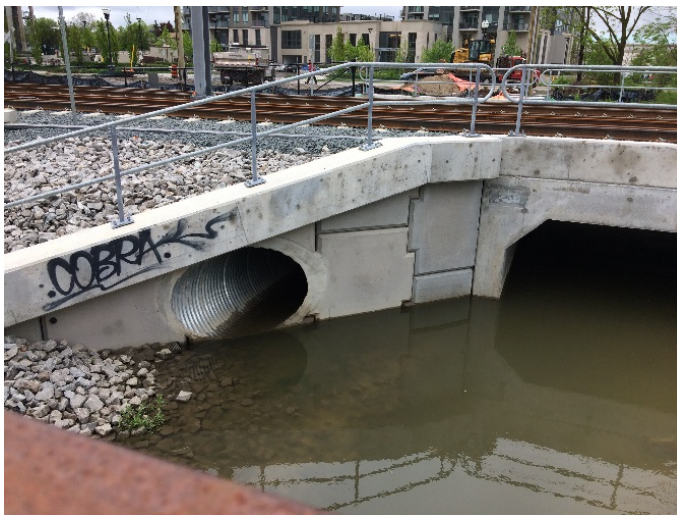
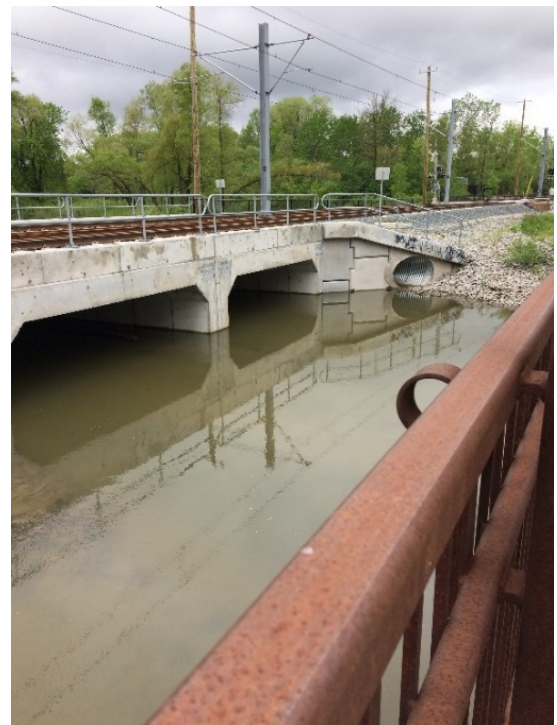
The LRT construction has significantly modified the entrance to the park along Father David Bauer Drive where Laurel Creek transitions into Silver Lake. As previously mentioned, a triple box culvert has been added for the rail crossing to accommodate for dual tracks in place of the previous wood trestle bridge carrying a single railway track.

The tracks have also been modified within the corridor to accommodate the dual track and associated catenary systems. In addition, significant fencing lines the tracks and prevents crossing of the tracks along its length within the Park. This limits the ability to implement some of the recommendations made in previous reports.

Photo 21. Sediment deposition in Silver Lake, downstream of LRT tracks.

Photo 22. LRT tracks at Silver Lake (south side of crossing).

Photo 23. LRT tracks at Silver Lake (north side of crossing).

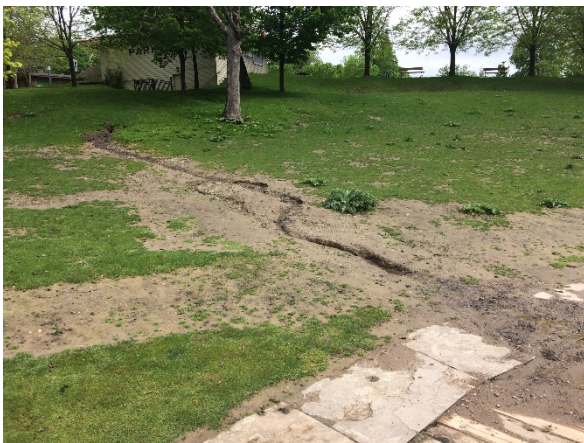
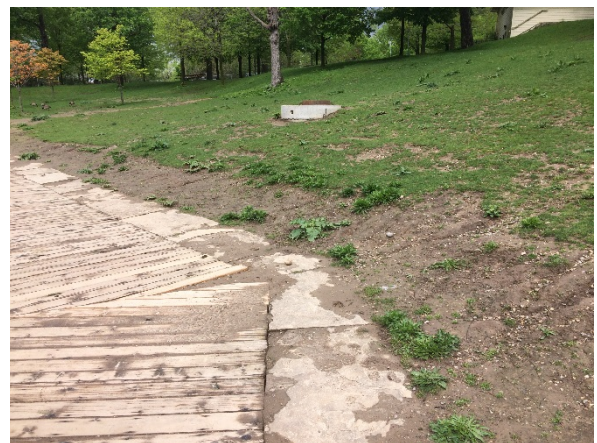
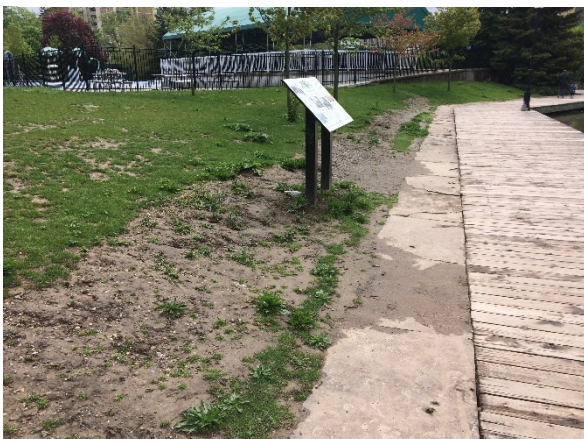
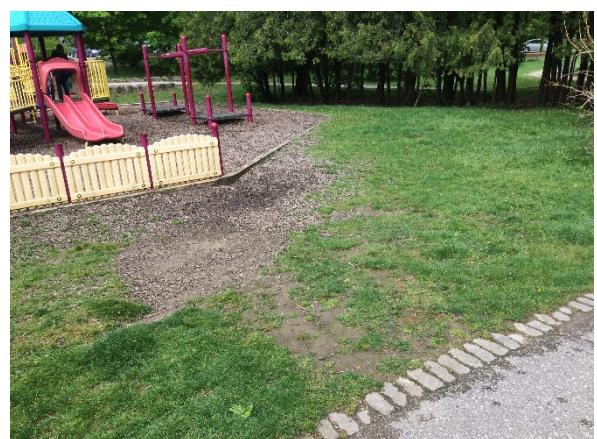
Within the perimeter of Silver Lake there are several issues identified. These primarily relate to surface runoff, surrounding bare surfaces and discharge likely from roof leaders which are eroding adjacent banks. As a result of exposed soils and surface treatment, sediment is accumulating along the boardwalk surrounding Silver Lake. Not only are these items providing additional sediment load into the Lake, they are also aesthetically unpleasant.

Photo 24. Rill erosion and sediment deposition, Waterloo Park near Silver Lake.

Photo 25. Exposed soil, Waterloo Park.

Photo 26. Exposed soil, Waterloo Park. Silver Lake at right.

Photo 27. Exposed soil, Waterloo Park.

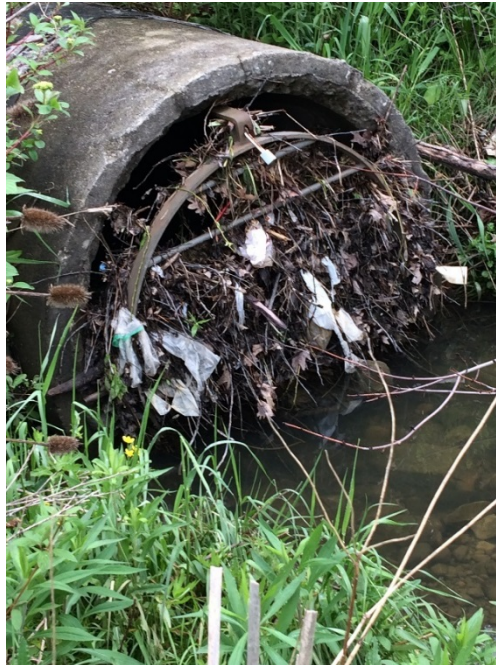
Debris is accumulating on the inside of outlets within the trash racks (see attached photos). It is unknown as to the maintenance schedule of removing debris from the structures, however, the accumulation per the attached photo are reducing the outlet capacity.

Photo 28. Debris in trash rack of stormwater outlet.

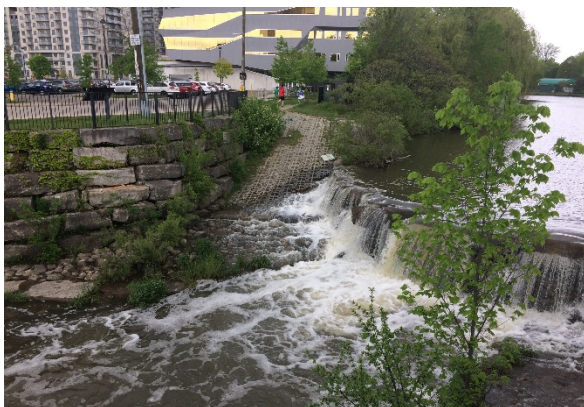
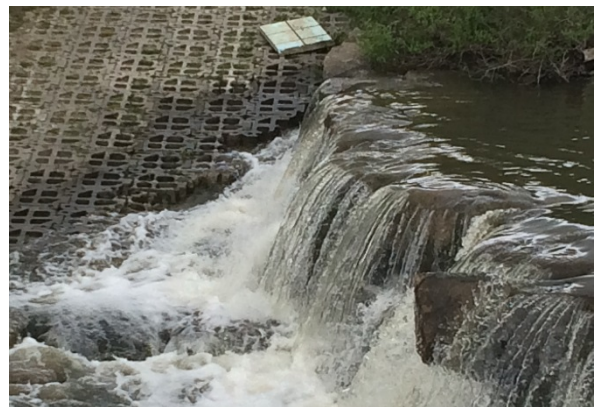
The maintenance access road at the outlet structure is experiencing significant erosion and as such, the access is limited to the remaining intact portion. This is a result of the spill over the armoustone scouring the terrafix and dislodging the blocks.

Photo 29. Silver Lake outlet structure.

Photo 30. Terrafix access road at outlet structure.

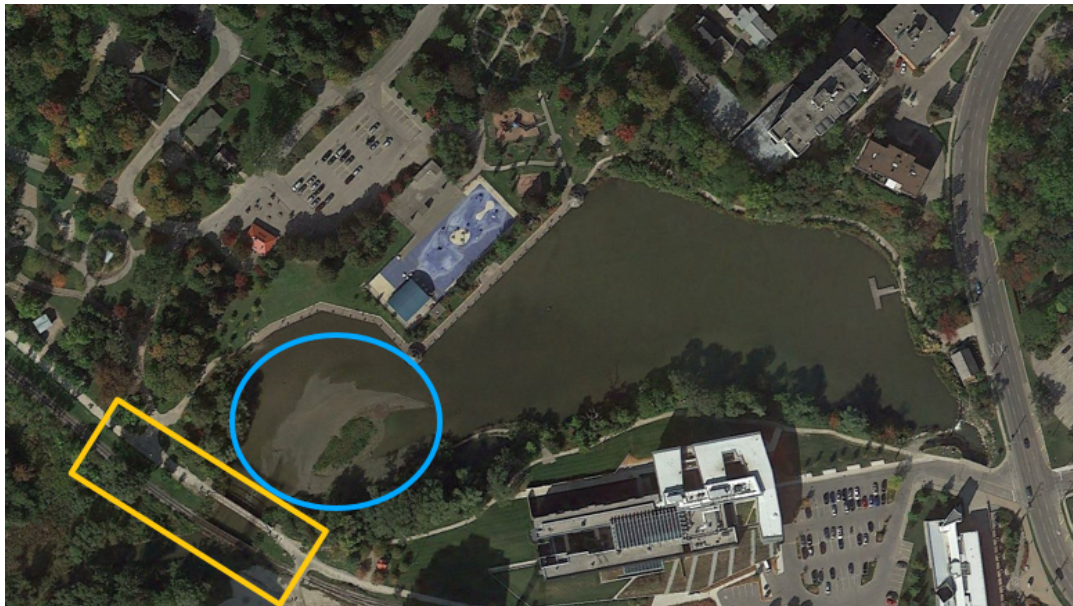
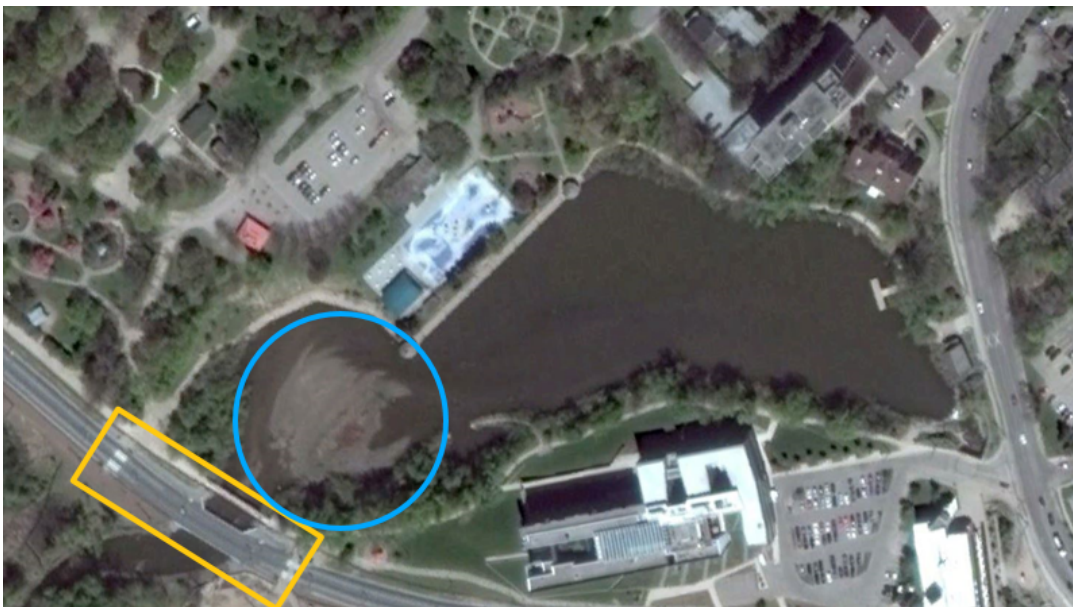
Google Earth images from 2013 and 2017 are provided in Figures 2 and 3 which clearly show the modifications to the bridge/LRT crossing at the mouth of the Lake as well as the extended area of sediment accumulation.

Figure 2: Sediment deposition Silver Lake - 2013 Google Earth Image

Figure 3: Sediment deposition Silver Lake - 2017 Google Earth Image
