CITY OF WATERLOO

Municipal Class Environmental Assessment

WATERCOURSE EROSION MASTER PLAN

Aquafor Beech Ltd.

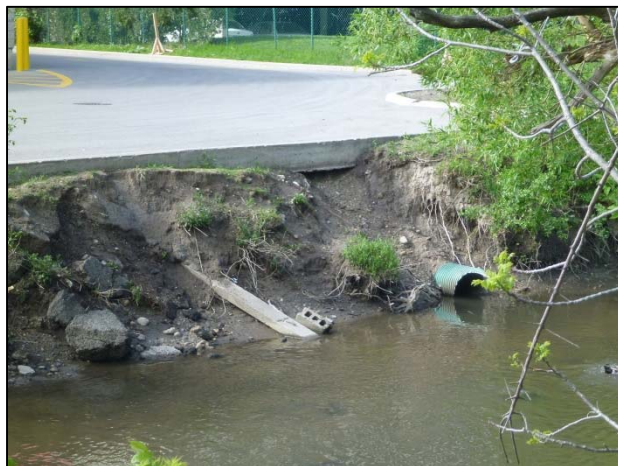
Erosion concerns were identified from Erb Street East to Weber Street with near-vertical bank erosion occurring on both sides of channel. A recreation trail and sanitary sewer run along the left bank and the eroding bank is within 1 m of the trail in some areas. Private property is located on the top of the right bank with erosion posing a risk to a fire hydrant, parking lot, loading area, and structures. Numerous storm outfalls are in poor repair. Concrete rubble and yard waste dumping on the bank was noted at the upstream end of the site.

Figure 8-5: Undermining of paved loading area on private property at LRL-E7

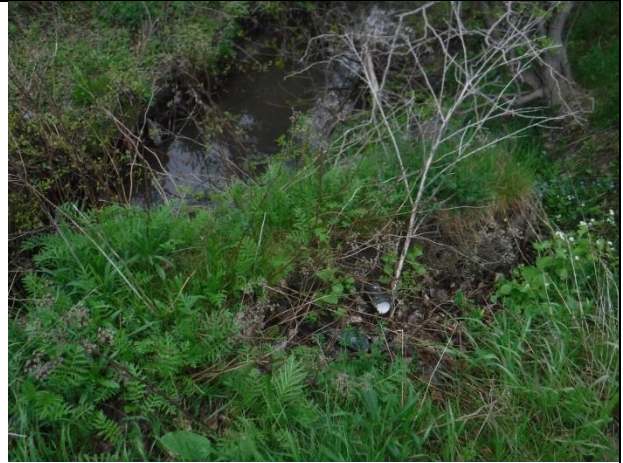
Outflanked and leaning headwall

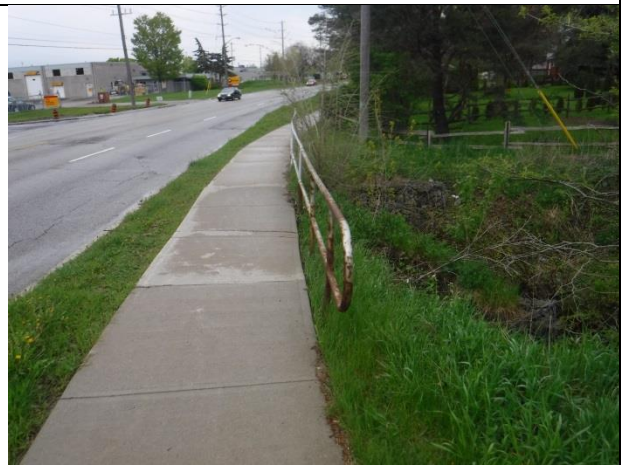
Cracks in sidewalk and road behind headwall

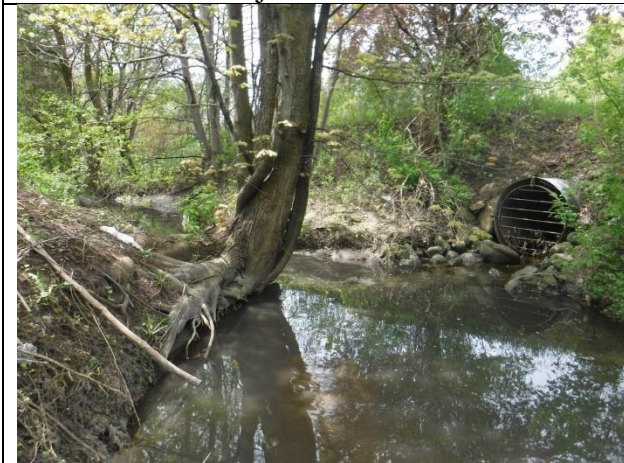
Storm sewer outfall and tree deflecting flow to opposite bank

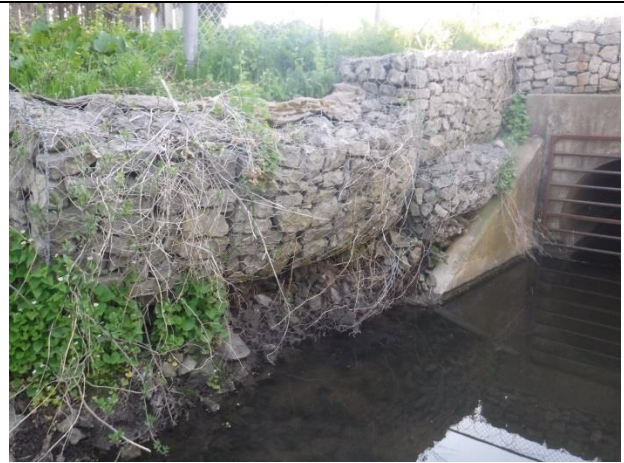
Condition of gabion baskets on left bank

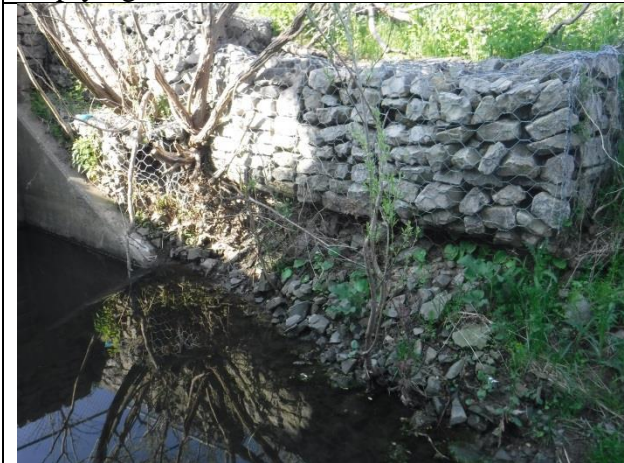
Condition of gabion baskets on right bank

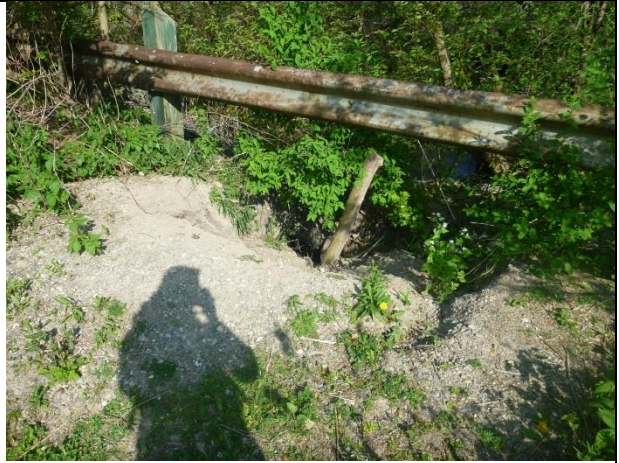
Embankment erosion

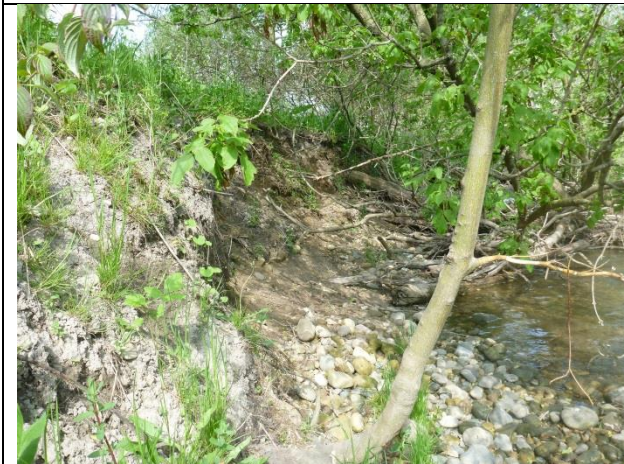
Bank erosion towards sanitary sewer

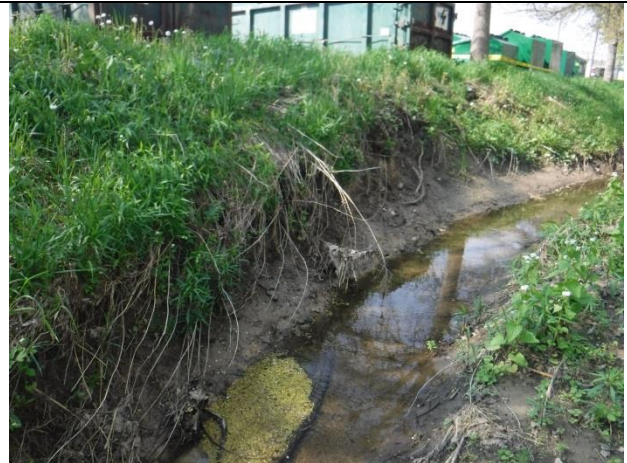
Bank erosion towards parking lot and dumpsters

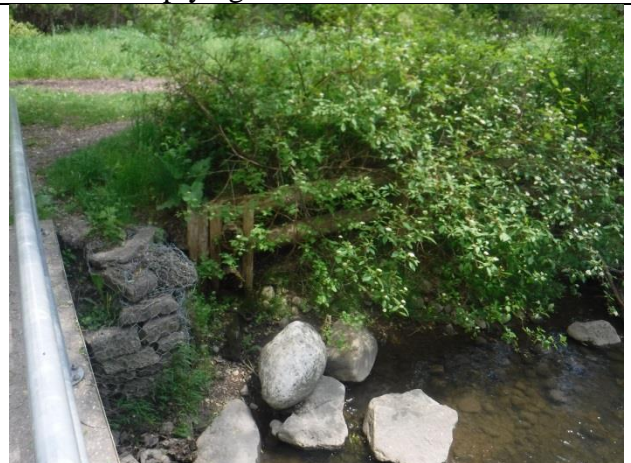
Crib wall in poor condition but vegetation well established

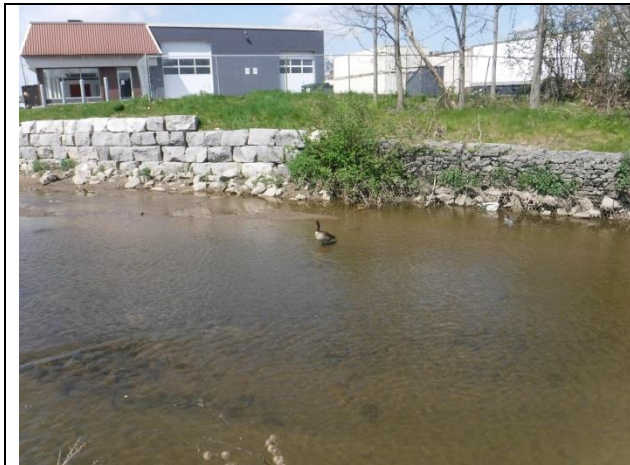
Failing gabions at end of armourstone wall

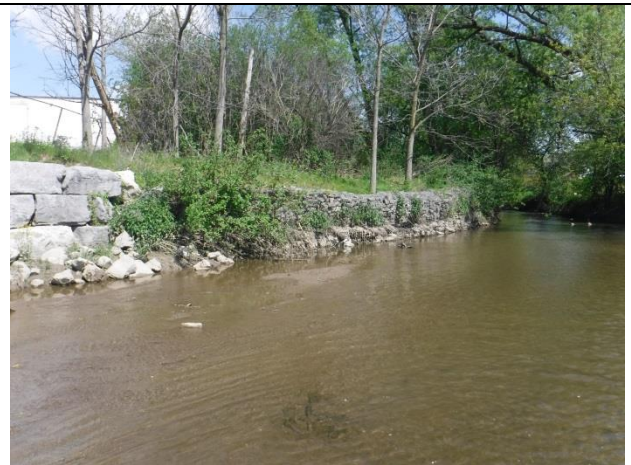
Failing gabions at end of armourstone wall

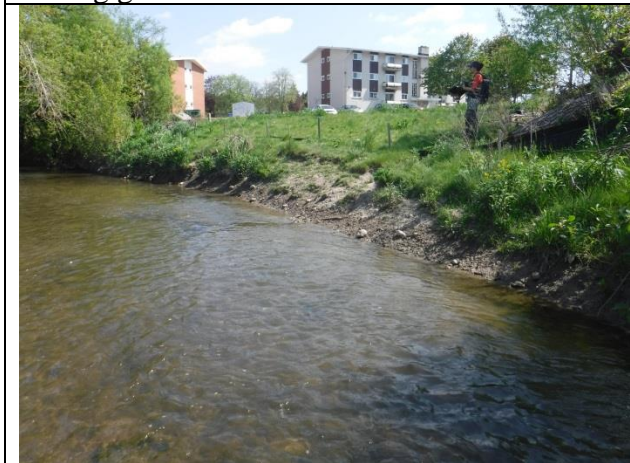
Bank erosion on right bank

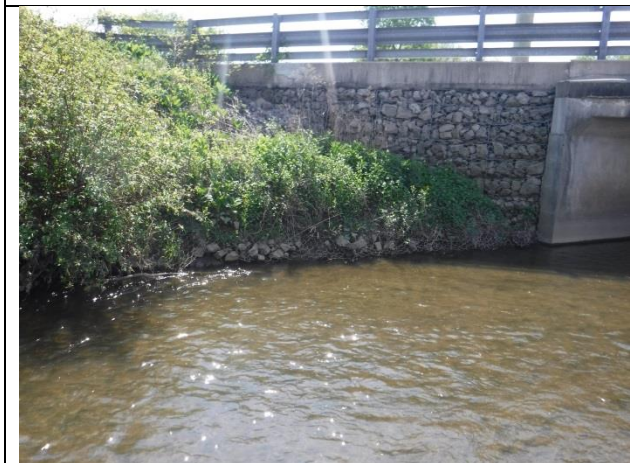
Failing gabion toe on right bank

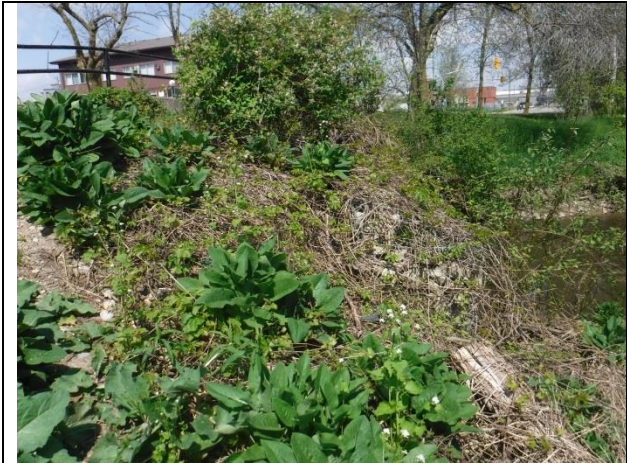
Failing gabion basket abutments

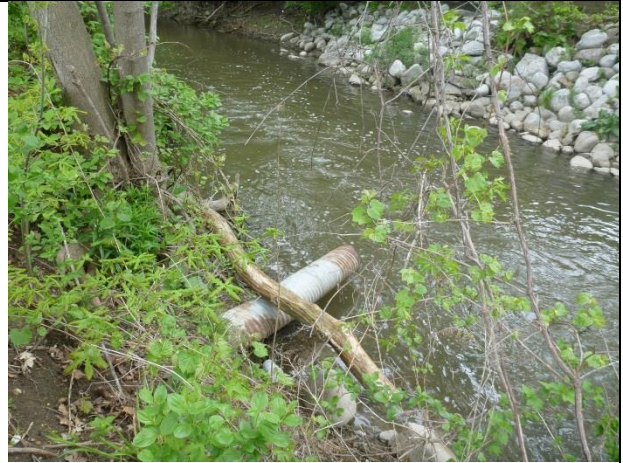
Storm outfall in poor repair

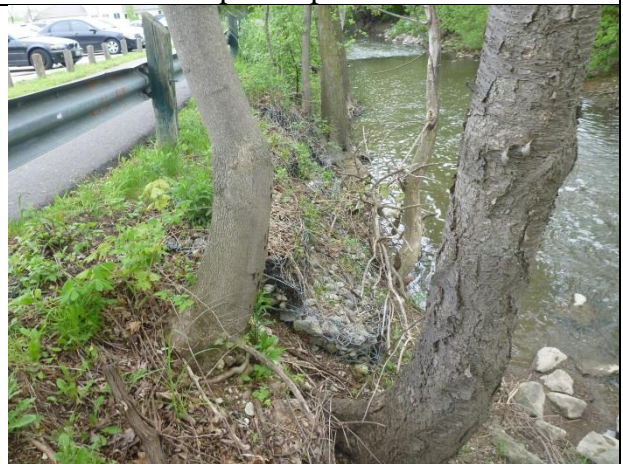
Failing gabions on slope adjacent to trail

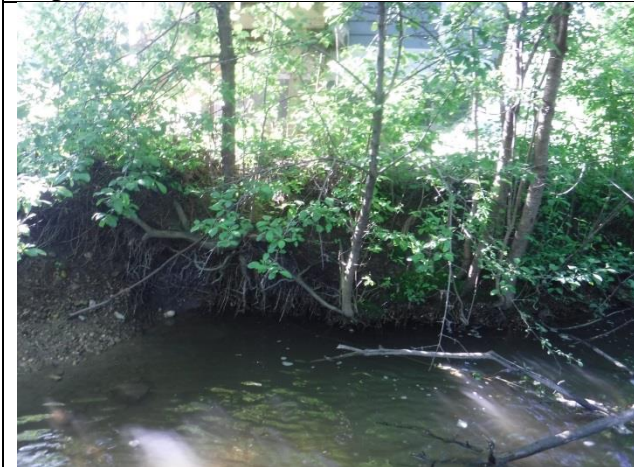
Eroding bank with structure in background

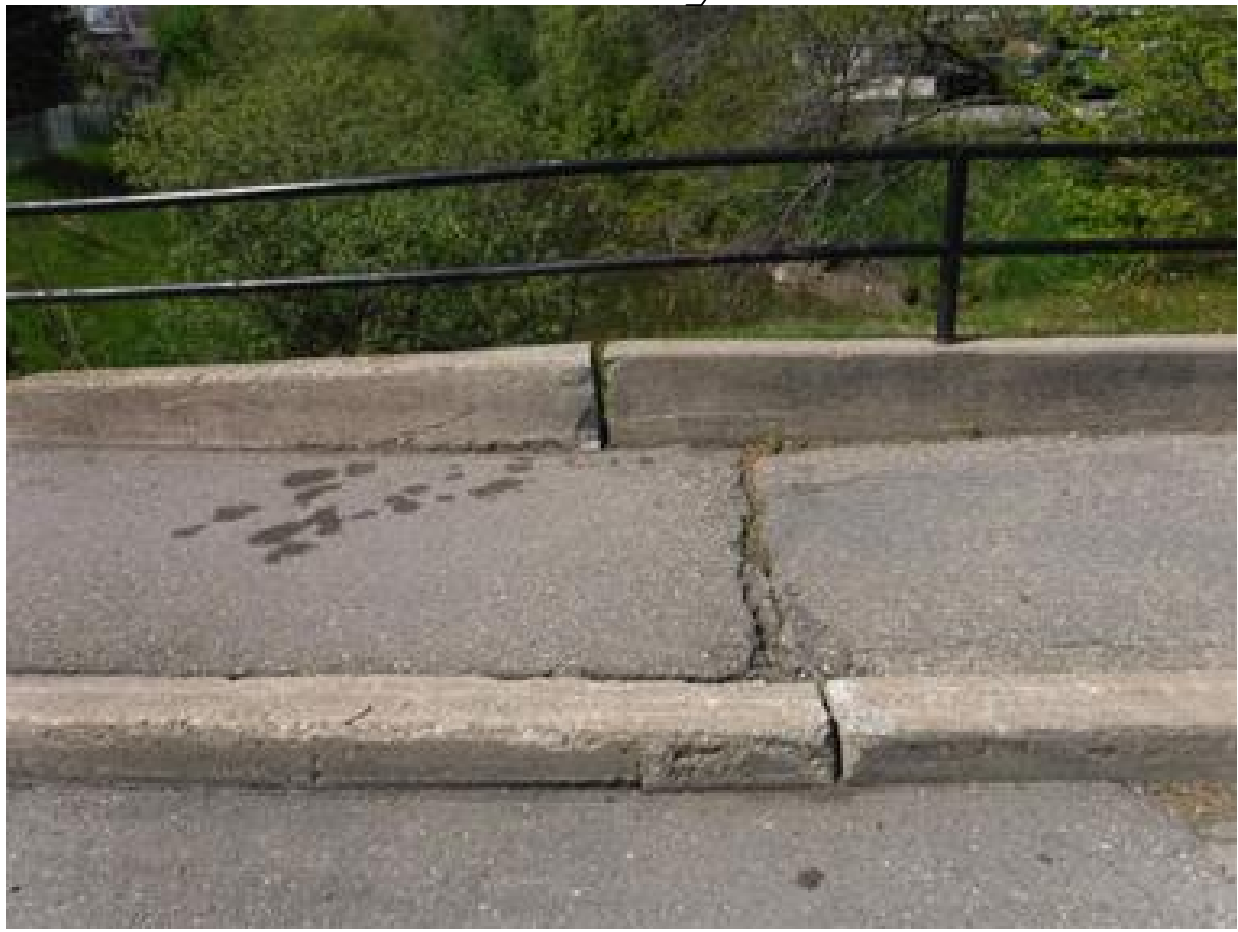
CRACKS IN CURB AND ASPHALT ON BRIDGE DECK

The private bridge structure should be assessed for structural condition and replaced as required. At a minimum, the failing gabion basket abutments should be replaced as part of the above channel bank restoration works.

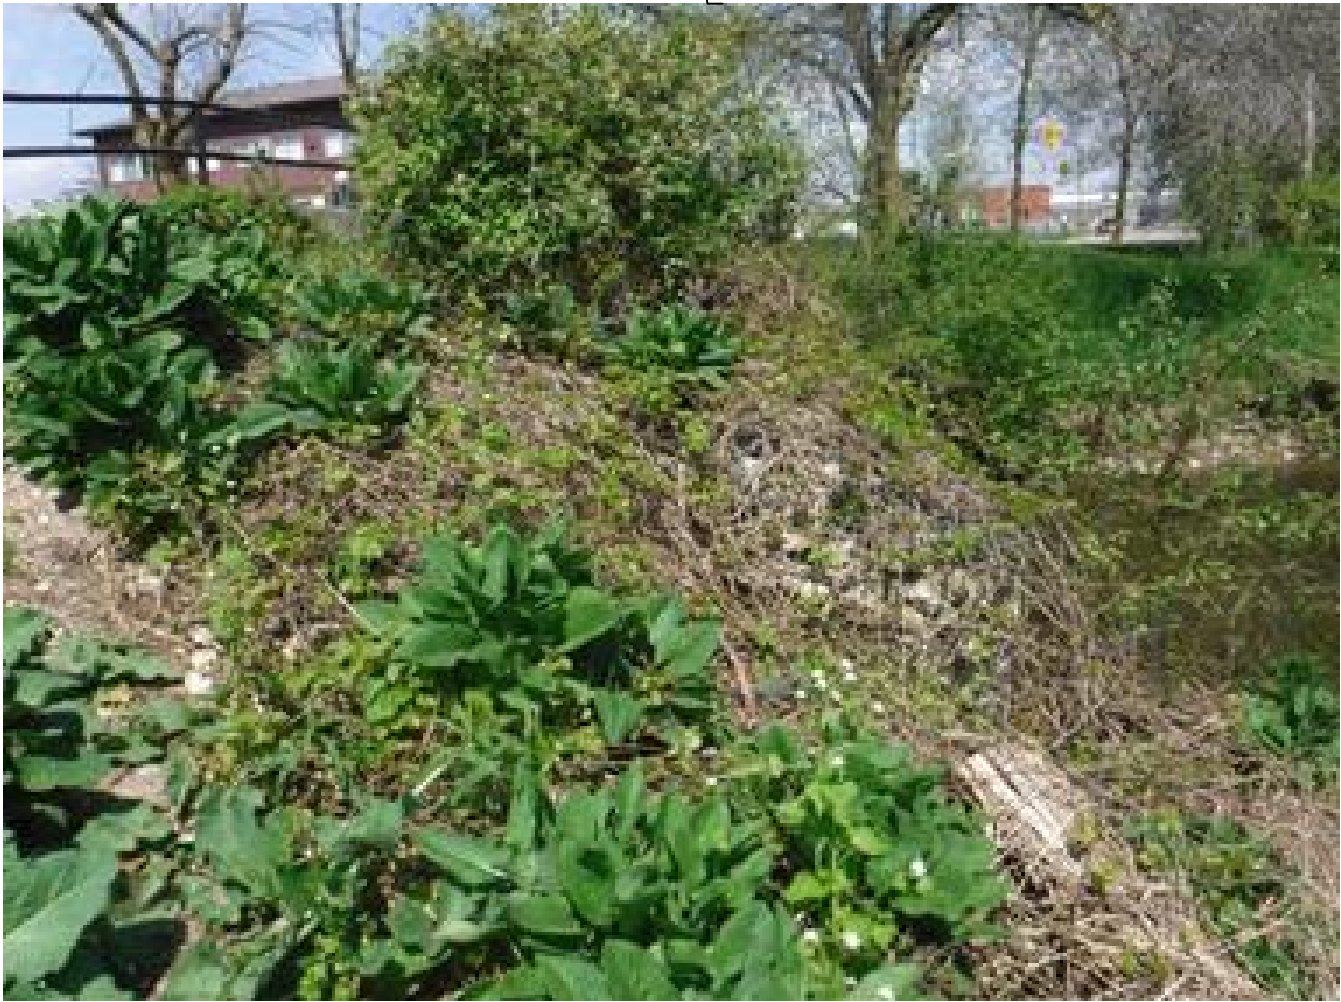
FAILING GABION BASKET ABUTMENTS

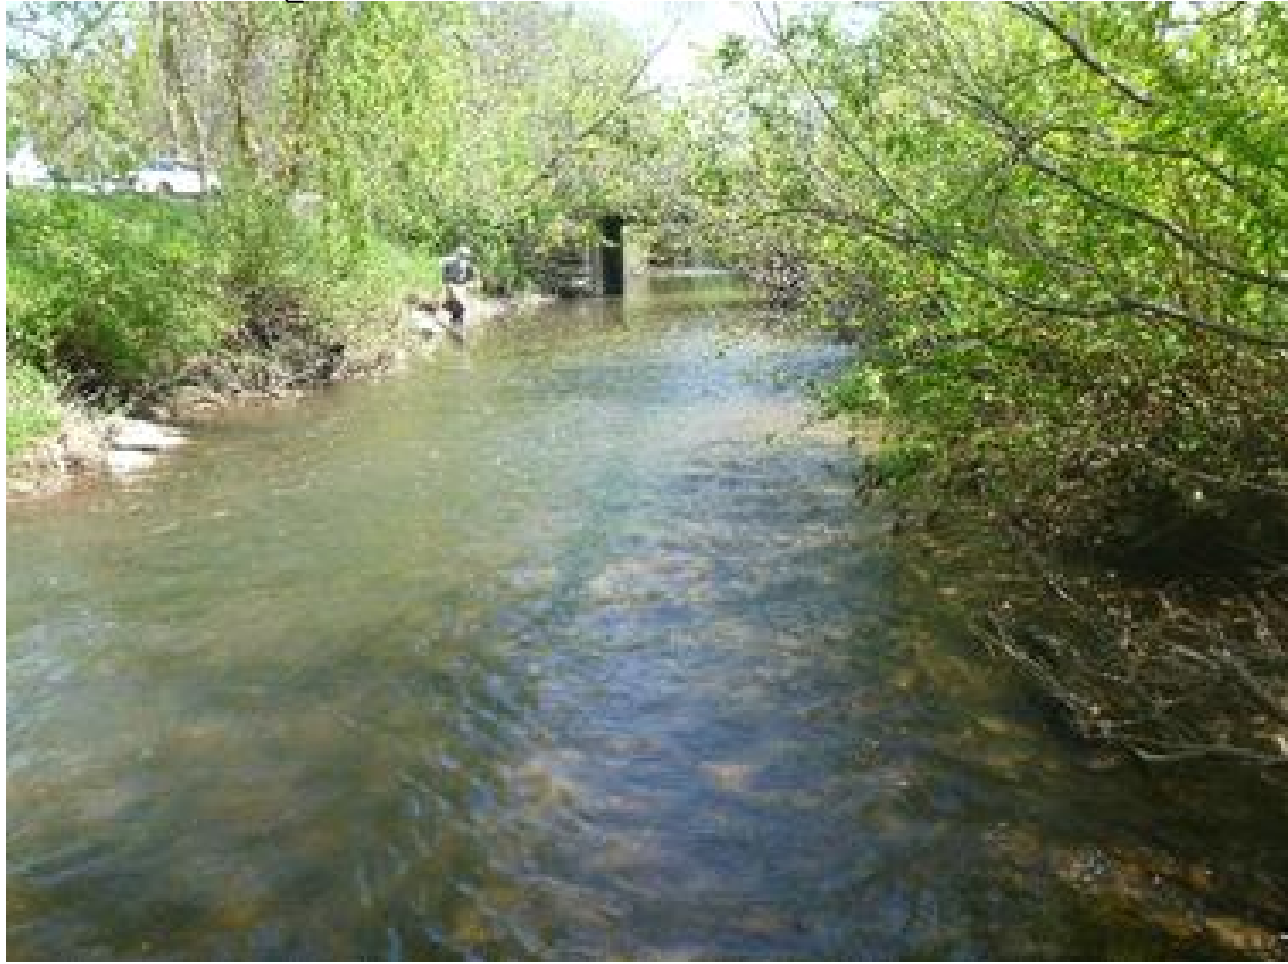
A concrete conduit, approximately 2.5 m in width, was exposed to varying degrees on the channel bed between University Avenue and Marshal Street. The sides of conduit are exposed in some areas. Planning locates were requested through Ontario One Call and no utilities identified in the planning locates ran along the length of the creek.

EXPOSED CONCRETE ON CHANNEL BED

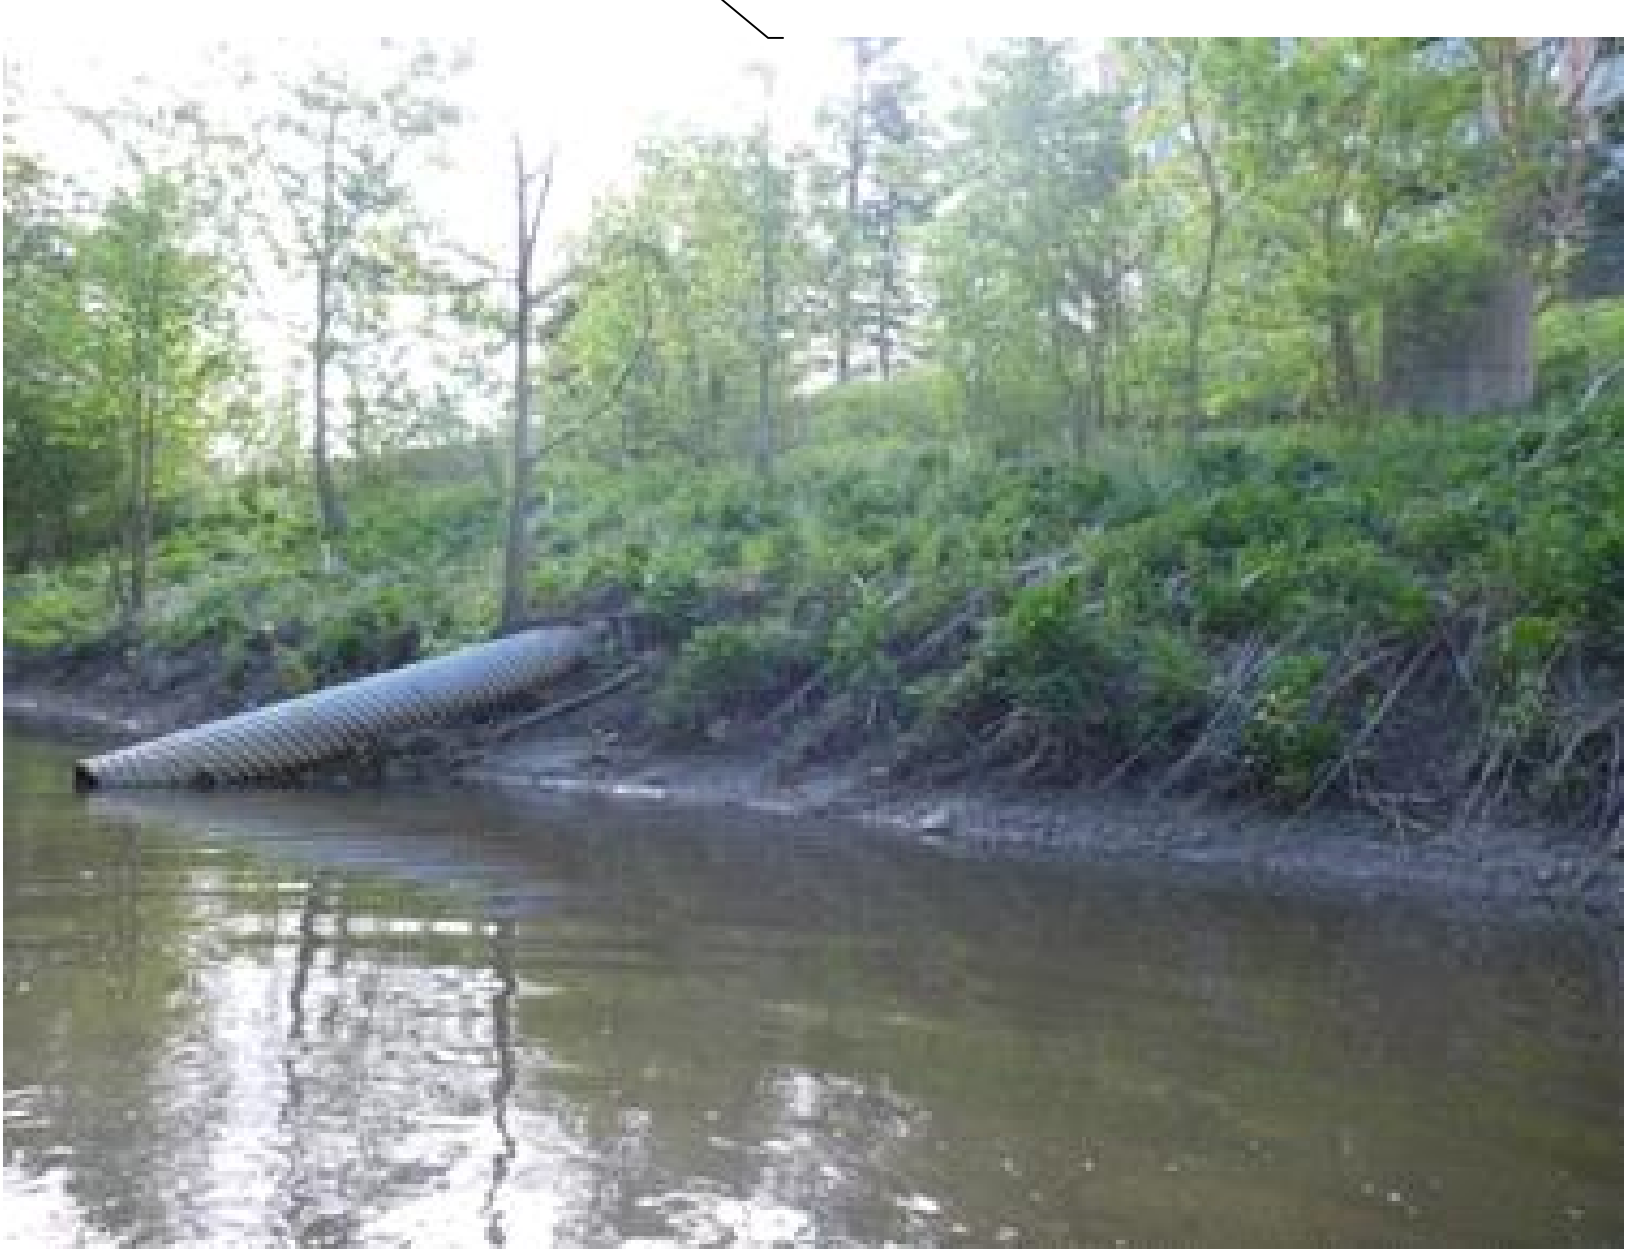
NEAR VERTICAL BANK EROSION IN FRONT OF MH. FAILING PRIVATE OUTFALL.

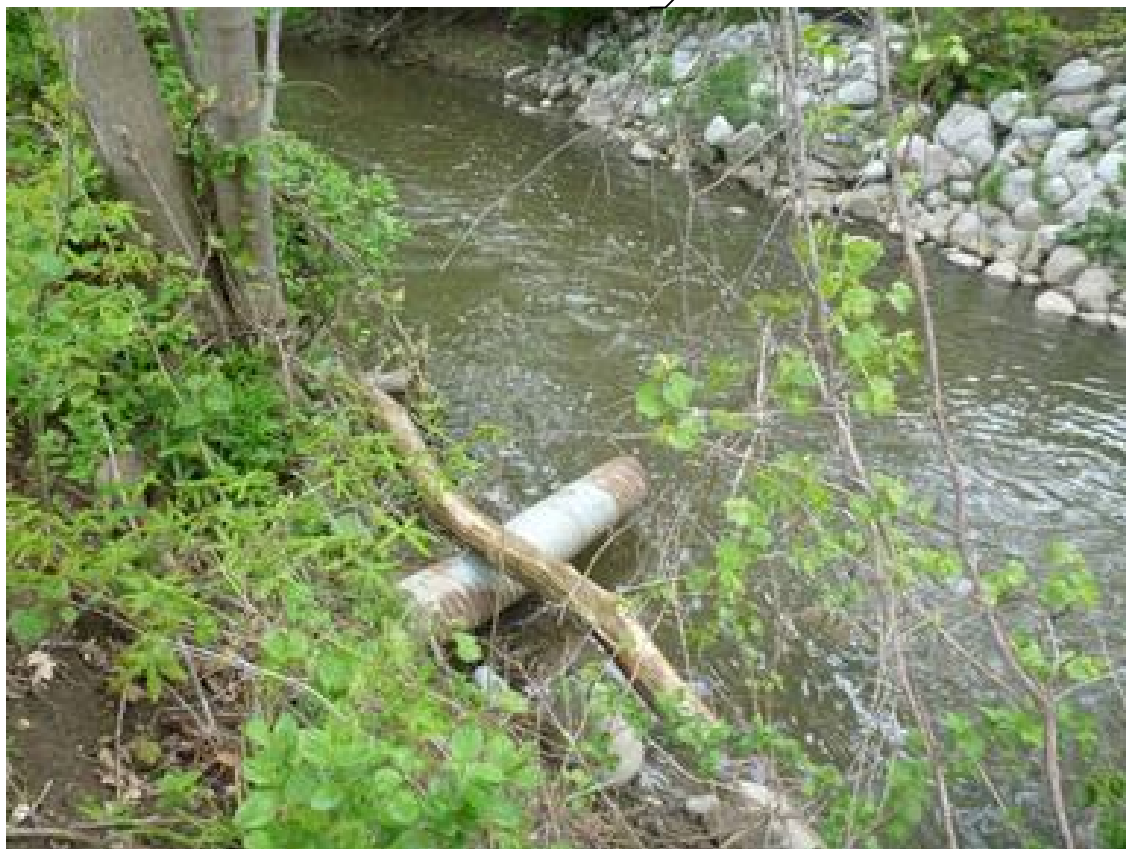
STORM OUTFALL IN POOR REPAIR

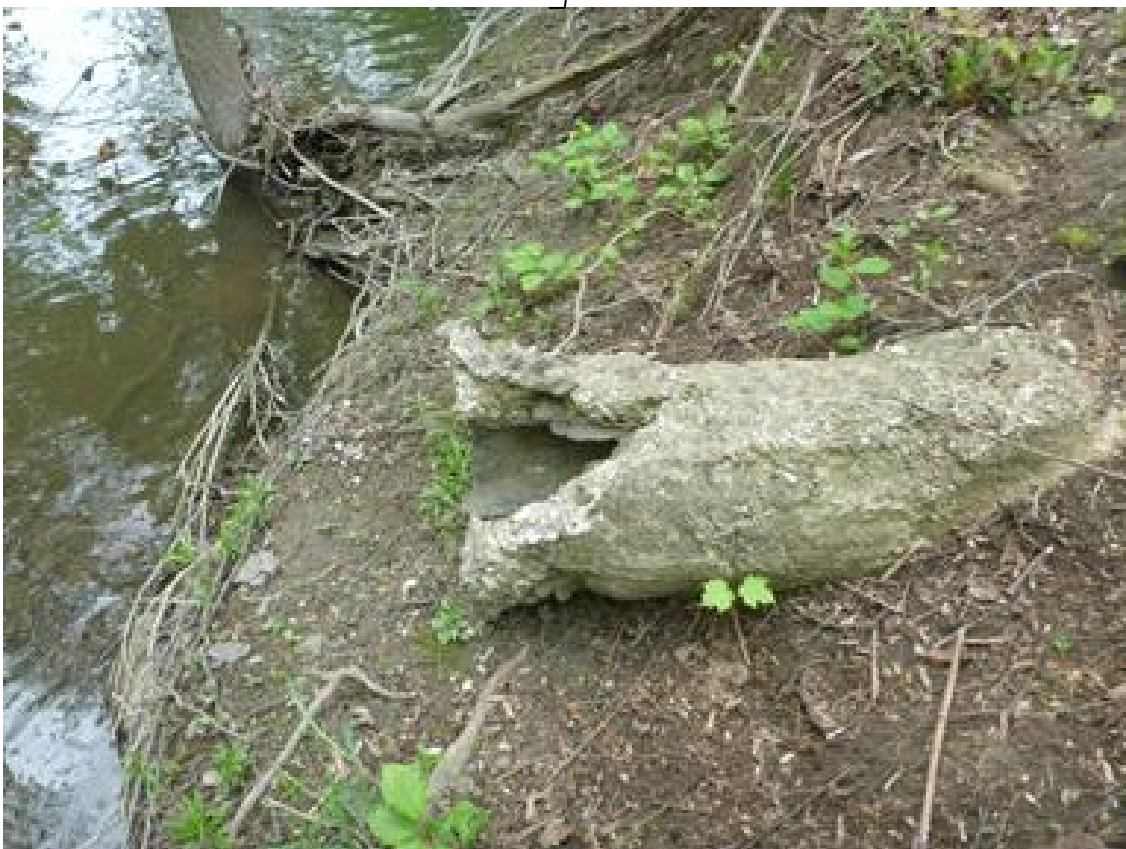
STORM OUTFALL IN POOR REPAIR

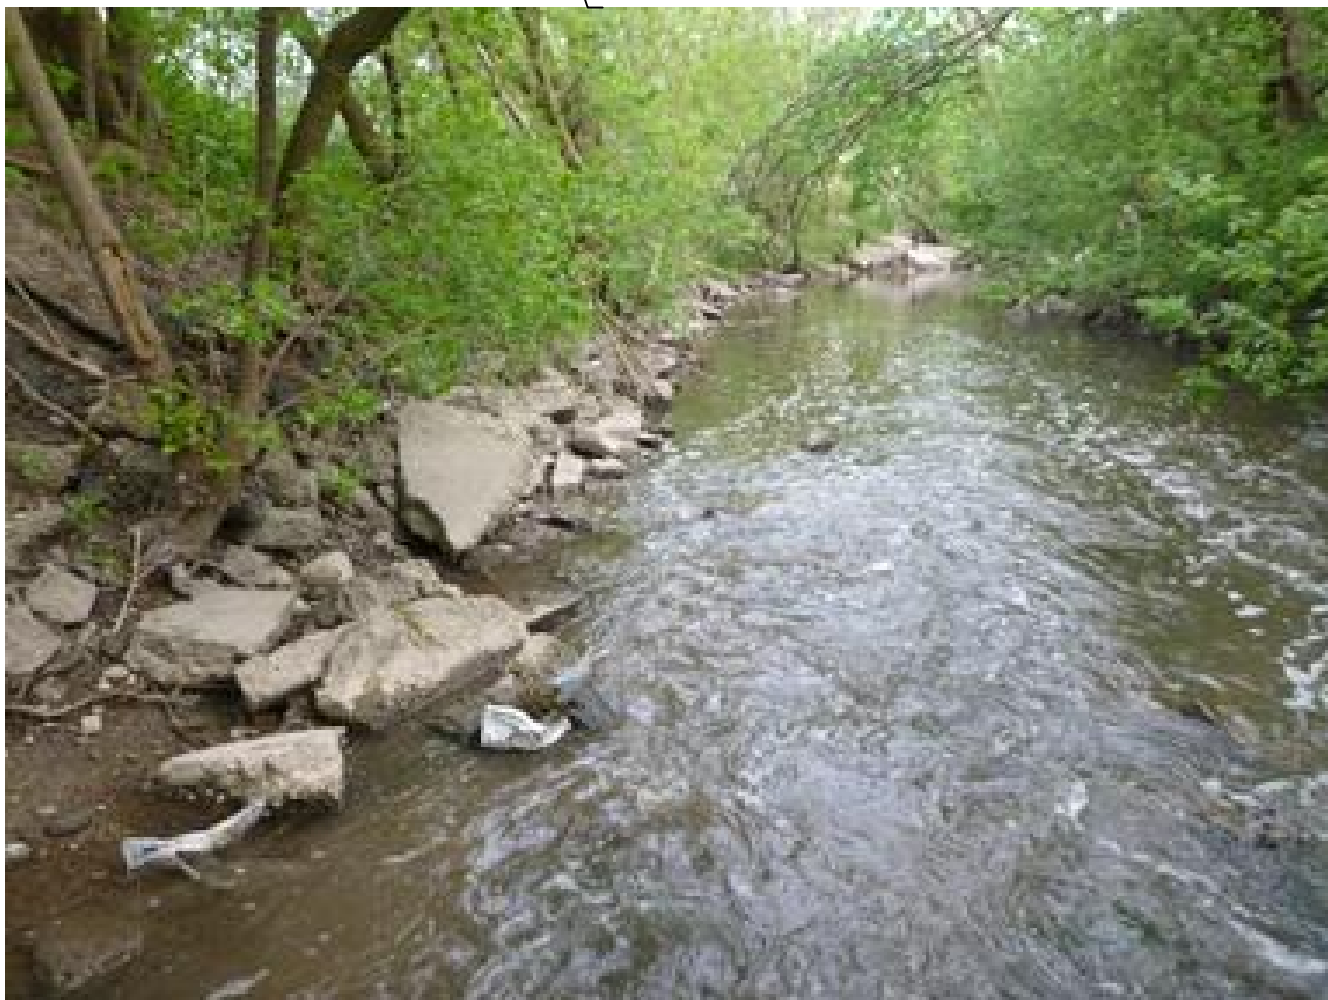
CONCRETE DEBRIS ON TOE OF BANK

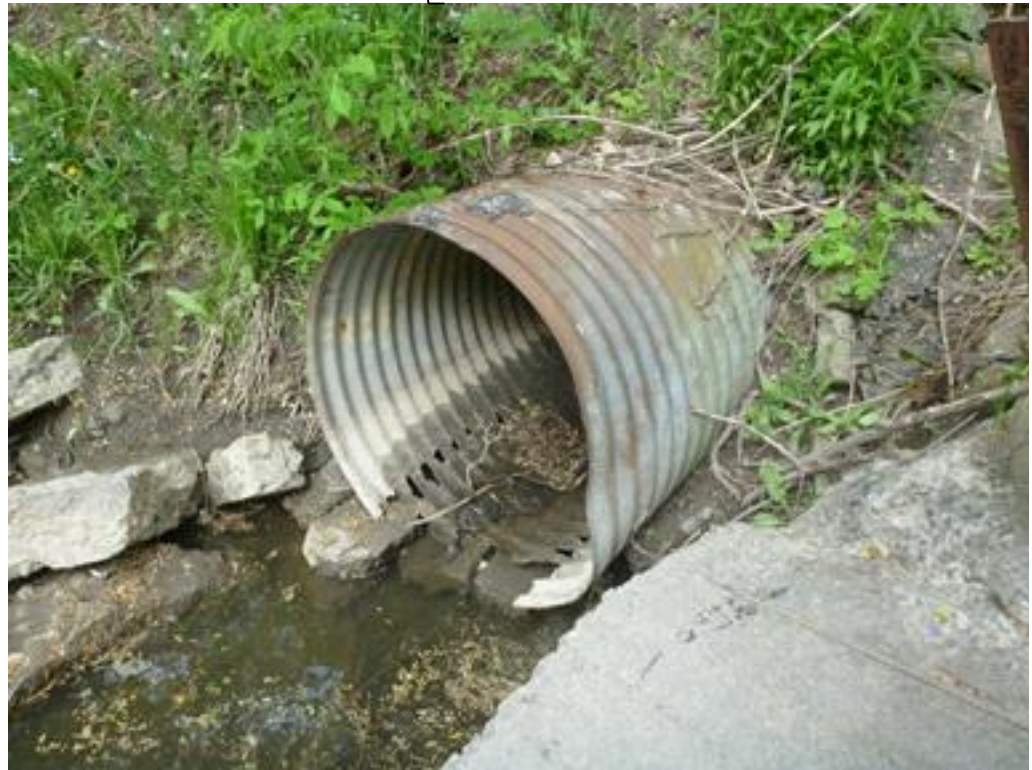
STORM OUTFALL IN POOR CONDITION

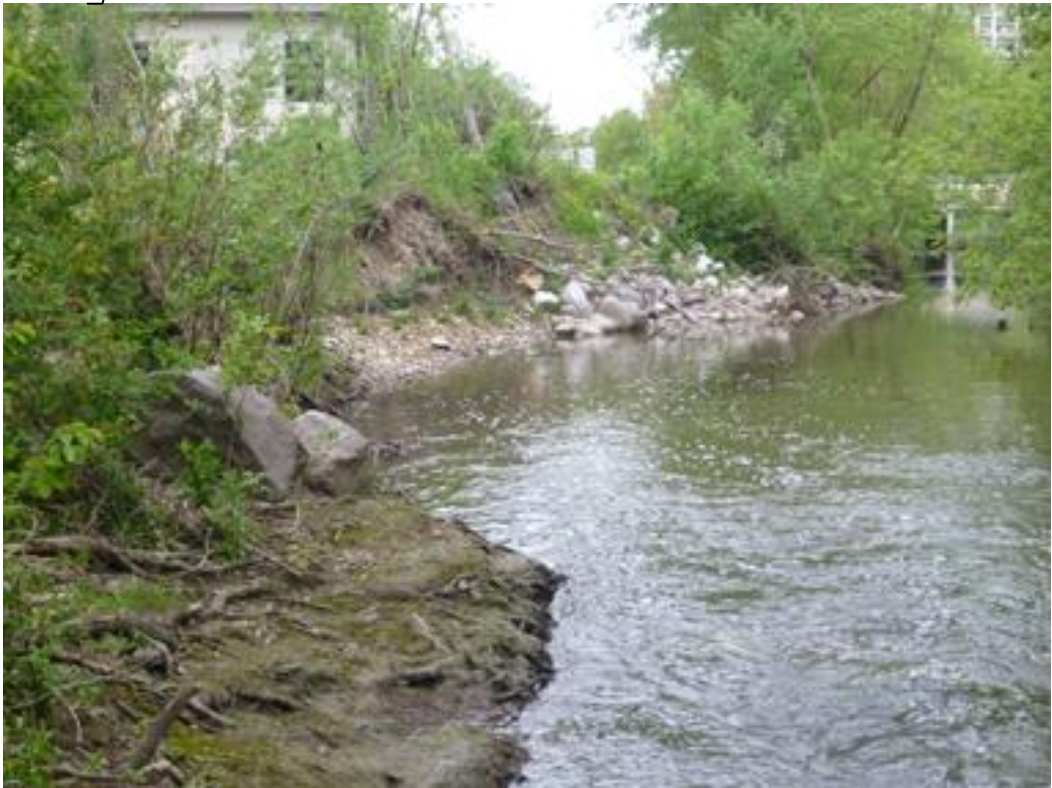
EROSION UPSTREAM OF ROUNDSTONE TREATMENT

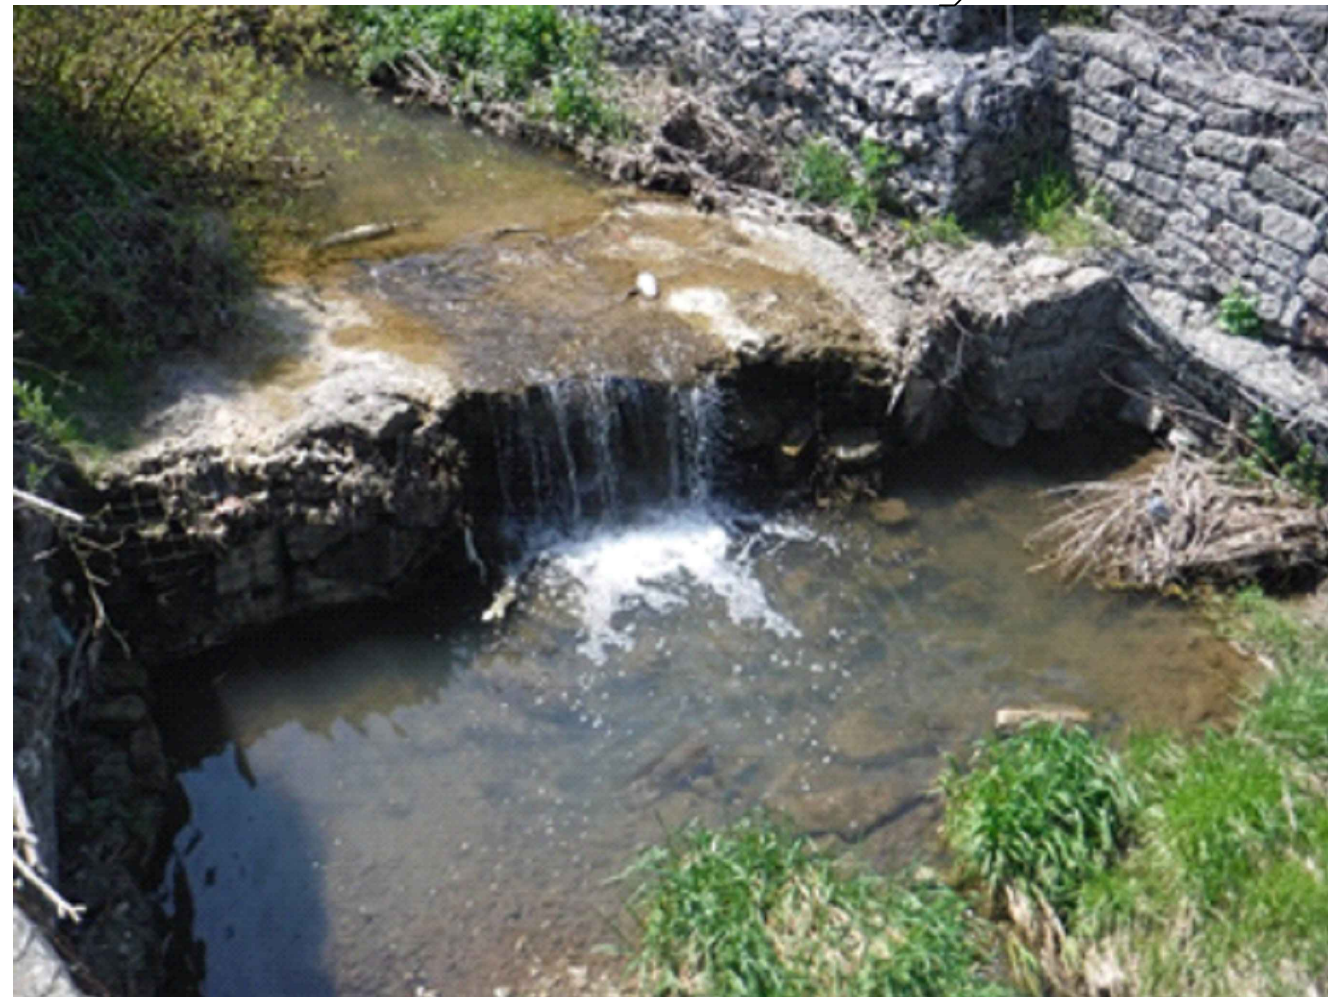
FAILING GABION BASKET WEIR

On the upstream side of Albert Street, a gabion weir is failing with scour occurring downstream of the weir. The base layer of the gabion treatments is failing and as is the concrete lining on the bed.

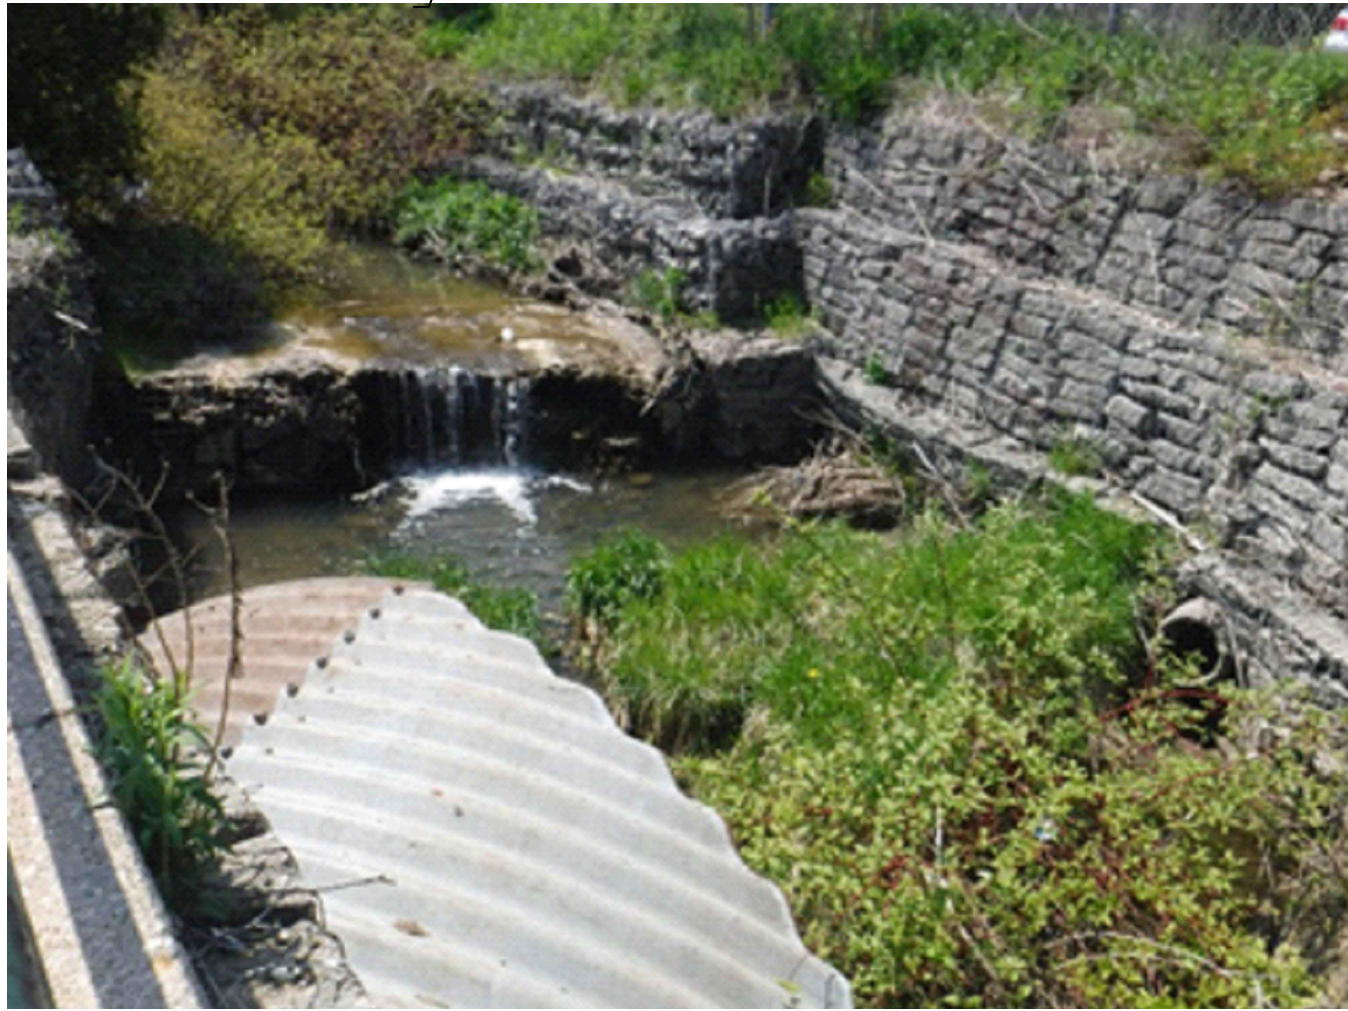
FAILING CONCRETE AND GABION BASKET WEIR ON UPSTREAM SIDE OF ALBERT STREET

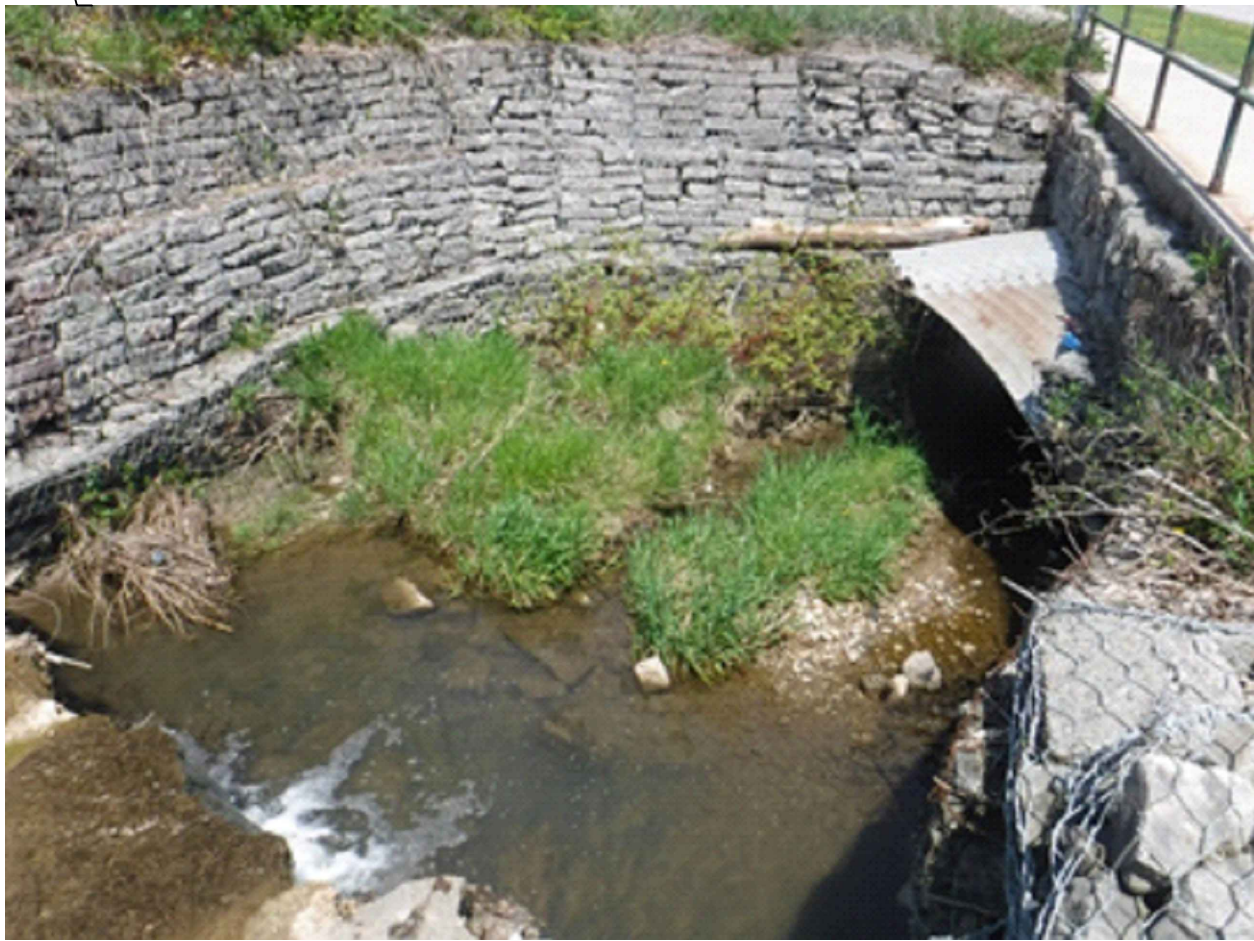
CULVERT ON UPSTREAM SIDE OF ALBERT STREET

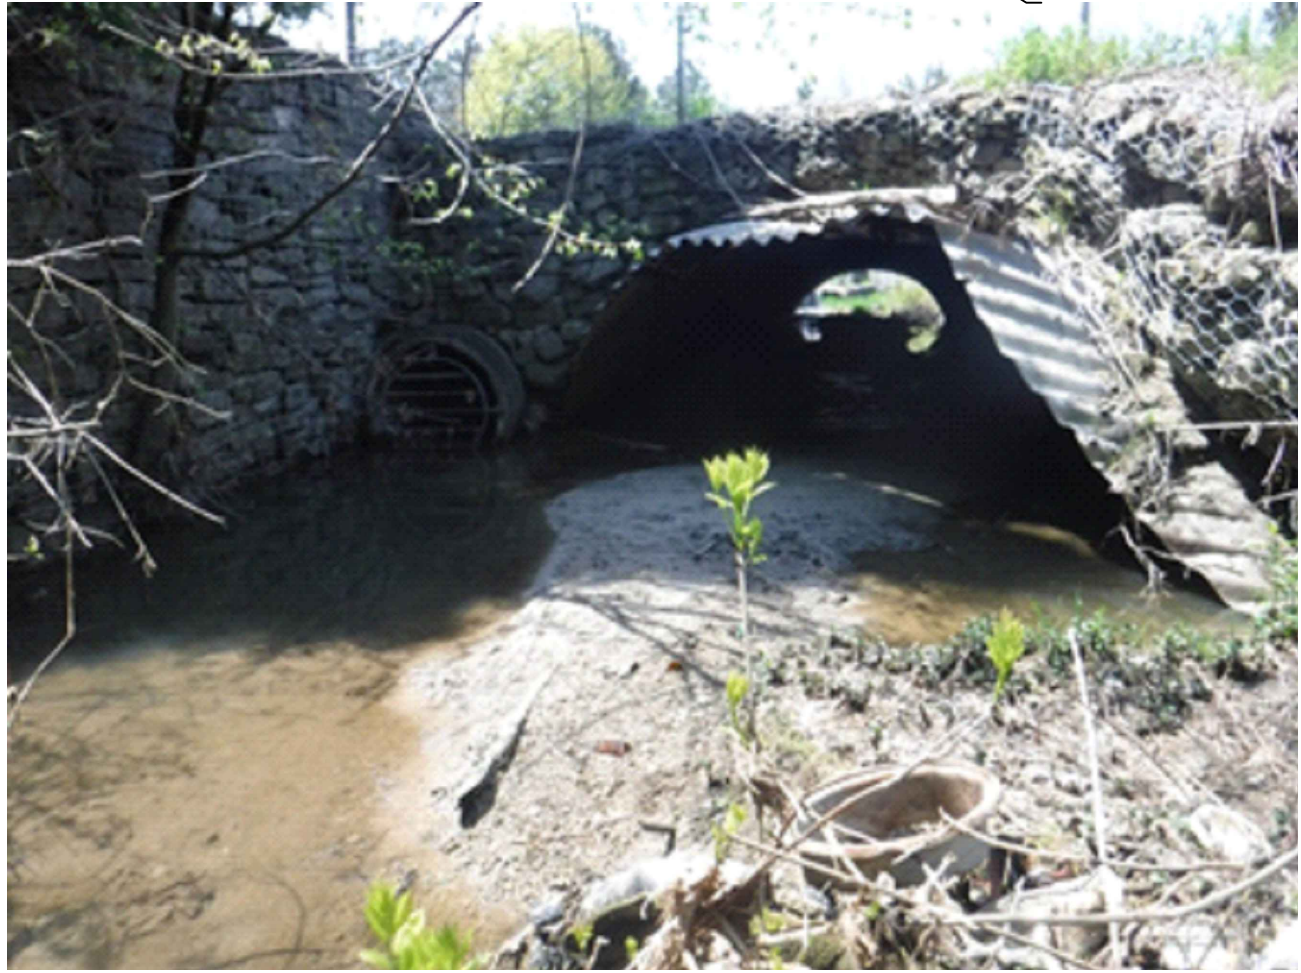
CONDITION OF CULVERT ON DOWNSTREAM SIDE OF ALBERT STREET

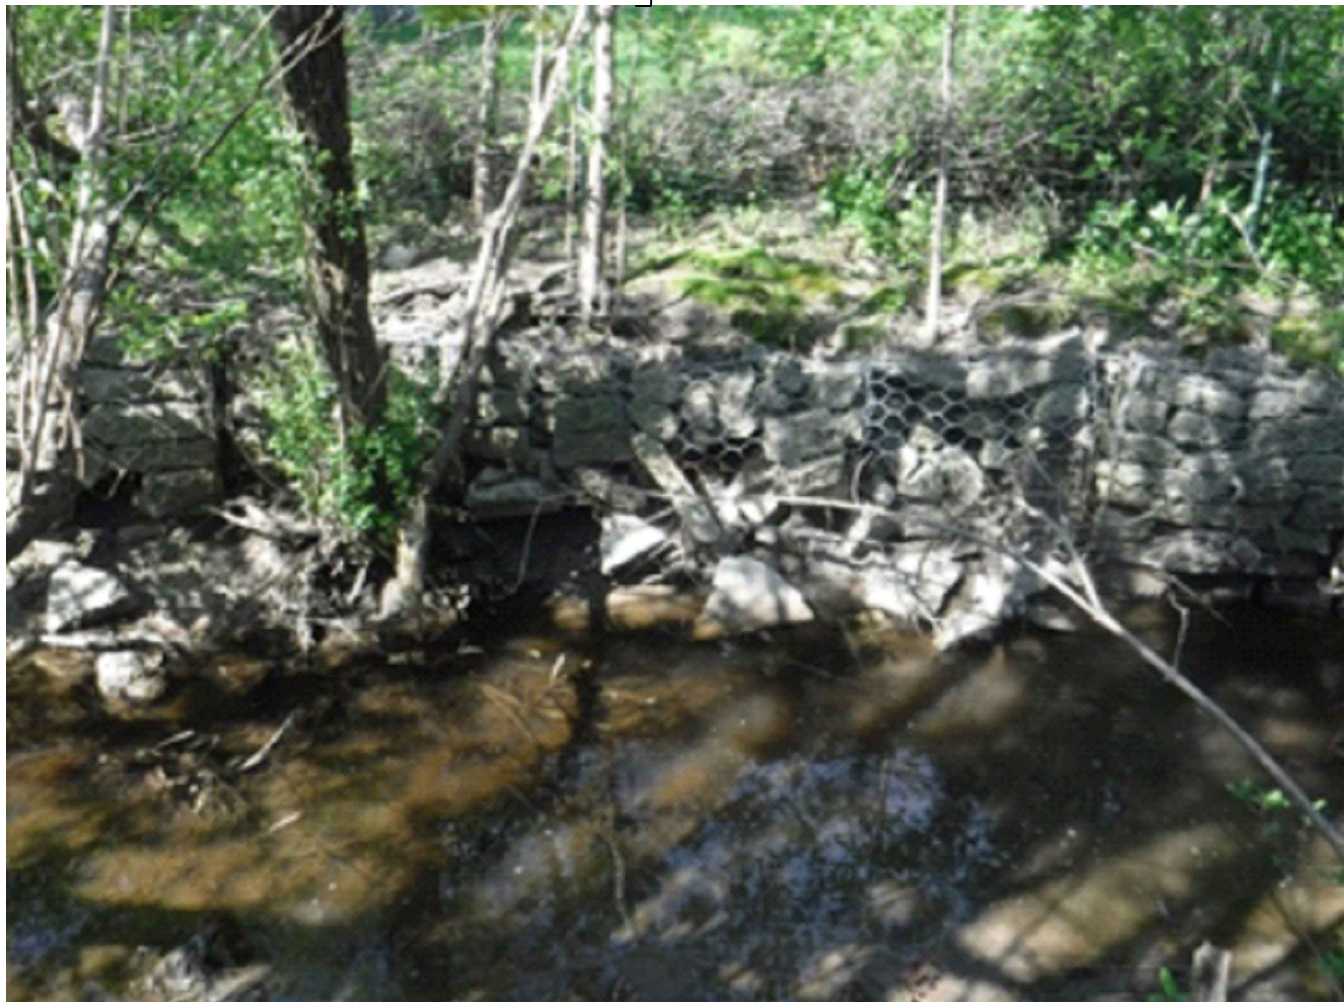
LOCATION 2 - FAILING GABION BASKETS ON LEFT BANK
