CITY OF WATERLOO

Municipal Class Environmental Assessment

WATERCOURSE EROSION MASTER PLAN

Aquafor Beech Ltd.

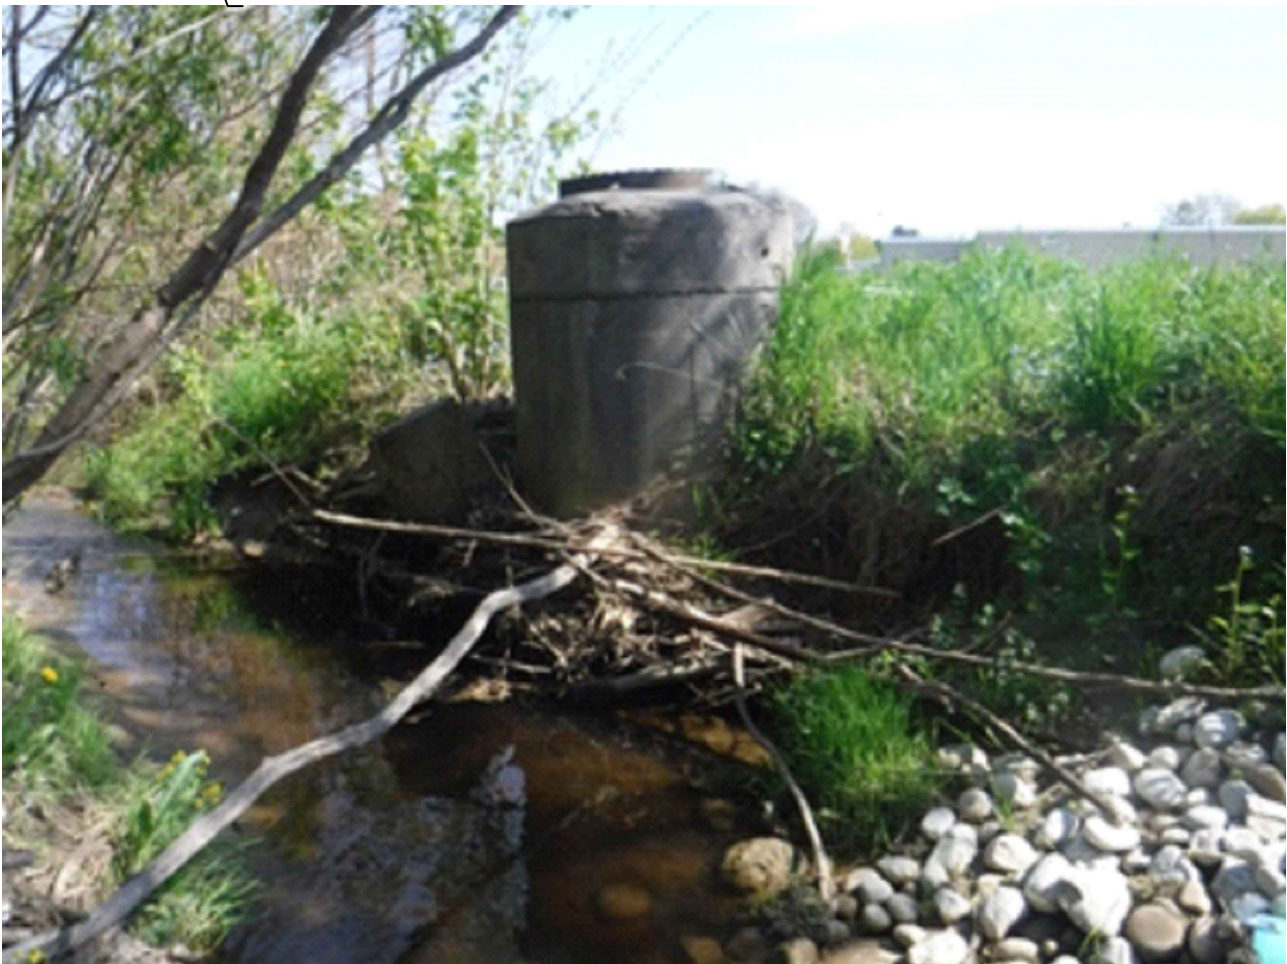
LOCATION 1 - SCoured BANK IMMEDIATELY UPSTREAM OF MH

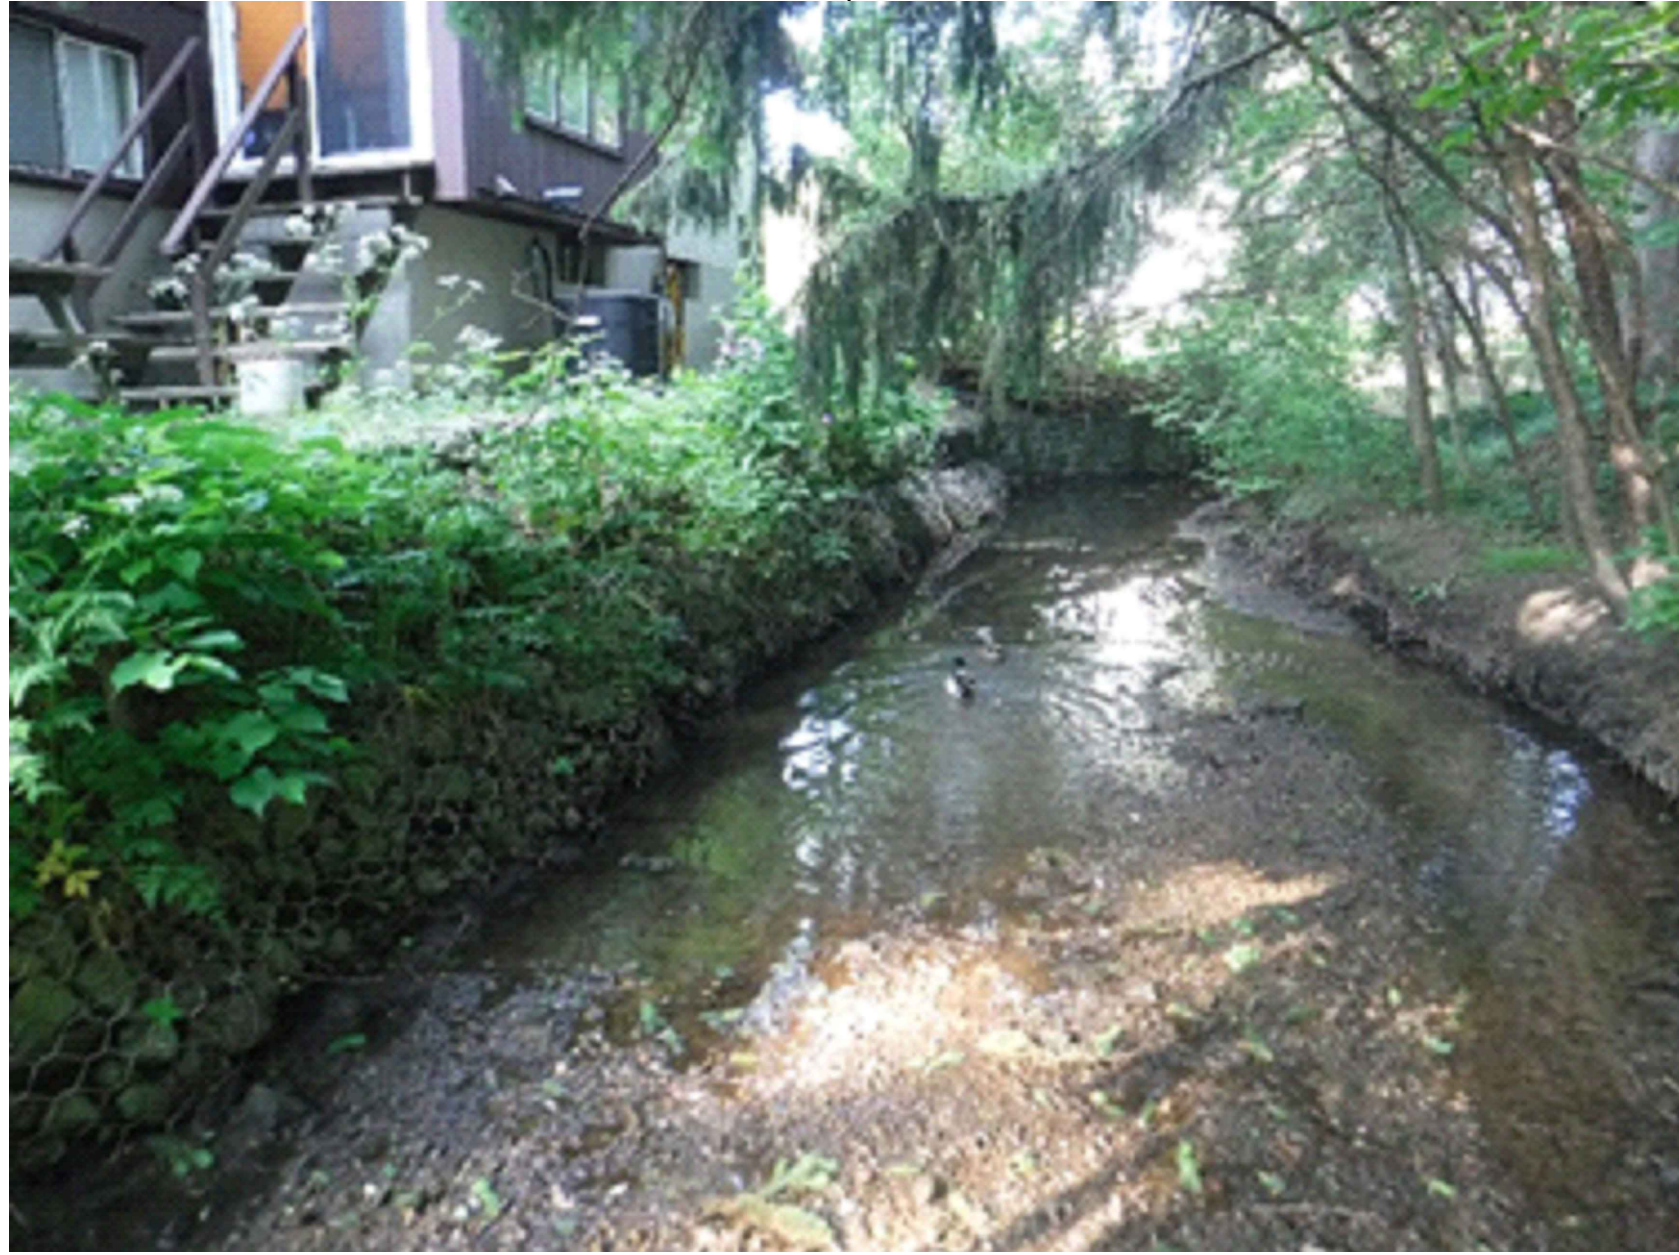
Gabion basket bank treatments are failing behind 116 Keats Way Place. The gabions are located on the south side of the creek and the building is located within 5m of the top of bank.

HOUSE LOCATED WITHIN 5 M OF THE TOP OF BANK

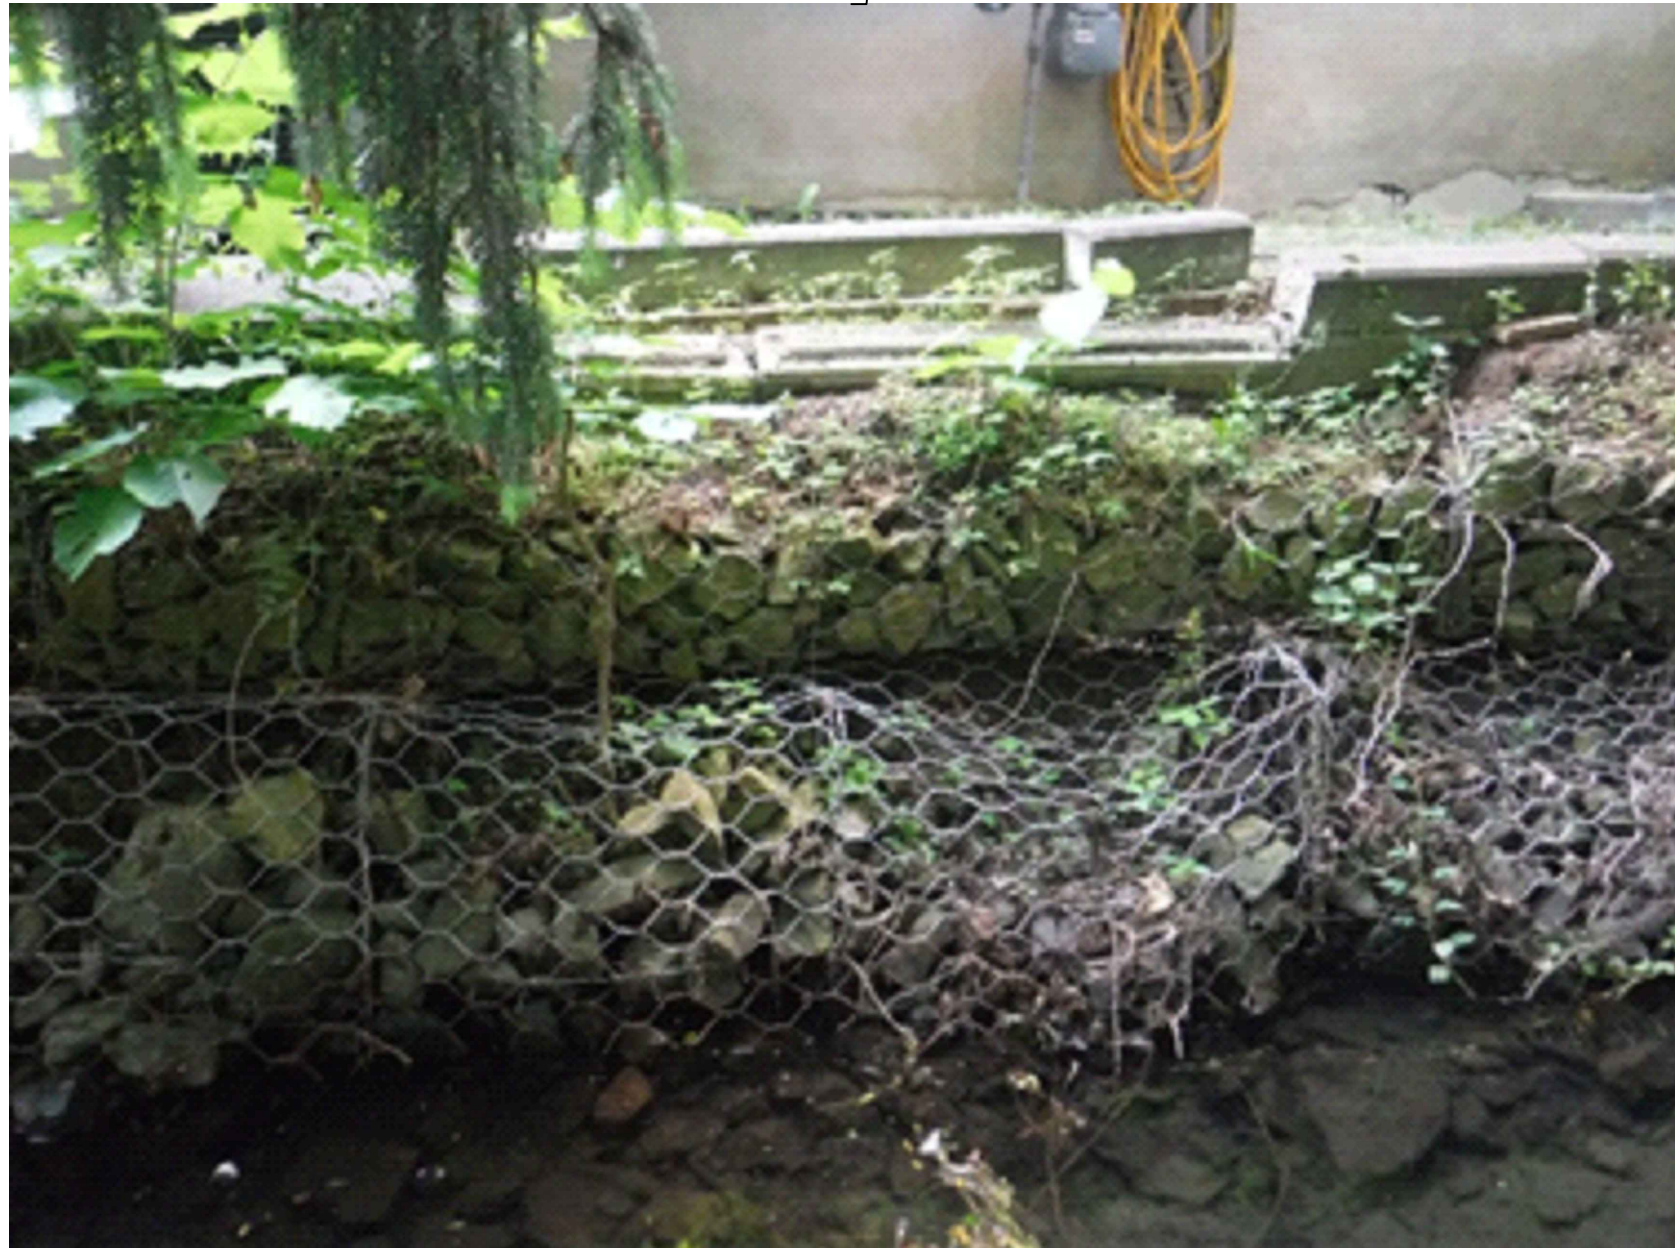
FAILING GABION BASKETS

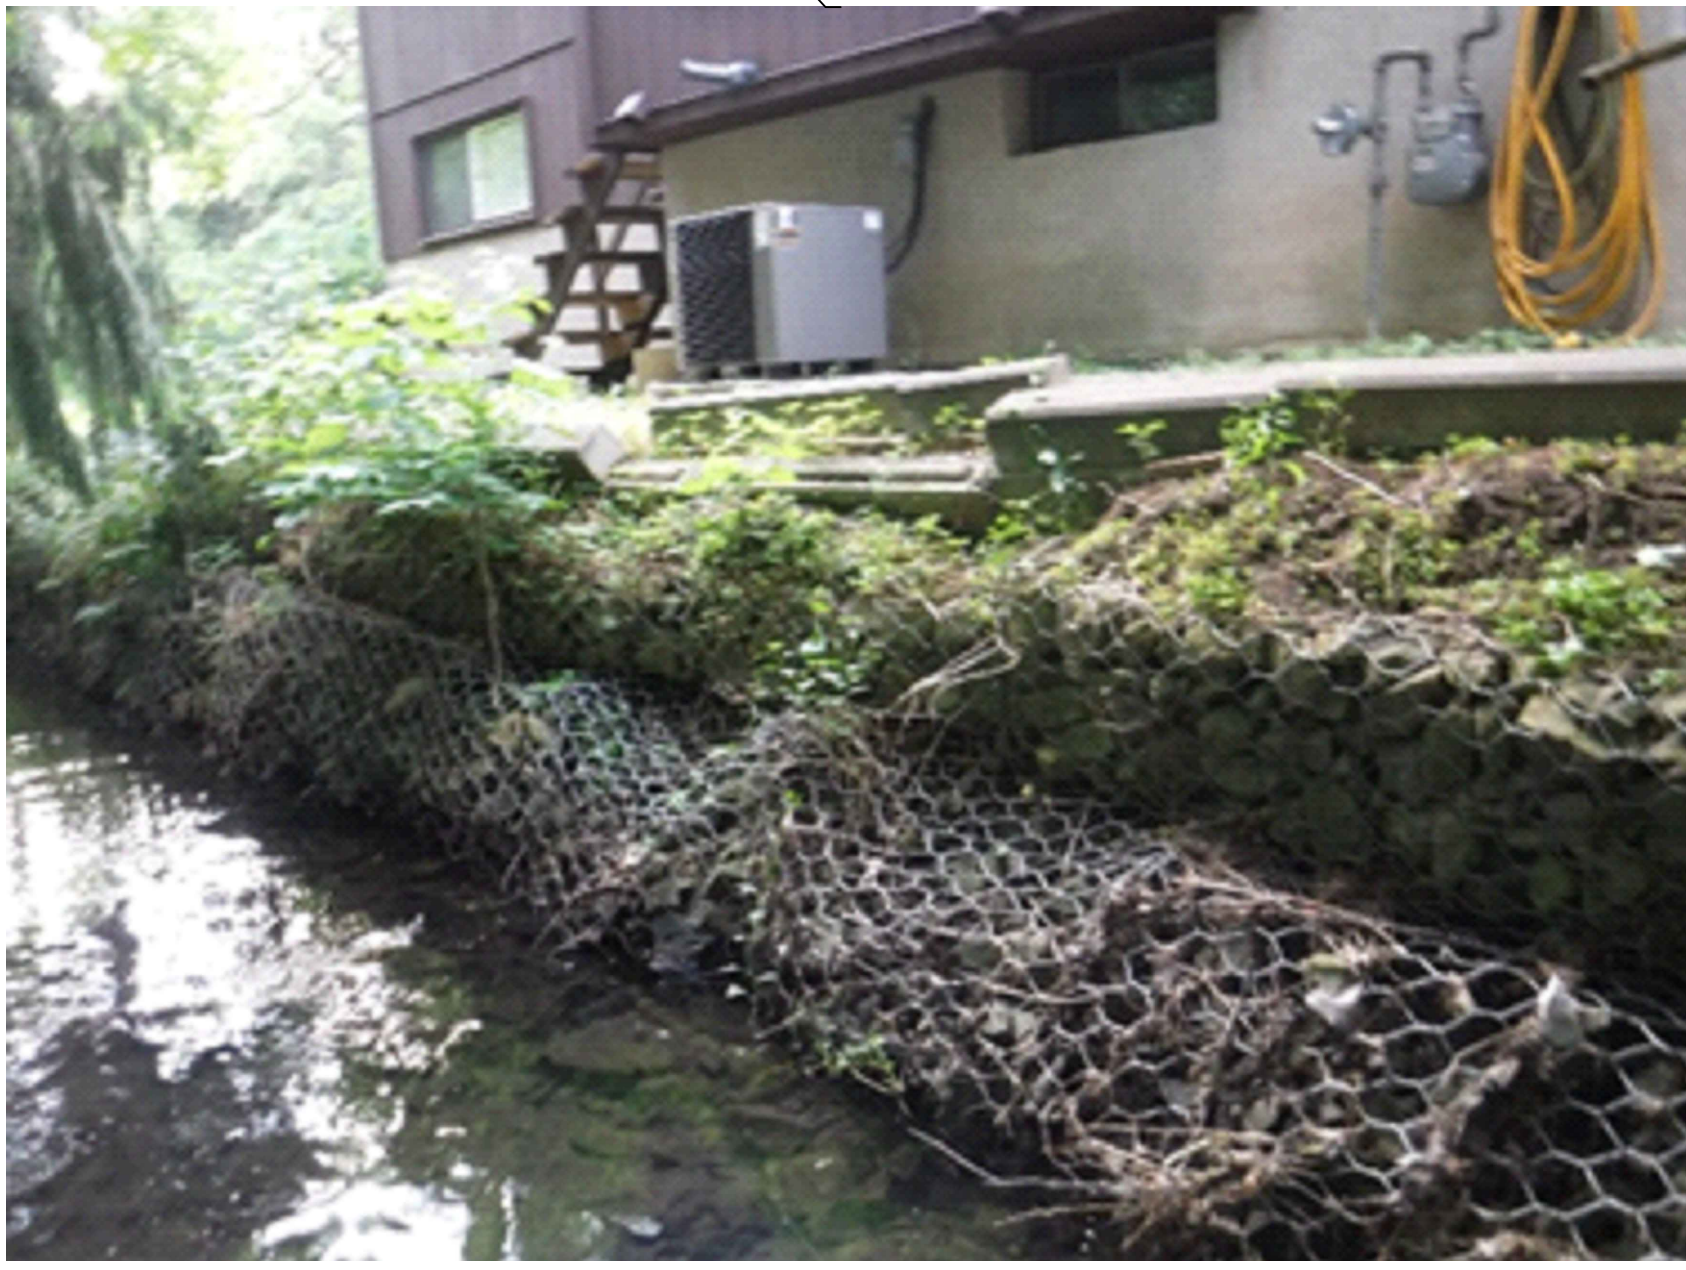
FAILING GABION BASKETS

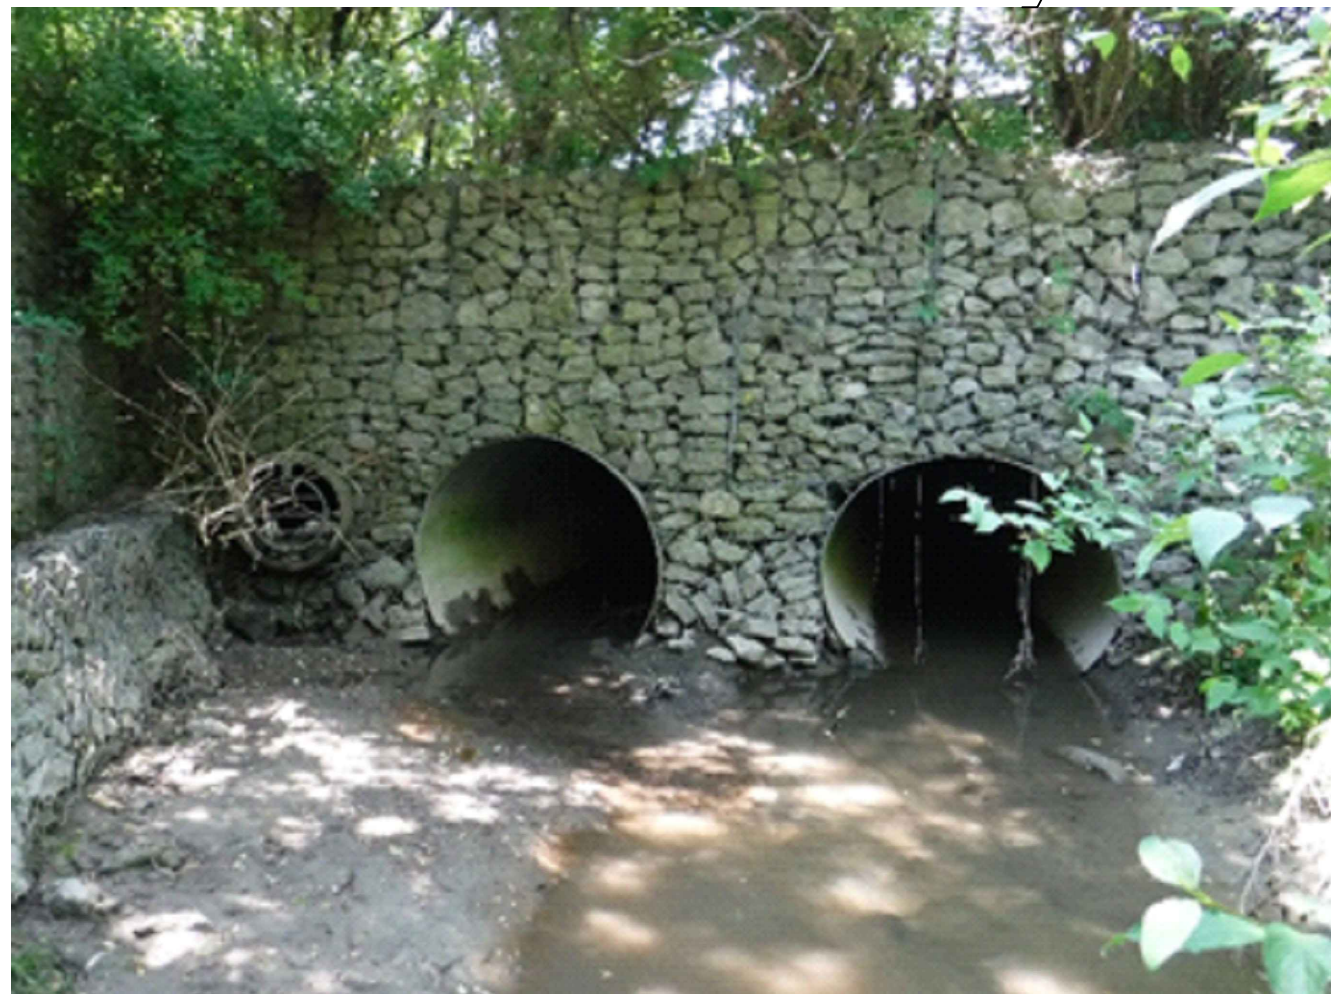
Gabion basket bank treatments are in varying states of failure extending from Columbia Street downstream to 2 storm sewer outfalls. A pile of rip rap has developed in this area. A sanitary sewer crosses under the creek in the vicinity of the storm sewer outfalls. At Columbia Street, 2 CSPs convey flows under the road. The CSP on the east appears to be deformed.

GABION BASKET HEADWALL AT COLUMBIA STREET WITH LOWER BASKETS EMPTYING

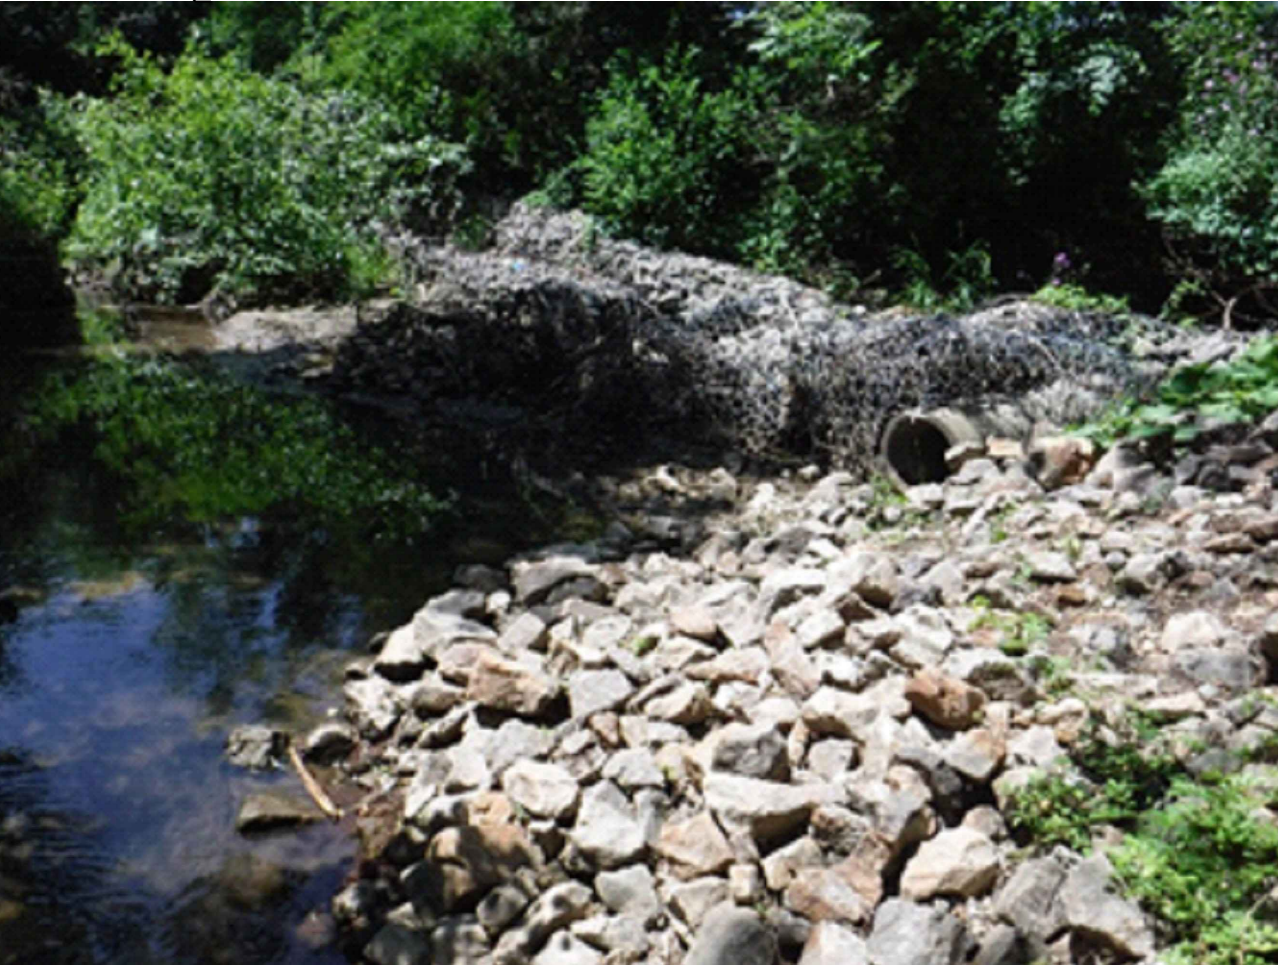
RIP RAP WITH FAILED GABION BASKETS AND STORM OUTFALL IN BACKGROUNDS

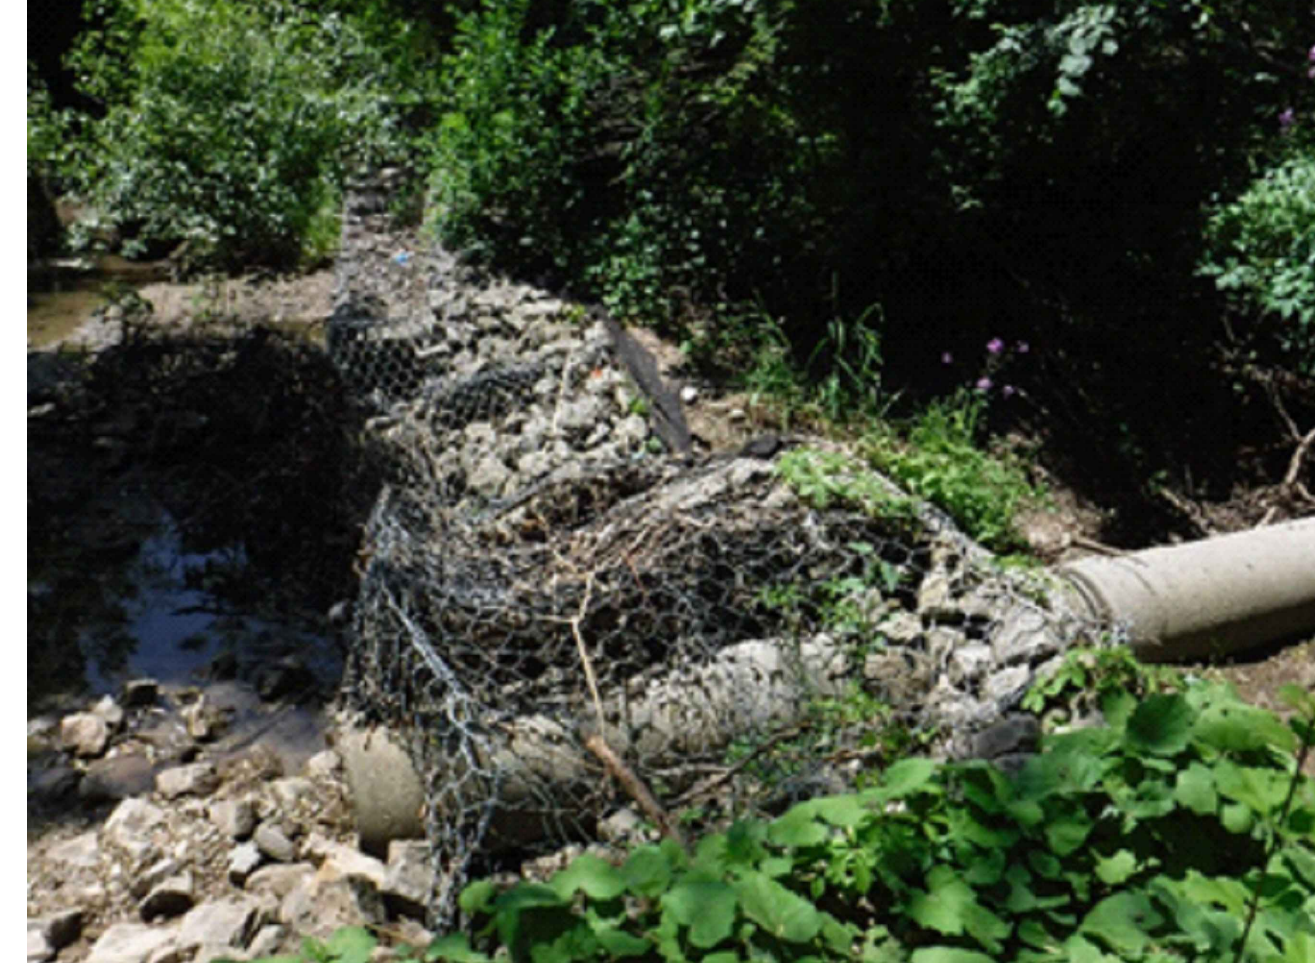
FAILED GABIONS OVER STORM SEWER OUTFALL
