# Memorandum

<b>To/Attention</b>	City of Waterloo	<b>Date</b>	March 9, 2020
<b>From</b>	Tim McCormick	<b>Project No</b>	37090
<b>cc</b>	Thomas Hardacre, IBI Group Sunvest Homes Corp.		
<b>Subject</b>	Multi-Use Trail Assessment for 364 Woolwich Street, Waterloo ON

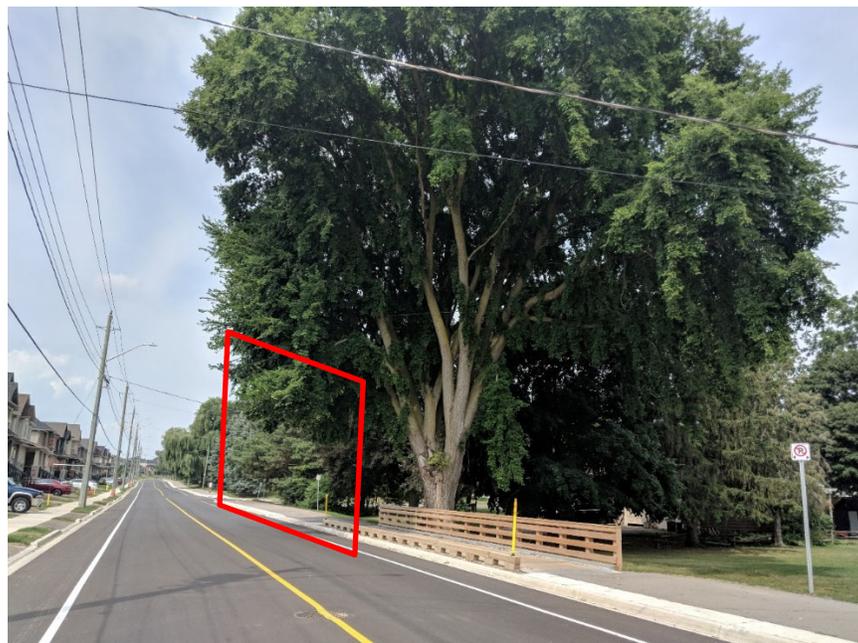
Woolwich Street was urbanized in 2017/2018 upgrades included concrete curb and gutter, infrastructure improvements, road widening uni-directional cycling lanes on both sides of the road, concrete sidewalk on the south side of the road and a 3.0m wide asphalt multi-use trail on the north side which is part of the Walter Bean Trail network. The current property at 364 Woolwich Street has a frontage of 51.6m with a double car driveway located at the eastern limit of the property. The existing driveway is approximately 7m wide by 20m long and extends to a double car garage that is set approximately 2.0m deeper than the front of the house. Currently, there are potential conflicts at the trail due to cars entering and exiting the property across the trail at this location.

Photo1: Site location and existing condition.

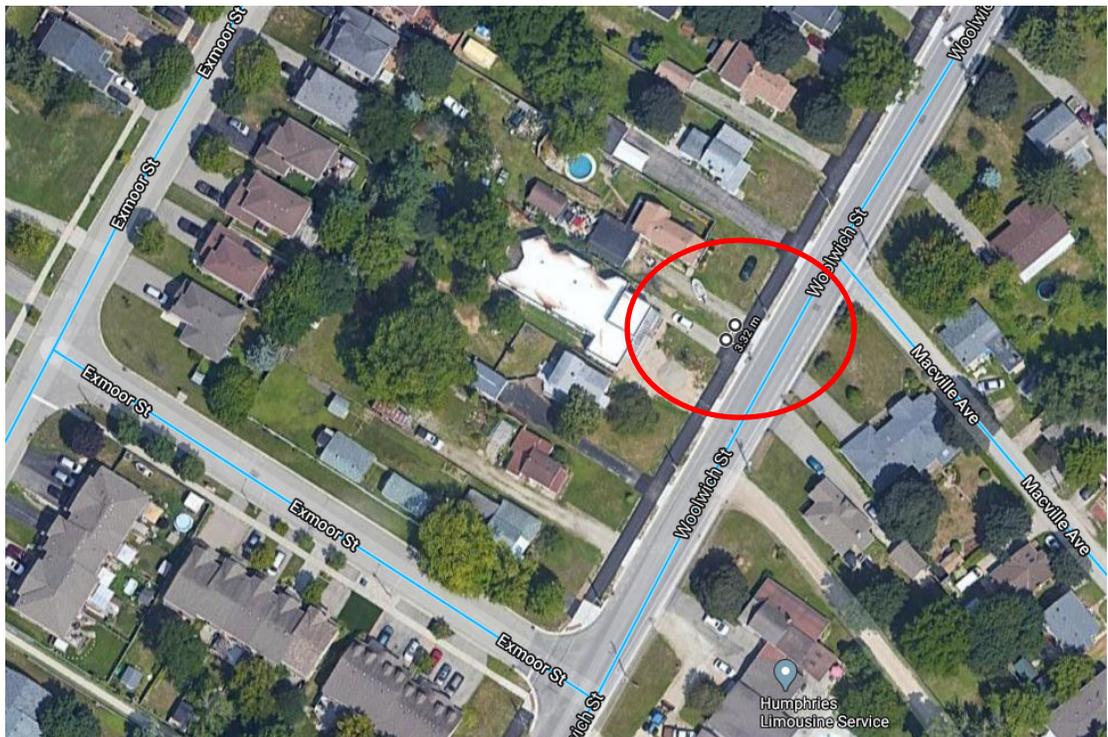
The proposed lot severance will divide the lot into three separate lots (see attached plan). This could result in an additional two driveway crossings over the Walter Bean Trail for a total of three. This creates a potential for conflict, however it is not a unique situation along the trail and there are several areas that have a similar condition along the Walter Bean Trail south of the property on Woolwich Street. We noted that there are driveway locations as close as 4m apart in section south of this property on Woolwich Street at Exmoor Street, see Figure 1.

Figure 1: Walter Bean Trail – driveway proximity on Woolwich Street south of the property.

1. The detailed design of these lots should strive to minimize the number of driveways that cross the Walter Bean Trail. If possible, Lot A should have the driveway access from Lexington Crescent to reduce the total number of crossings of the Walter Bean Trail to two.

2. The driveways should be as narrow as possible at the trail crossing. We would recommend that the trail crossing be single car width to minimize the potential for conflict.
3. The driveway depth should be a minimum of 7m to allow for vehicles to park without blocking the trail.
4. The distance between driveways should be maximized to allow as much sighting distance for the future residents and trail users as possible.
5. Homeowners should be provided with a letter that notifies them of the presence of the Walter Bean Trail and includes requirements for not parking or blocking the trail and explains that extra care is needed when entering and exiting their property to limit the potential for harm to trail users. The letter should also provide instruction not to modify their driveway at the limits of the trail.
