To:	Steve Brown Waterloo	From:	Carrie Curtis and Trevor Chandler Waterloo
File:	Silver Lake Environmental Assessment Addendum 161413464	Date:	August 17, 2017

**Reference: Surface Water Resources Status Memo
 Hydrology, Hydraulics and Fluvial Geomorphology**

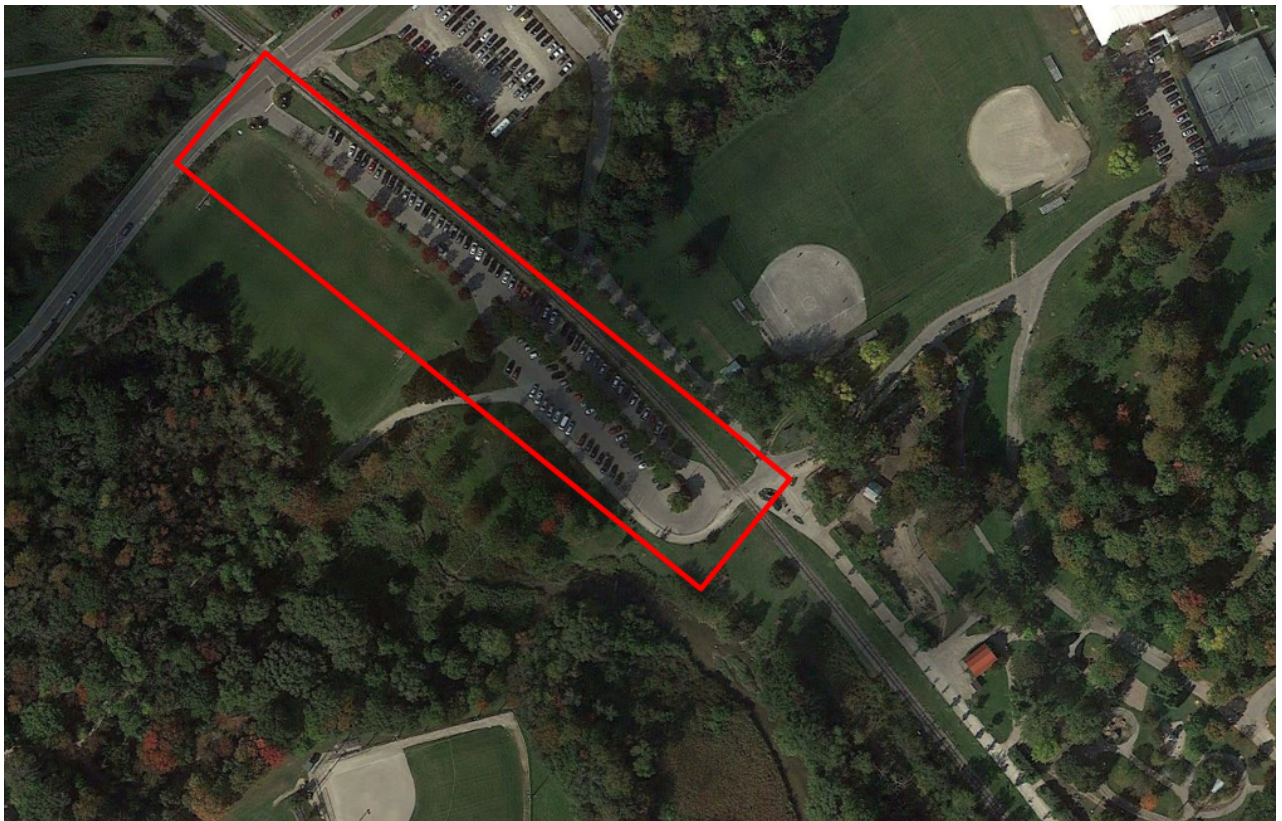
Figure 4: 2013 Google Image with West Parking Lot and Single Rail Track

- The single track rail line has been replaced with a double track rail line and has been completely fenced on either side prohibiting movement across the track;
- The parking lot on the west side of the tracks has been removed and replaced with a trail per Figure 4 (2013) below and Figure 5 (2017) on the following page; and
- The discharge from Lions Lagoon was previously directed untreated to Silver Lake. Following completion of the 2013 MTE Report, the discharge is now directed to the sanitary system, thus eliminating the discharge to the Lake.

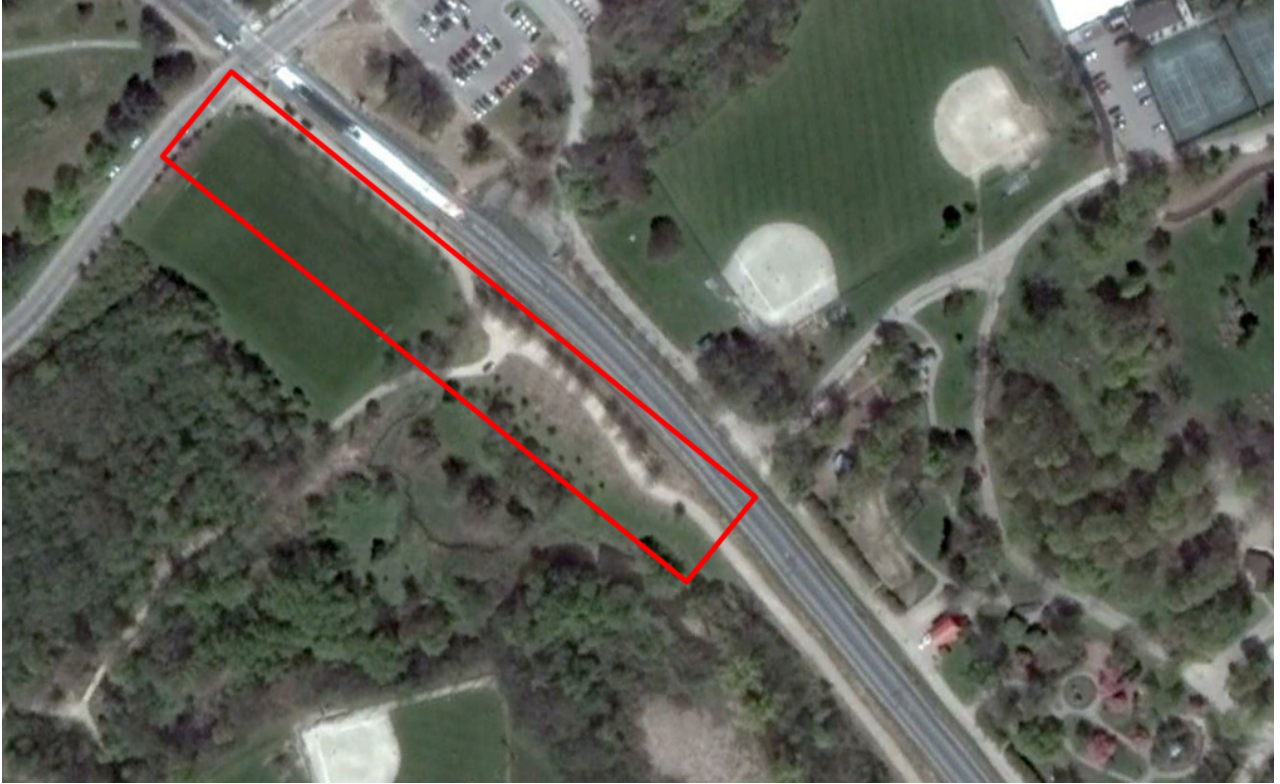
Figure 5: 2017 Google Image with Parking Eliminated and Double LRT Track

Other than the above noted elements, the overall characteristics of the contributing drainage area remain largely unchanged from the 2013 MTE Report. There appears to be a greater source of sediment immediately north of the Lake adjacent to the boardwalk in part due to what is likely roof leader discharge eroding the bank as well as lack of vegetation along the bank. The reduced vegetation may be the result of the bank restoration not stabilizing following construction of the Lions Lagoon sanitary connection in this area. There is visible sediment accumulation on the boardwalk due to the sediment washing from the adjacent slopes.
