CITY OF WATERLOO

Municipal Class Environmental Assessment

WATERCOURSE EROSION MASTER PLAN

Aquafor Beech Ltd.

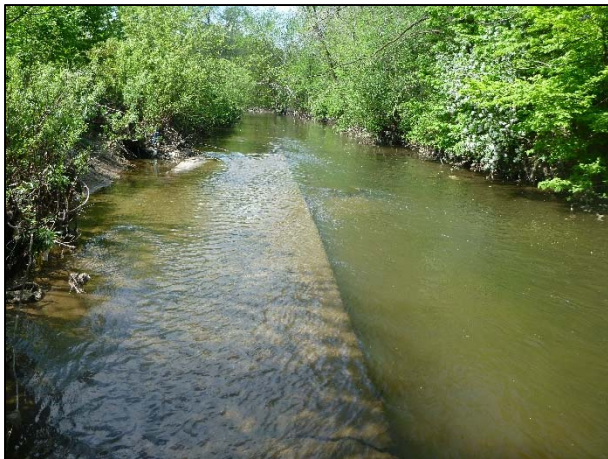
A concrete conduit, approximately 2.5 m in width, is exposed to varying degrees on the channel bed between University Avenue and Marshal Street. The sides of conduit are also exposed in some areas. Utilities have been investigated through City of Waterloo records and through a planning request to Ontario One Call. No utilities were identified in the location of the observed conduit.

An additional erosion issue was identified within this site at the private road crossing upstream of University Avenue East. Gabion headwalls are failing, with baskets leaning and emptying. Possible piping was noted along the right abutment/culvert wall. On the road deck, cracks were observed in the curb and asphalt.

Figure 8-1: Exposed concrete conduit on channel bed at LRL-E5

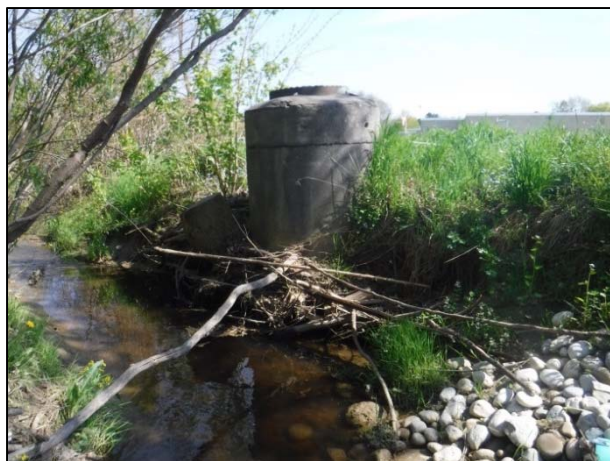
Erosion concerns were identified at 4 locations between Glen Forest Boulevard and Cedarbrae Avenue. The concerns consist of risk to 3 sanitary maintenance holes and a failing gabion bank treatment posing a risk to private property.

Figure 8-2: Sanitary maintenance hole in creek at CDR-E4

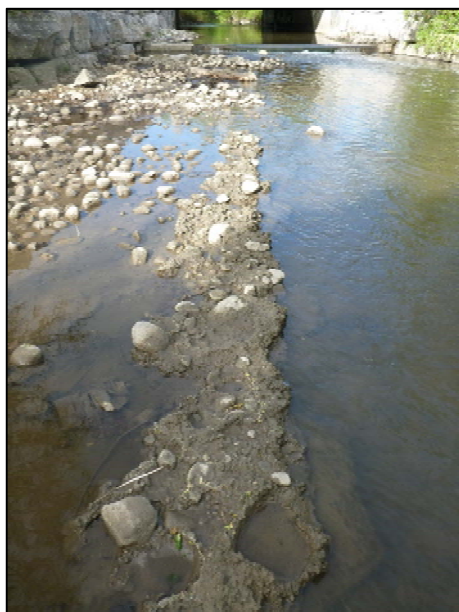
Downstream of Weber Street, near-vertical bank erosion was observed on the right bank with a maintenance hole located within about 4 m of the top of bank. A second maintenance is located downstream behind a failing crib wall. A private storm outfall is located at the upstream end of the site and protrudes into the flow, likely contributing to bank scour. Closer to Weber Street, exposed concrete was observed on the channel bed and is likely a sanitary sewer encasement. Armourstone walls are located on either side of channel in this area.

Figure 8-3: Exposed concrete on channel bed at LRL-E6

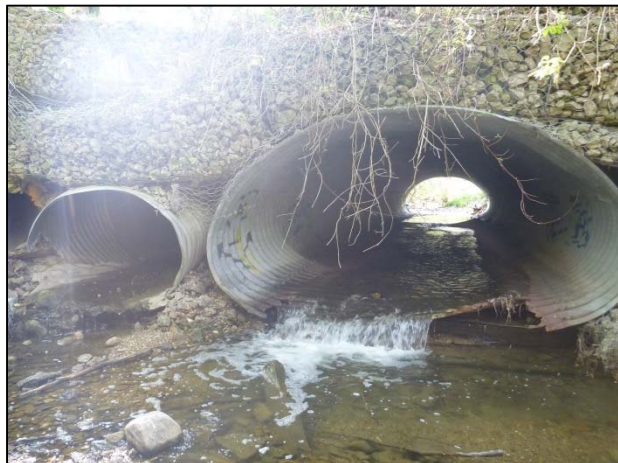
The culverts and headwall for the Forwell Creek Road recreational trail crossing are in very poor condition. The gabion baskets are slumping and the corrugated steel pipe (CSP) culverts are deforming and highly corroded. There appear to have been maintenance works on the culverts but the condition of the culverts has continued to degrade. A recreational trail, a sanitary sewer, a

natural gas pipeline, and hydro lines cross the creek in this location. Material has been lost from the sides of the trail and gravel restoration works have continued to erode.

Figure 8-4: Failing, undermined culverts on downstream side of Forwell Creek Road crossing at FRW-E2

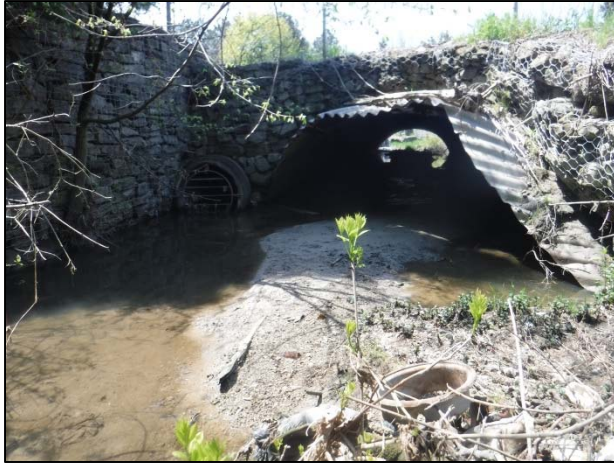
On the downstream side of the Albert Street crossing, the left side of the culvert is collapsing. The gabion baskets over the culvert are also failing in this area and the sidewalk above is cracked. On the upstream side of Albert Street, a gabion weir is failing with scour occurring downstream of the weir. The base layer of the gabion treatments is failing, as is the concrete lining on the bed.

Figure 8-6: Downstream end of failing culvert under Albert Street at CDR-E3

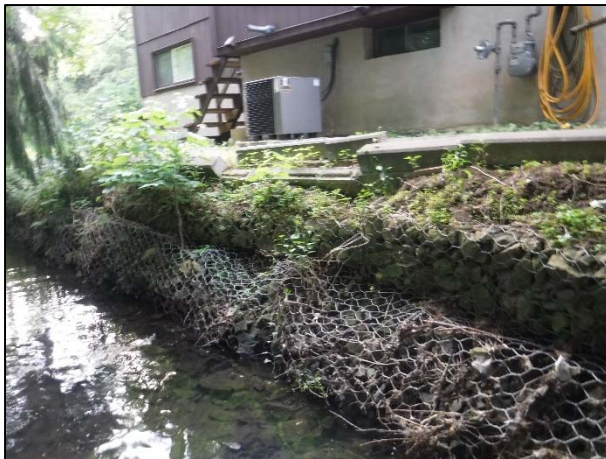
Gabion basket bank treatments are failing at the first house upstream of McDougall Road. The gabions are located on the south side of the creek and the building is located within 5m of the top of bank.

Figure 8-7: Failing gabion baskets with building located within 5 m of the top of bank at CLR-T1-E1

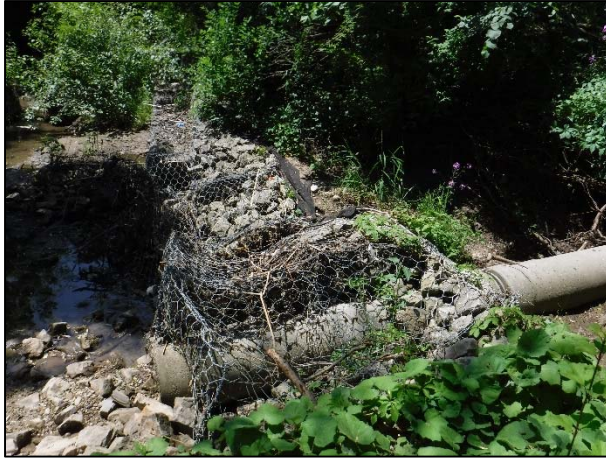
This site extends from Columbia Street downstream to 2 storm sewer outfalls on the channel banks. At Columbia Street, 2 corrugated steel pipe culverts convey flows under the road and the CSP on the east appears to be deformed. From Columbia Street downstream, gabion basket bank treatments are in varying states of failure and a pile of rip rap has developed in this area, likely sourced from the failed gabion baskets. A sanitary sewer crosses under the creek in the vicinity of the downstream storm sewer outfalls.

Figure 8-8: Failed gabion basket treatment and exposed storm sewer outfall at CLR-E4

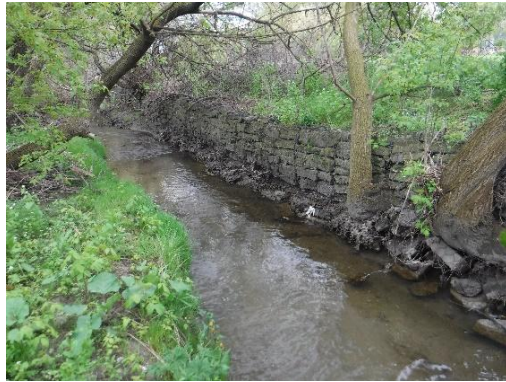
Reach	Summary	Channel Characteristics	Representative Photograph	Key Map
<p>Cedar Creek CDR-R1</p> <p>Upstream Limit: Confluence with drainage channel</p> <p>Downstream Limit: Confluence with Forwell Creek</p>	<p>Straightened, entrenched, trapezoidal channel with gabion treatments. Sand deposits likely from road sand and upstream bank erosion.</p>	<p>Average Channel Dimensions Width ~ 4 m Depth ~ 0.7 m</p> <p>RGA Results N/A</p>

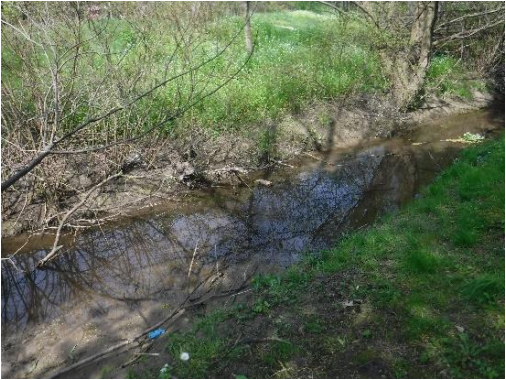
Reach	Summary	Channel Characteristics	Representative Photograph	Key Map
<p>Cedar Creek CDR-R4</p> <p>Upstream Limit: Recreational trail crossing to Park Lawn Place</p> <p>Downstream Limit: LRT crossing</p>	<p>Straightened, entrenched channel with intermittent gabion baskets, armourstone. Large woody jams present. Bed material is mainly sand and silt.</p>	<p>Average Channel Dimensions Width ~ 2–3.5 m Depth ~ 0.5–1 m</p> <p>RGA Results N/A</p>

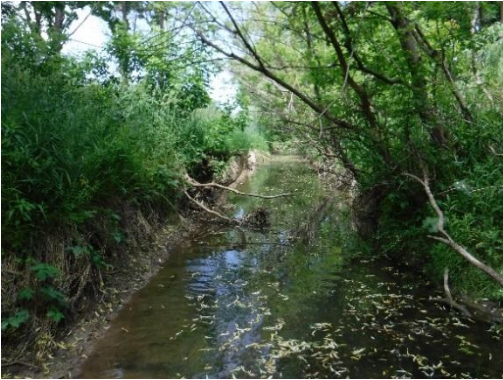
Reach	Summary	Channel Characteristics	Representative Photograph	Key Map
<p>Clair Creek CLR-R8</p> <p>Upstream Limit: Fischer-Hallman Rd.</p> <p>Downstream Limit: Craigleith Dr.</p>	<p>Most of reach appears to have been previously straightened. Channel is mildly entrenched with clay exposed on bed.</p> <p>Gabion treatments present. Bed material ranges from clay to cobbles.</p>	<p>Average Channel Dimensions Width ~ 3–3.5 m Depth ~ 1–1.2 m</p> <p>RGA Results Dominant Process: Widening SI: 0.52 (In adjustment)</p>

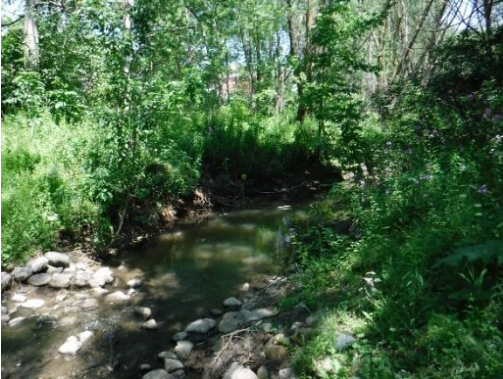
<p>Clair Creek CLR-R9</p> <p>Upstream Limit: Columbia St. W.</p> <p>Downstream Limit: Craigleith Dr.</p>	<p>Straightened alluvial channel with toe scour throughout the vegetated corridor. Channel is connected to floodplain. Bed is silty with roundstone.</p>	<p>Average Channel Dimensions Width ~ 2–3 m Depth ~ 0.3–0.5 m</p> <p>RGA Results Dominant Process: Widening SI: 0.40 (Transitional)</p>

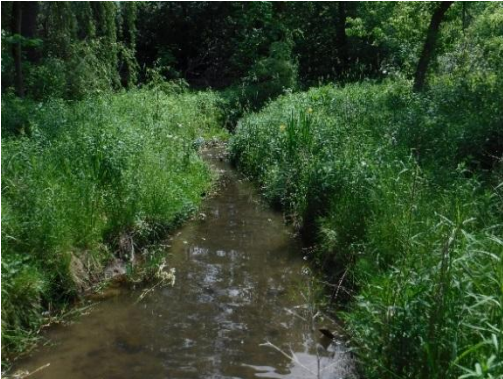
<p>Clair Creek CLR-R10</p> <p>Upstream Limit: Confluence with Tributary 2</p> <p>Downstream Limit: Columbia St. W.</p>	<p>Constructed meandering channel with roundstone riffles. Pools extend into clay in some areas. Banks have vegetative control where roundstone is not present. Channel is well connected to the floodplain. Bed material ranges from clay to cobbles.</p>	<p>Average Channel Dimensions Width ~ 2–2.5 m Depth ~ 0.4–0.5 m</p> <p>RGA Results Dominant Process: Aggradation & planform adjustment SI: 0.15 (Stable)</p>

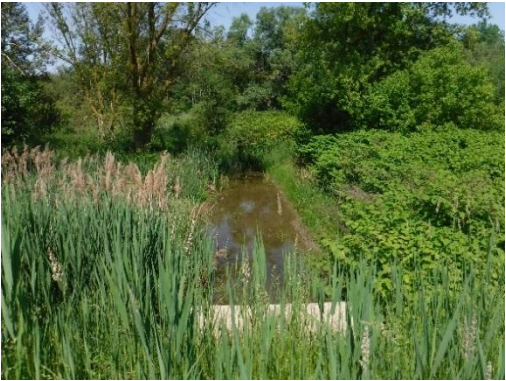
Reach	Summary	Channel Characteristics	Representative Photograph	Key Map
<p>Clair Creek CLR-R11</p> <p>Upstream Limit: Confluence with Tributary 3</p> <p>Downstream Limit: Confluence with Tributary 2</p>	<p>Constructed and straightened channel with roundstone riffles and rip-rap and armourstone treatments. Channel is connected to the floodplain. Bed material ranges from silt to cobbles.</p>	<p>Average Channel Dimensions Width ~ 3–4 m Depth ~ 0.4 m</p> <p>RGA Results N/A</p>

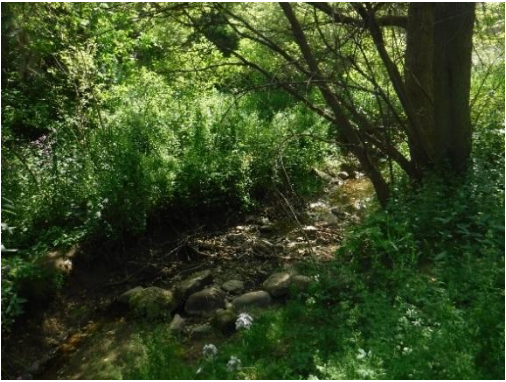
<p>Clair Creek CLR-R12</p> <p>Upstream Limit: Mature forest</p> <p>Downstream Limit: Confluence with Tributary 3</p>	<p>Straightened, entrenched channel with roundstone control. Channel appears to be over- widened from stormwater flows. Large woody debris jams and sediment deposits were present throughout. Bed material ranges from silt to cobbles.</p>	<p>Average Channel Dimensions Width ~ 3–5 m Depth ~ 0.5 m</p> <p>RGA Results Dominant Process: Widening SI: 0.48 (In adjustment)</p>

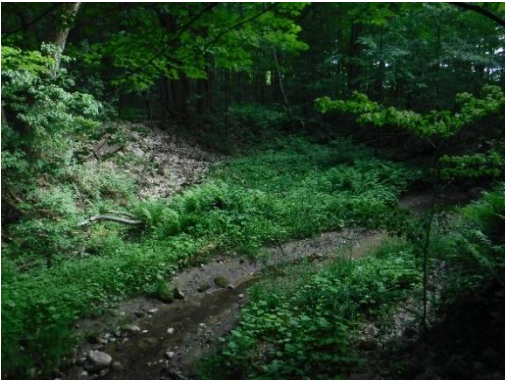
<p>Clair Creek CLR-R13</p> <p>Upstream Limit: SWMFs</p> <p>Downstream Limit: Mature forest</p>	<p>Over-widened, entrenched channel with urbanized cross sections flowing through mature forest. Armourstone treatments were present. Bed material ranges from silt to boulders with roundstone.</p>	<p>Average Channel Dimensions Width ~ 4–12 m Depth ~ 1–3 m</p> <p>RGA Results Dominant Process: Widening SI: 0.46 (In adjustment)</p>

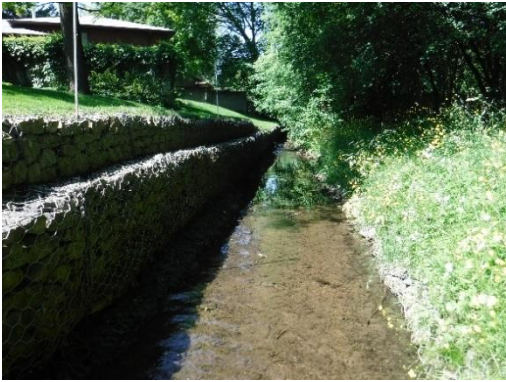
Reach	Summary	Channel Characteristics	Representative Photograph	Key Map
<p>Clair Creek CLR-T1-R1</p> <p>Upstream Limit: Keats Way and Keats Walk</p> <p>Downstream Limit: Confluence</p>	<p>Engineered channel with gabion baskets. Channel is confined and entrenched. Bed material ranges from silt to boulders.</p>	<p>Average Channel Dimensions Width ~ 4 m Depth ~ 0.8 m</p> <p>RGA Results N/A</p>

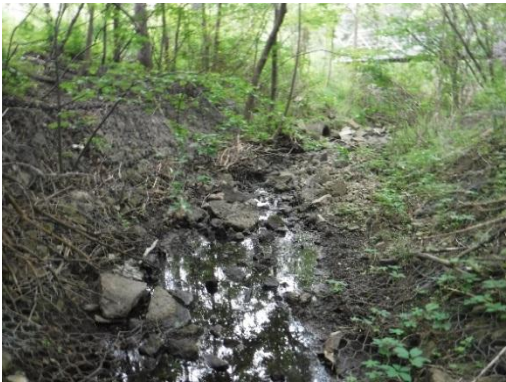
<p>Clair Creek CLR-T1-R3</p> <p>Upstream Limit: Fischer-Hallman Rd.</p> <p>Downstream Limit: Keats Way and Glenburn Dr.</p>	<p>Engineered channel with gabion baskets and broken concrete toe. Channel is entrenched. Bed material consists of fines with organics and gravel.</p>	<p>Average Channel Dimensions Width ~ 2–2.5 m Depth ~ 0.3–0.5 m</p> <p>RGA Results N/A</p>

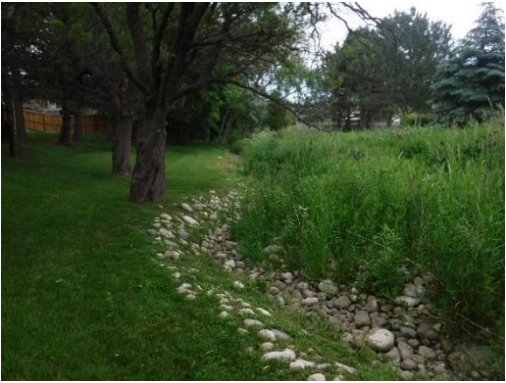
Reach	Summary	Channel Characteristics	Representative Photograph	Key Map
<p>Clair Creek CLR-T1-R4</p> <p>Upstream Limit: SWMF</p> <p>Downstream Limit: Fischer-Hallman Rd.</p>	<p>Roundstone-lined, rock-controlled ditch with some meandering. Channel is well connected to the floodplain. Some minor erosion observed. Tree roots are maintaining stability in intermittent grass lined sections.</p>	<p>Average Channel Dimensions Width ~ 1.2 m Depth ~ 0.4 m</p> <p>RGA Results N/A</p>

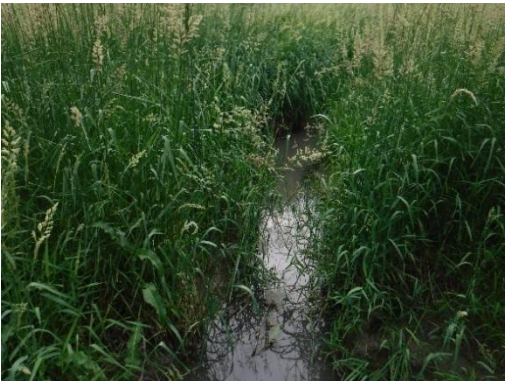
<p>CLR-T3-R1</p>

<p>CLR-T1-R4</p>
<p>Clair Creek CLR-T3-R1</p> <p>Upstream Limit: Hydro corridor</p> <p>Downstream Limit: Confluence with main branch</p>	<p>Constructed channel with meandering planform and roundstone and vegetation control. Channel is well connected to floodplain. Bed material ranges from silt to cobbles.</p>	<p>Average Channel Dimensions Width ~ 1–1.5 m Depth ~ 0.3–0.5 m</p> <p>RGA Results Dominant Process: Stable/regime SI: 0.11 (Stable)</p>

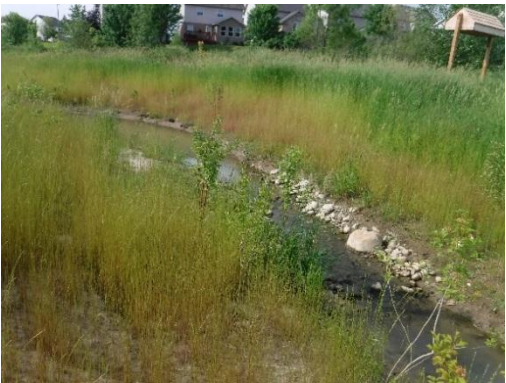
<p>CLR-T3-R2</p>

<p>Clair Creek CLR-T3-R2</p> <p>Upstream Limit: Brandenburg SWMF</p> <p>Downstream Limit: Hydro corridor</p>	<p>Constructed channel in grassed corridor. Bed material clay with constructed roundstone riffles. Upstream portion appears to be recently constructed and vegetation establishment is limited. Channel is well connected to the floodplain.</p>	<p>Average Channel Dimensions Width ~ 0.5–1 m Depth ~ 0.3–0.5 m</p> <p>RGA Results Dominant Process: Widening SI: 0.26 (Transitional)</p>

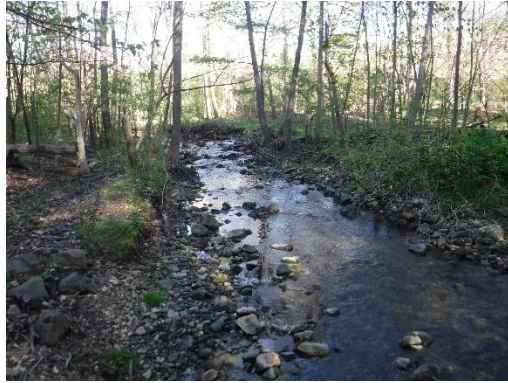
Reach	Summary	Channel Characteristics	Representative Photograph	Key Map
<p>Colonial Creek CLN-R1</p> <p>Upstream Limit: West-most driveway culvert on Malabar Dr.</p> <p>Downstream Limit: Grand River</p>	<p>Step-pool boulder lined constructed channel with moderate bank erosion throughout. Well connected to floodplain. Bed material ranges from gravel to boulders.</p>	<p>Average Channel Dimensions Width ~ 2.5–3 m Depth ~ 0.5 m</p> <p>RGA Results Dominant Process: Widening SI: 0.24 (Stable)</p>

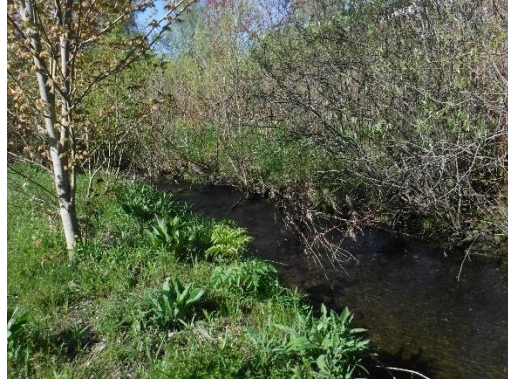
<p>Colonial Creek CLN-R2</p> <p>Upstream Limit: Confluence with SWM channel</p> <p>Downstream Limit: West-most driveway culvert on Malabar Dr.</p>	<p>Constructed u-shaped channel with roundstone riffles and herbaceous vegetation and willows on banks. Well connected to floodplain. Bed material ranges from sand to boulders.</p>	<p>Average Channel Dimensions Width ~ 1.5 m Depth ~ 0.6 m</p> <p>RGA Results Dominant Process: Widening SI: 0.17 (Stable)</p>

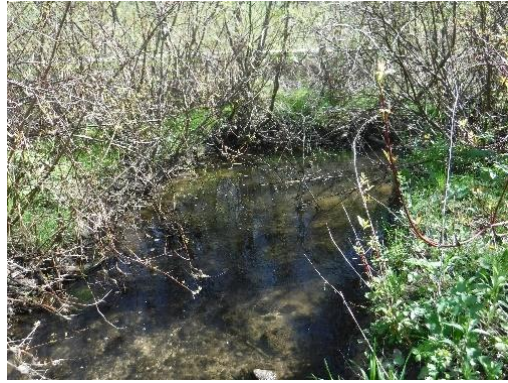
<p>Colonial Creek CLN-R3</p> <p>Upstream Limit: Confluence with Tributary</p> <p>Downstream Limit: Confluence with SWM channel</p>	<p>Vegetation controlled, u-shaped channel with willows on banks. Large woody debris jams from yard waste. Well connection to floodplain. Bed material ranges from silt to boulders</p>	<p>Average Channel Dimensions Width ~ 1.5–2 m Depth ~ 0.5–0.7 m</p> <p>RGA Results Dominant Process: Widening SI: 0.25 (Stable)</p>

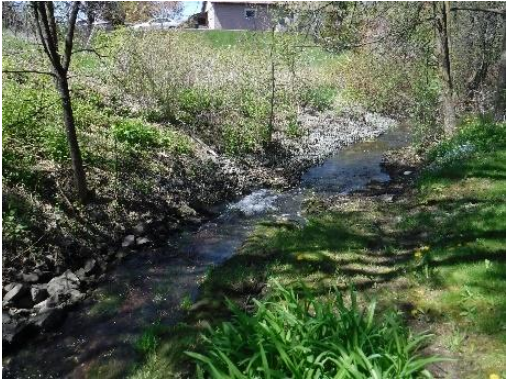
Reach	Summary	Channel Characteristics	Representative Photograph	Key Map
<p>Colonial Creek CLN-R4</p> <p>Upstream Limit: Bridge St.</p> <p>Downstream Limit: Confluence with Tributary</p>	<p>Engineered channel with gabions on the bed and banks. Bed material ranges from silt to gravel. The channel is connected to the floodplain.</p>	<p>Average Channel Dimensions Width ~ 1–2 m Depth ~ 0.4–0.7 m</p> <p>RGA Results N/A</p>

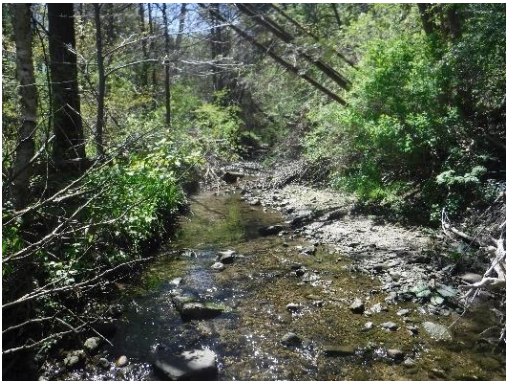
<p>Colonial Creek CLN-R5</p> <p>Upstream Limit: Lee Ave.</p> <p>Downstream Limit: Bridge St.</p>	<p>Over-widened alluvial channel with steep banks and well-defined pools and riffles. System has good riparian cover and is slightly entrenched. Bed material ranges from clay to cobbles.</p>	<p>Average Channel Dimensions Width ~ 3–4 m Depth ~ 1.2 m</p> <p>RGA Results Dominant Process: Degradation and widening SI: 0.50 (In adjustment)</p>

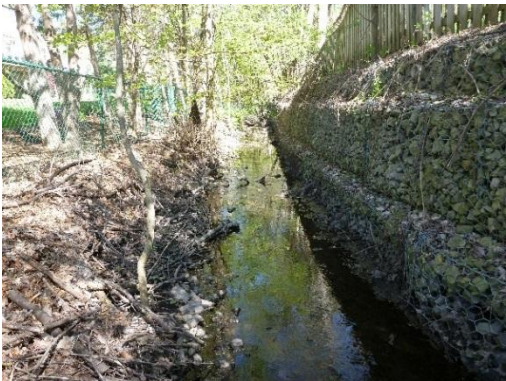
<p>Colonial Creek CLN-R6</p> <p>Upstream Limit: Anndale Park</p> <p>Downstream Limit: Lee Ave.</p>	<p>Engineered channel with various gabion treatments. System is channelized and entrenched. Bed material ranges from silt to gravel.</p>	<p>Average Channel Dimensions Width ~ 1.5–5 m Depth ~ 1–2 m</p> <p>RGA Results N/A</p>

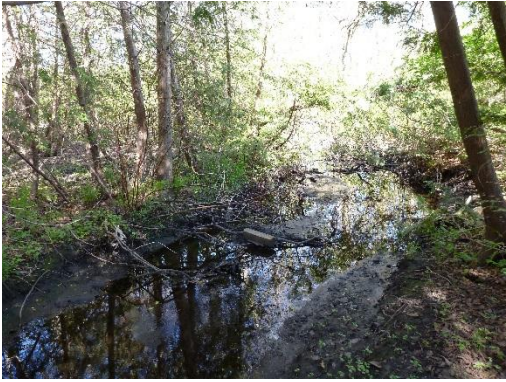
Reach	Summary	Channel Characteristics	Representative Photograph	Key Map
Colonial Creek CLN-R7 Upstream Limit: Old Abbey Downstream Limit: Anndale Park	Wide and shallow alluvial channel through a wooded corridor. Leaning cedars on banks. Well connected to floodplain. Reach has fine organic bed material.	Average Channel Dimensions Width ~ 2–2.5 m Depth ~ 0.3 m RGA Results Dominant Process: Aggradation SI: 0.30 (Transitional)

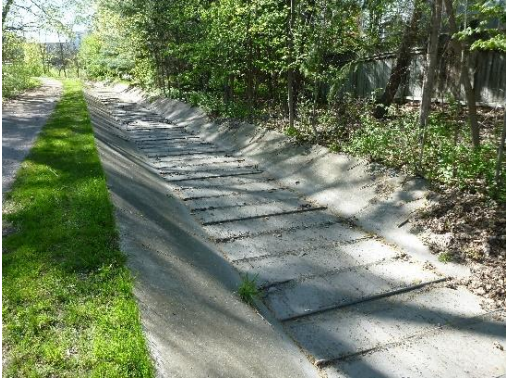
Colonial Creek CLN-R8 Upstream Limit: Davenport Rd. Downstream Limit: Old Abbey Rd.	Concrete trapezoidal channel with rails on bed.	Average Channel Dimensions Width ~ 3 m Depth ~ 0.5 m RGA Results N/A

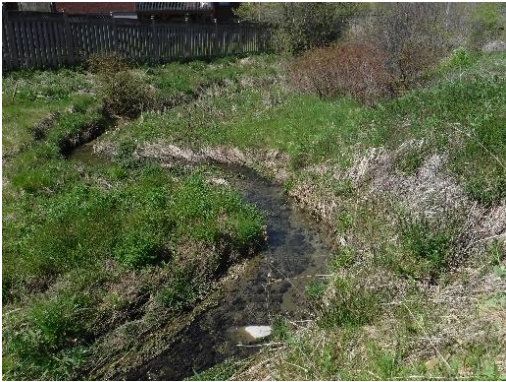
Tributary to Colonial Creek CLN-T-R1 Upstream Limit: Bridge St. Downstream Limit: Confluence with main branch	Vegetation controlled, meandering channel with lots of erosion and a well-connected floodplain. Bank vegetation is limited (mostly grass and some stumps) and the channel appears to be constructed. Bed material is silt to cobbles.	Average Channel Dimensions Width ~ 0.5–1.2 m Depth ~ 0.5–0.6 m RGA Results Dominant Process: Aggradation, widening and planform adjustment SI: 0.41 (In adjustment)

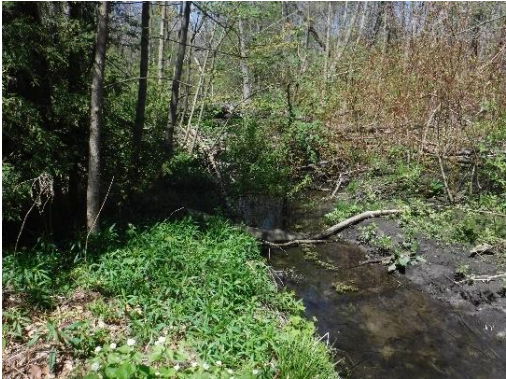
Reach	Summary	Channel Characteristics	Representative Photograph	Key Map
Tributary to Colonial Creek CLN-T-R2 Upstream Limit: STM outfall from Parkridge Crt. Downstream Limit: Bridge St.	Vegetation controlled, u-shaped, low gradient, meandering channel with lots of large woody debris and a well-connected floodplain. Silt and sand on bed.	Average Channel Dimensions Width ~ 0.5–2 m Depth ~ 0.3 m RGA Results Dominant Process: Aggradation SI: 0.29 (Transitional)

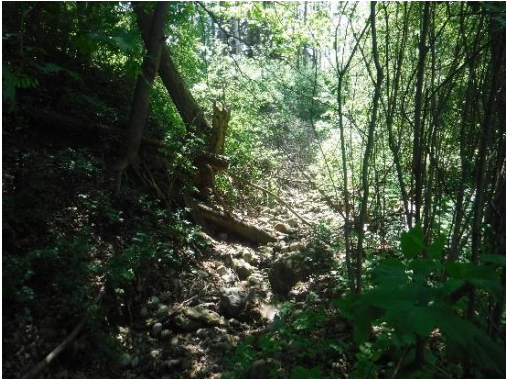
Cooper's Creek CPR-R1 Upstream Limit: University Ave. Downstream Limit: Grand River	Steep, incised channel originating at storm outfall. Bed material ranges from fines to boulders.	Average Channel Dimensions Width < 1 m Depth ~ 0.4 m RGA Results N/A

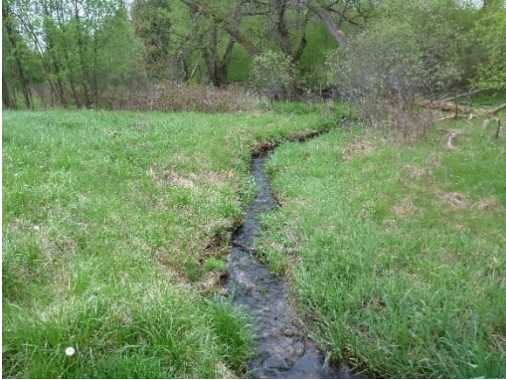
Critter Creek CRT-R1 Upstream Limit: University Ave. Downstream Limit: Confluence with Minnow Creek	Vegetation-controlled channel with meandering planform and pool-riffle sequence. Well connected to floodplain. Channel has a cobble-gravel bed and is cut into clay in some areas.	Average Channel Dimensions Width ~ 1 m Depth ~ 0.3 m RGA Results Dominant Process: Degradation SI: 0.06 (Stable)

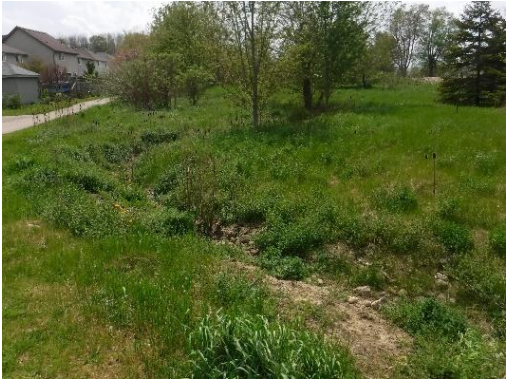
Reach	Summary	Channel Characteristics	Representative Photograph	Key Map
<p>Critter Creek CRT-R2</p> <p>Upstream Limit: Pedestrian crossing</p> <p>Downstream Limit: University Ave.</p>	<p>Constructed channel with meandering planform. Well connected to floodplain. Roundstone on channel bed.</p>	<p>Average Channel Dimensions Width ~ 0.5 m Depth ~ 0.2 m</p> <p>RGA Results N/A</p>

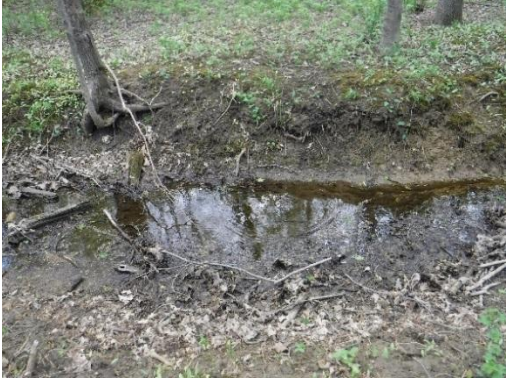
<p>Critter Creek CRT-R3</p> <p>Upstream Limit: Wetlands</p> <p>Downstream Limit: Recreational trail crossing</p>	<p>U-shaped constructed channel with fine organic bed material. Well connected to floodplain.</p>	<p>Average Channel Dimensions Width ~ 1.8 m Depth ~ 0.5 m</p> <p>RGA Results N/A</p>

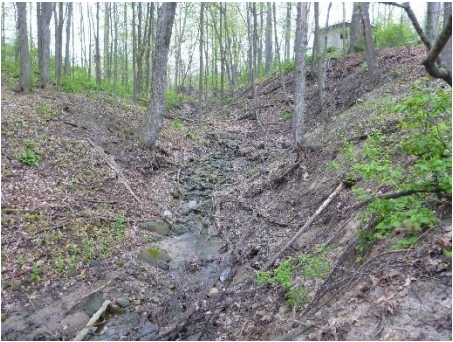
<p>Cuckoo Creek CCK-R1</p> <p>Upstream Limit: STM outfall from University Ave. drainage</p> <p>Downstream Limit: Confluence with Minnow Creek</p>	<p>Alluvial channel in narrow valley with steep valley walls. The channel is entrenched with erosion throughout. Channel appears to be adjusting to an altered flow regime and is entrenched. Bed material ranges from sand to boulders.</p>	<p>Average Channel Dimensions Low flow width ~ 0.5 m Low flow depth ~ 0.05 m</p> <p>RGA Results Dominant Process: Degradation SI: 0.36 (Transitional)</p>

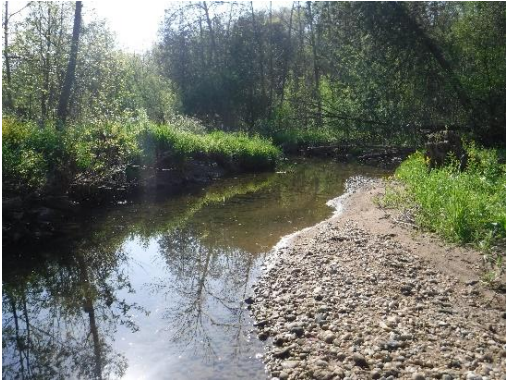
Reach	Summary	Channel Characteristics	Representative Photograph	Key Map
<p>Forwell Creek FRW-R1</p> <p>Upstream Limit: Forwell Creek Rd.</p> <p>Downstream Limit: Confluence with Laurel Creek</p>	<p>Meandering channel with pool-riffle form. Engineered treatments throughout (crib walls, woody bank treatments, and boulder riffles). Bed material ranges from silt to boulders with some deposition of roundstone from upstream throughout reach. and mostly grasses on banks.</p>	<p>Average Channel Dimensions Width ~ 6 m Depth ~ 1 m</p> <p>RGA Results Dominant Process: Aggradation SI: 0.49 (In adjustment)</p>

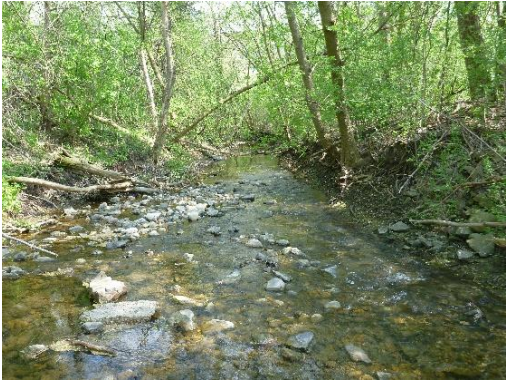
<p>Forwell Creek FRW-R2</p> <p>Upstream Limit: Blue Springs Dr.</p> <p>Downstream Limit: Forwell Creek Rd.</p>	<p>Channel appears to have been previously straightened and is redeveloping meandering form. Basal scour present throughout and Channel is mildly entrenched. Bed material ranges from silt to boulders with inputs of roundstone from upstream reach.</p>	<p>Average Channel Dimensions Width ~ 6 m Depth ~ 1.2 m</p> <p>RGA Results Dominant Process: Widening SI: 0.53 (In adjustment)</p>

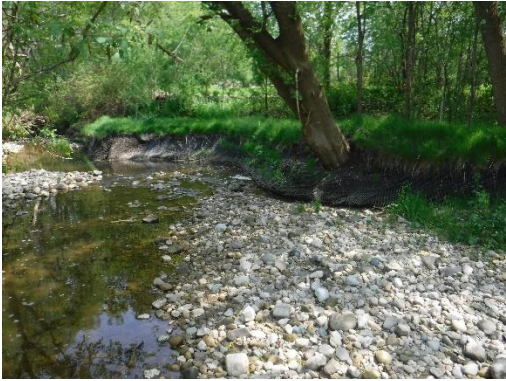
Reach	Summary	Channel Characteristics	Representative Photograph	Key Map
<p>Forwell Creek FRW-R3</p> <p>Upstream Limit: King St. N.</p> <p>Downstream Limit: Blue Springs Dr.</p>	<p>Engineered channel with roundstone and vegetated silt sock treatments in poor condition. Channel is connected to floodplain with bed material ranging from silt to boulders.</p>	<p>Average Channel Dimensions Width ~ 5.5 m Depth ~ 1.2 m</p> <p>RGA Results N/A</p>

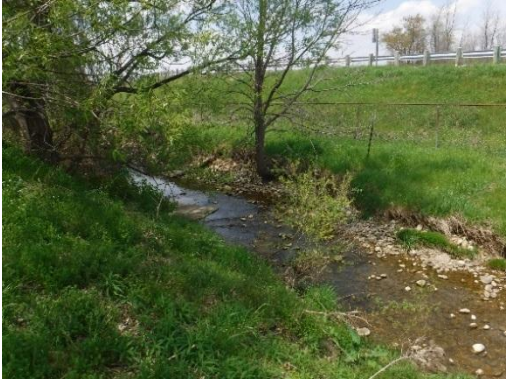
<p>Forwell Creek FRW-R4</p> <p>Upstream Limit: Confluence with Cedar Creek</p> <p>Downstream Limit: King St. N.</p>	<p>Entrenched, straightened channel. Bed material ranges from silt to cobbles.</p>	<p>Average Channel Dimensions Width ~ 2 m Depth ~ 0.7 m</p> <p>RGA Results N/A</p>

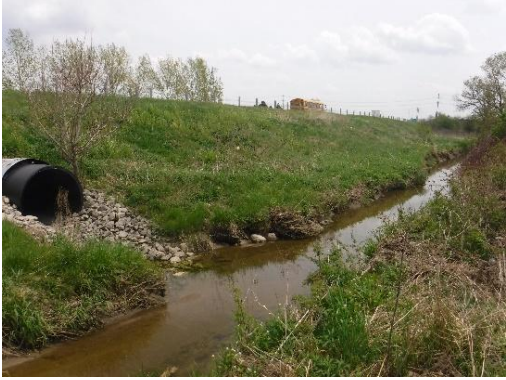
<p>Forwell Creek FRW-R5</p> <p>Upstream Limit: Northfield Dr.</p> <p>Downstream Limit: Confluence with Cedar Creek</p>	<p>Straightened, entrenched channel running adjacent to Conestoga Parkway. Bed material mainly sand and silt.</p>	<p>Average Channel Dimensions Width ~ 1–1.5 m Depth ~ 0.7 m</p> <p>RGA Results N/A</p>

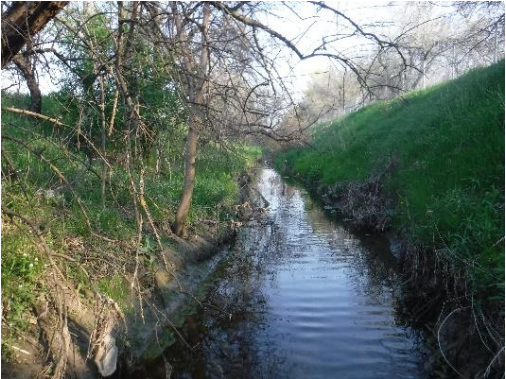
Reach	Summary	Channel Characteristics	Representative Photograph	Key Map
<p>Forwell Creek FRW-R6</p> <p>Upstream Limit: Railway at Randall Dr.</p> <p>Downstream Limit: Northfield Dr.</p>	<p>Straightened, entrenched channel running adjacent to Conestoga Parkway. Steep banks with some slumping. Bed material sandy with limited bedforms.</p>	<p>Average Channel Dimensions Width ~ 2.2 m Depth ~ 0.5 m</p> <p>RGA Results N/A</p>

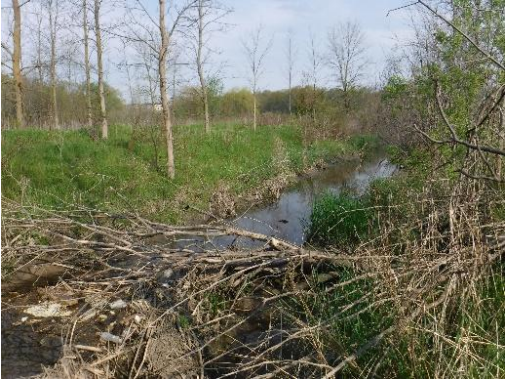
<p>Forwell Creek FRW-R7</p> <p>Upstream Limit: SWMF outlet</p> <p>Downstream Limit: Railway at Randall Dr.</p>	<p>Straightened, entrenched channel with silty bed and limited bedforms. Engineered bank treatments consist of gabion baskets.</p>	<p>Average Channel Dimensions Width ~ 1.2–1.5 m Depth ~ 0.3 m</p> <p>RGA Results N/A</p>

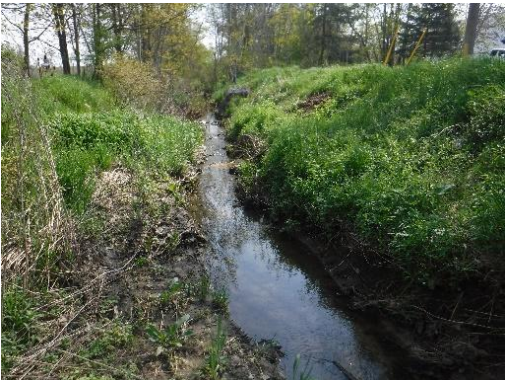
<p>Forwell Creek FRW-R8</p> <p>Upstream Limit: Weber St.</p> <p>Downstream Limit: SWMF outlet</p>	<p>Straightened, u- shaped, vegetation- controlled channel starting to develop limited meandering. Connected to floodplain. Bed material ranges from silt to gravel with some coarser material.</p>	<p>Average Channel Dimensions Width ~ 1 m Depth ~ 0.6 m</p> <p>RGA Results N/A</p>

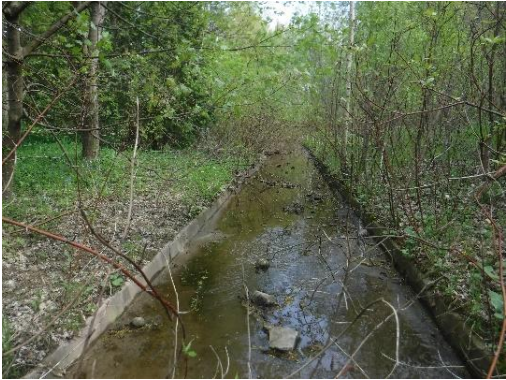
Reach	Summary	Channel Characteristics	Representative Photograph	Key Map
<p>Forwell Creek FRW-R9</p> <p>Upstream Limit: Recreational trail crossing</p> <p>Downstream Limit: Weber St.</p>	<p>Straightened concrete channel. Well connected to floodplain.</p>	<p>Average Channel Dimensions Width ~ 2 m Depth ~ 0.2 m</p> <p>RGA Results N/A</p>

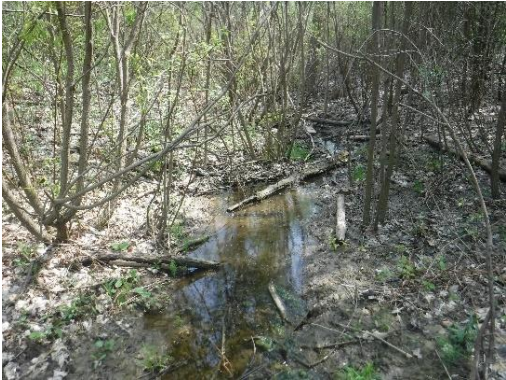
<p>Forwell Creek FRW-R10</p> <p>Upstream Limit: Storm outfall from Waterbury Lane</p> <p>Downstream Limit: Recreational trail crossing</p>	<p>Low gradient, straightened channel contained in trapezoidal corridor. Connected to floodplain.</p>	<p>Average Channel Dimensions Width <1 m Depth <0.1 m</p> <p>RGA Results N/A</p>

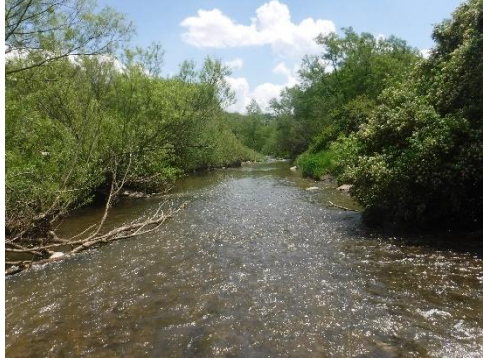
Reach	Summary	Channel Characteristics	Representative Photograph	Key Map
<p>Laurel Creek LRL-R1</p> <p>Upstream Limit: Conestoga Parkway</p> <p>Downstream Limit: City Limit</p>	<p>Constructed channel with crib walls, ribs/veins, and gabions throughout. Sanitary sewer runs parallel to creek and wetlands are present on right overbank.</p> <p>There is terrace development within the channel but floodplain access is limited. Bed material ranges from silt to boulders.</p>	<p>Average Channel Dimensions Width ~ 8–10 m Depth ~ 0.7–1.0 m</p> <p>RGA Results Dominant Process: SI: N/A</p>

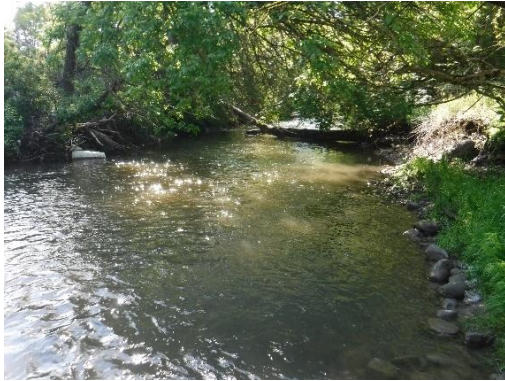
<p>LRL-R2</p>

<p>LRL-R1</p>
<p>Laurel Creek LRL-R2</p> <p>Upstream Limit: Confluence</p> <p>Downstream Limit: Conestoga Parkway</p>	<p>Semi-alluvial structural channel with some constructed weirs and rip-rap and gabion treatments. A trail separates the trapezoidal, entrenched channel and a wetland area.</p> <p>Bed material ranges from silt to cobbles.</p>	<p>Average Channel Dimensions Width ~ 8 m Depth 1.5 m</p> <p>RGA Results Dominant Process: Degradation and Widening SI: 0.49 (In adjustment)</p>

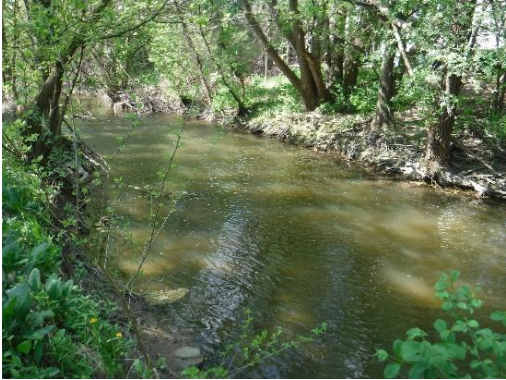
Reach	Summary	Channel Characteristics	Representative Photograph	Key Map
<p>Laurel Creek LRL-R3</p> <p>Upstream Limit: Village on the Green</p> <p>Downstream Limit: Confluence with Forwell Creek</p>	<p>Alluvial channel containing runs with shallow pools and having limited meandering form. A lot of basal scour and some gabion and armoustone treatments were observed. Channel is connected to the floodplain. Bed material is comprised of silt to boulders with sand deposits.</p>	<p>Average Channel Dimensions Width ~ 8 m Depth ~ 1.5 m</p> <p>RGA Results Dominant Process: Widening SI: 0.41 (In adjustment)</p>

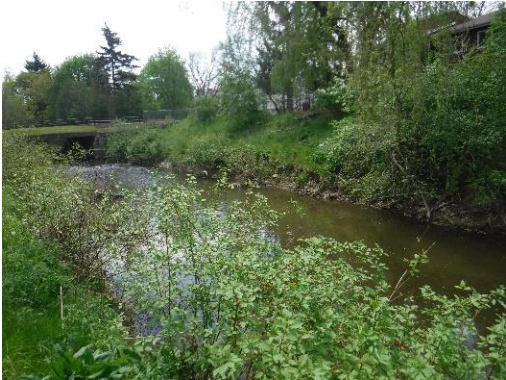
<p>LRL-R4</p>

<p>LRL-R3</p>
<p>Laurel Creek LRL-R4</p> <p>Upstream Limit: Marshall St.</p> <p>Downstream Limit: Village on the Green</p>	<p>The entrenched creek is in a trapezoidal corridor with gabion treatments on both sides of the upstream section. Bed material ranges from silt to cobbles.</p>	<p>Average Channel Dimensions Width ~ 10 m Depth ~ 1 m</p> <p>RGA Results N/A</p>

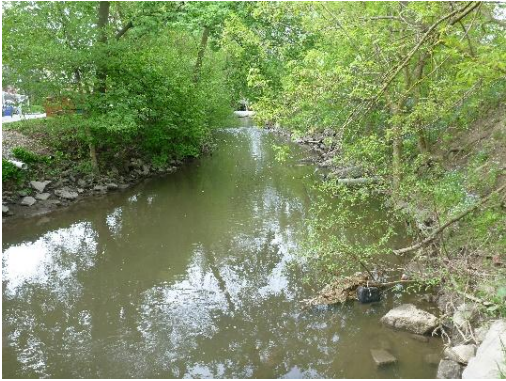
Reach	Summary	Channel Characteristics	Representative Photograph	Key Map
<p>Laurel Creek LRL-R5</p> <p>Upstream Limit: Erb St.</p> <p>Downstream Limit: Marshall St.</p>	<p>Structural channel with limited riffle-pool form and limited floodplain access. The channel flows through a confined corridor. Bed material ranges from silt to cobbles.</p>	<p>Average Channel Dimensions Width ~ 10 m Depth ~ 1.6 m</p> <p>RGA Results N/A</p>

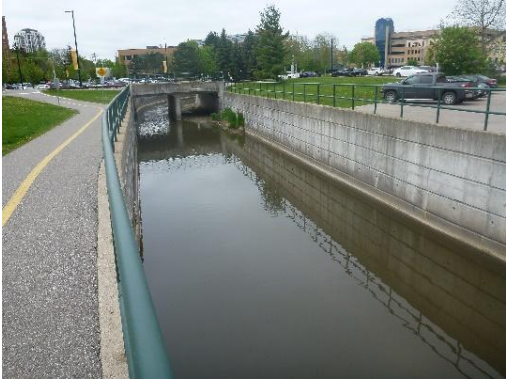
<p>LRL-R5</p>
<p>Laurel Creek LRL-R6</p> <p>Upstream Limit: Regina St.</p> <p>Downstream Limit: Erb St.</p>	<p>Concrete, rectangular channel.</p>	<p>Average Channel Dimensions Width ~ 8 m Depth ~ 1 m</p> <p>RGA Results N/A</p>

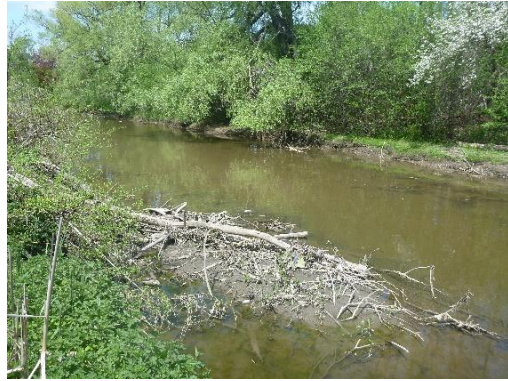
Reach	Summary	Channel Characteristics	Representative Photograph	Key Map
<p>Laurel Creek LRL-R8</p> <p>Upstream Limit: Confluence with tributary</p> <p>Downstream Limit: Silver Lake</p>	<p>Alluvial, meandering channel that is backwatered by Silver Lake. Some basal scour observed. Bed is silty and channel is well connected to floodplain.</p>	<p>Average Channel Dimensions Width ~ 8 m Depth ~ 0.6 m</p> <p>RGA Results Dominant Process: Aggradation SI: 0.51 (In adjustment)</p>

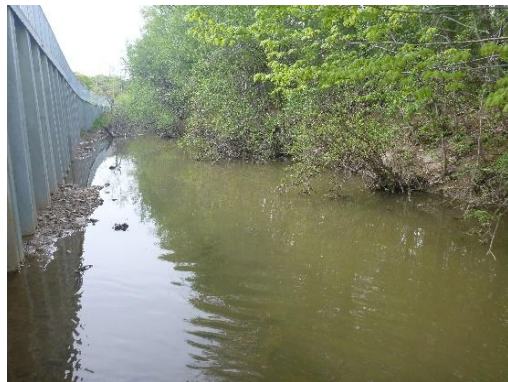
<p>LRL-R10</p>

<p>Laurel Creek LRL-R10</p> <p>Upstream Limit: Weir at Conrad Grebel</p> <p>Downstream Limit: Confluence with Clair Creek</p>	<p>Constructed, confined channel running parallel to Westmount Rd. N. Bed material is sand to cobbles.</p>	<p>Average Channel Dimensions Width ~ 7 m Depth ~ 1 m</p> <p>RGA Results N/A</p>

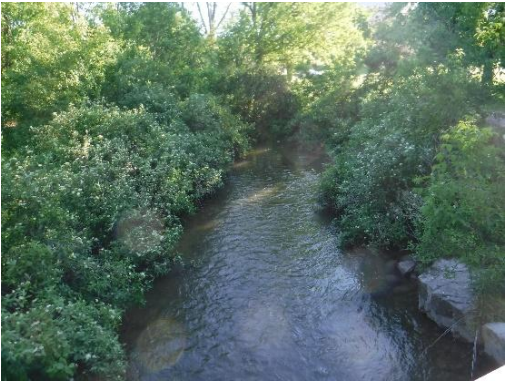
Reach	Summary	Channel Characteristics	Representative Photograph	Key Map
<p>Laurel Creek LRL-R11</p> <p>Upstream Limit: Upstream end of pond at UW Health Services</p> <p>Downstream Limit: Weir at Conrad Grebel</p>	<p>Semi-alluvial structural channel with steep, well-vegetated banks. Local gabion and armourstone treatments. Channel is connected to the floodplain.</p>	<p>Average Channel Dimensions Width ~ 5 m Depth ~ 0.7 m</p> <p>RGA Results Dominant Process: Widening SI: 0.24 (Stable)</p>

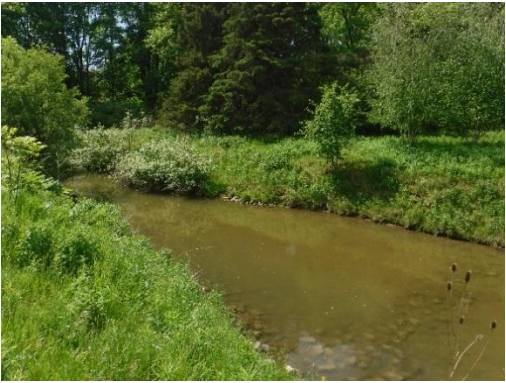
<p>Laurel Creek LRL-R12</p> <p>Upstream Limit: Columbia St.</p> <p>Downstream Limit: Upstream end of pond at UW Health Services</p>	<p>Alluvial, low gradient channel with some channelized sections with gabion and armourstone treatments. Channel is well connected to floodplain. Bed material ranges from silt to cobbles.</p>	<p>Average Channel Dimensions Width ~ 5 m Depth ~ 0.4 m</p> <p>RGA Results Dominant Process: Widening SI: 0.38 (Transitional)</p>

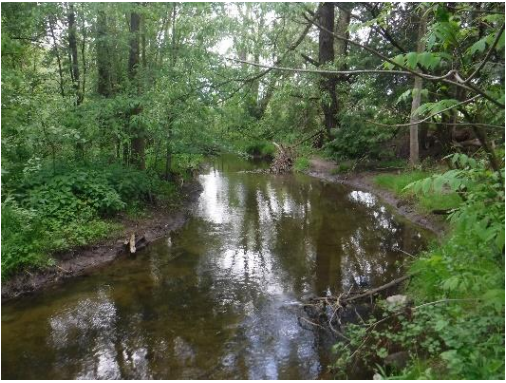
<p>Laurel Creek LRL-R13</p> <p>Upstream Limit: Westmount Rd. N.</p> <p>Downstream Limit: Columbia St.</p>	<p>Alluvial channel with meandering form. Bed material ranges from clay to boulders with coarser material occurring on the riffles. The channel is well connected to the floodplain.</p>	<p>Average Channel Dimensions Width ~ 5–7 m Depth ~ 0.6 m</p> <p>RGA Results Dominant Process: Planform adjustment SI: 0.30 (Transitional)</p>

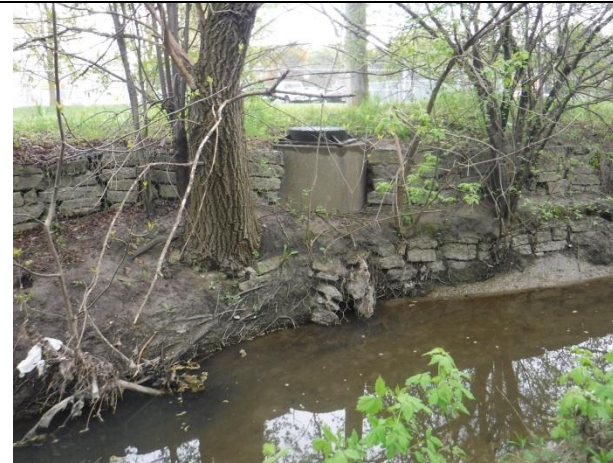
MH behind failing gabion basket treatment

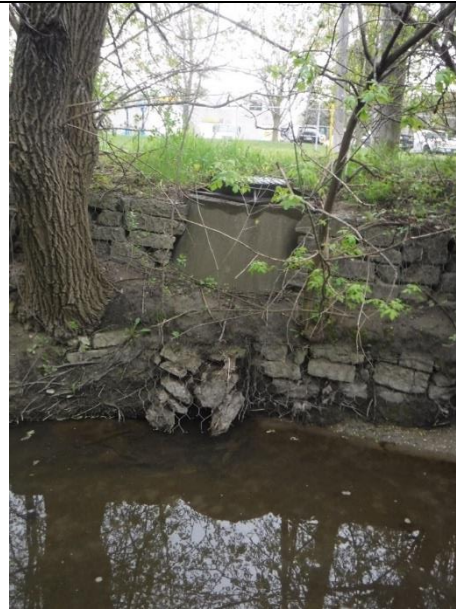
MH behind failing gabion basket treatment

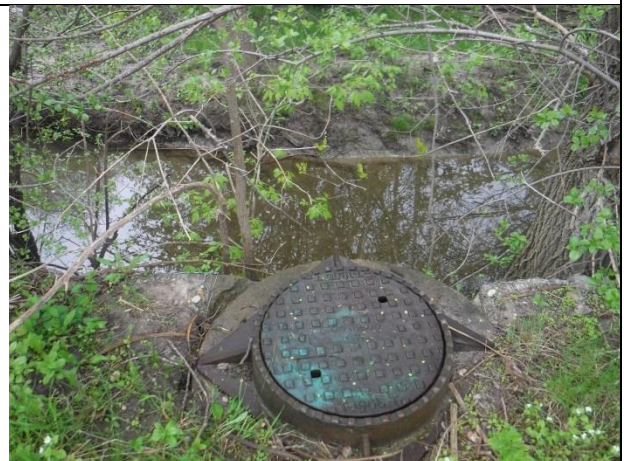
View of MH from above

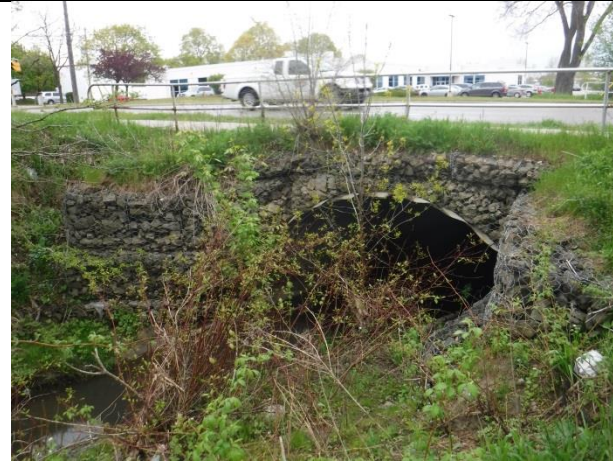
Failing headwall on upstream side of Weber Street

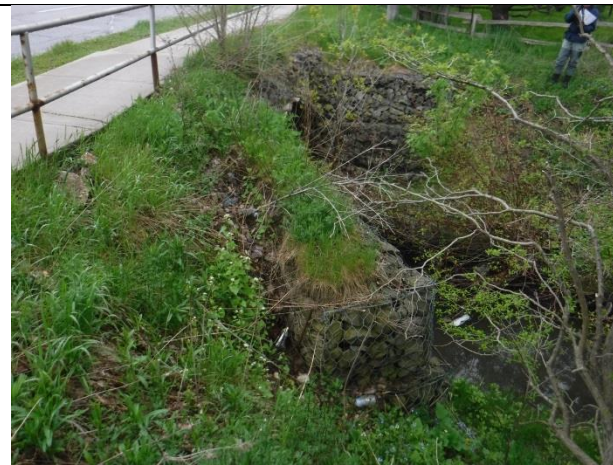
Outflanked gabion basket headwall

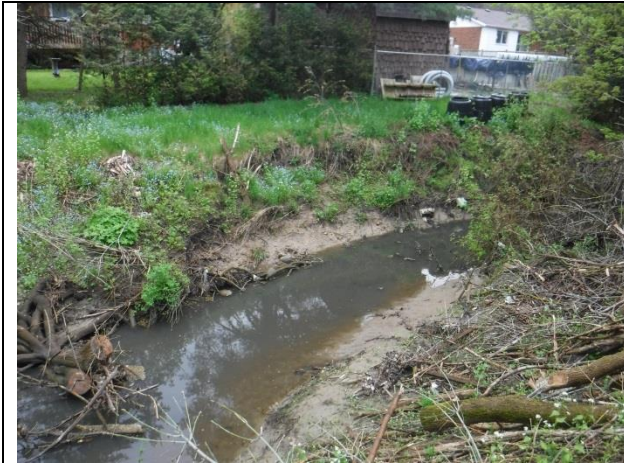
Remains of debris jam with eroded bank

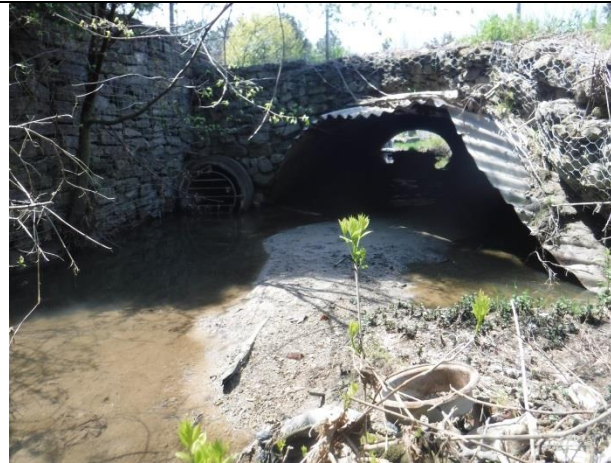
Condition of culvert on downstream side of Albert Street

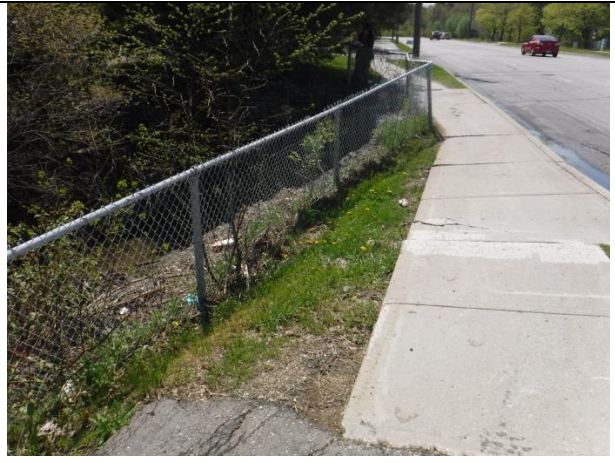
Sidewalk cracked on downstream side of Albert Street

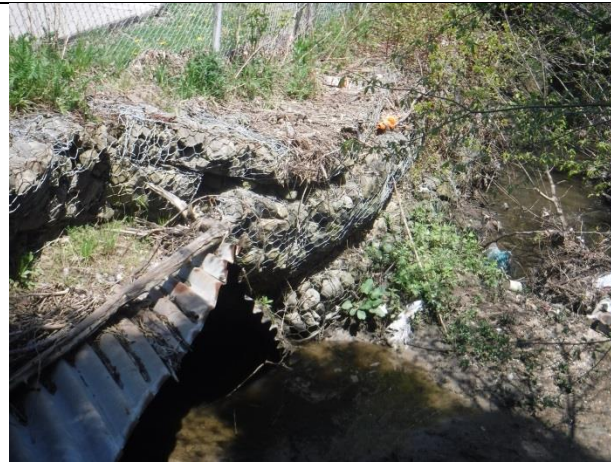
Detail of condition of collapsing culvert on downstream side of Albert Street

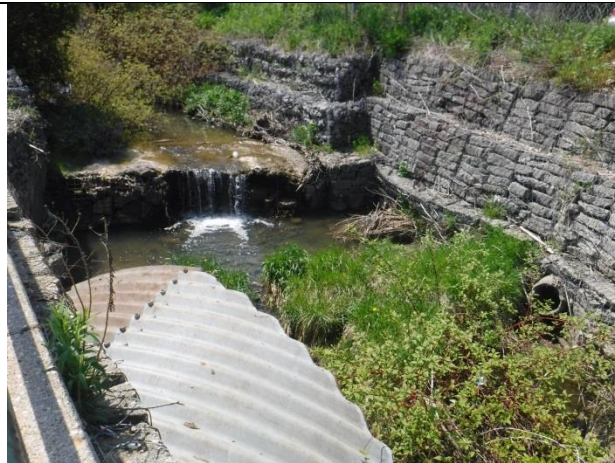
Failing concrete and gabion basket weir on upstream side of Albert Street

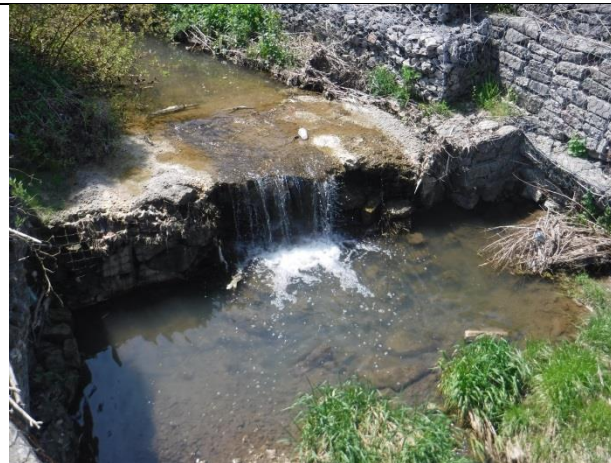
Failing gabion basket weir

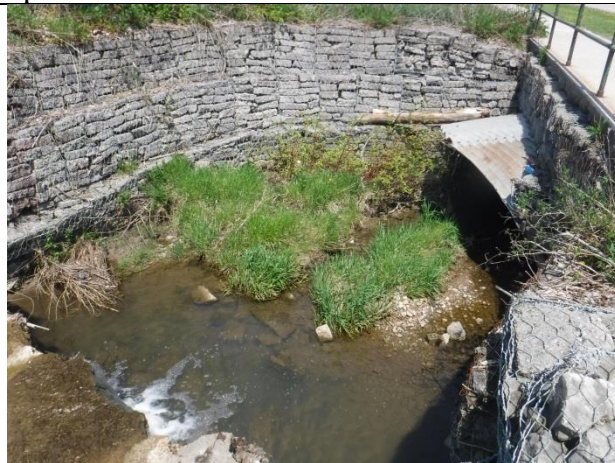
Culvert on upstream side of Albert Street

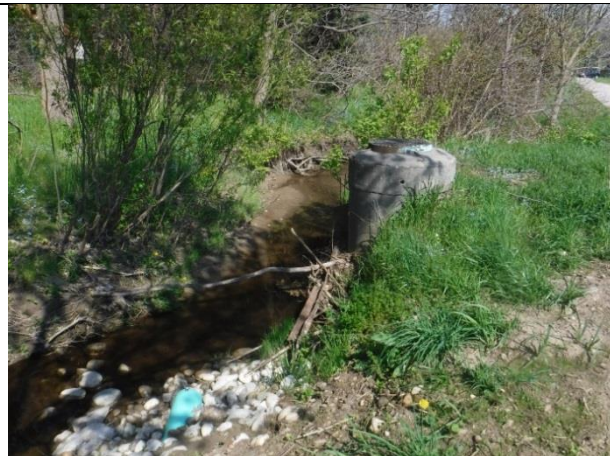
Location 1 – Roundstone and storm sewer outfall upstream of exposed MH

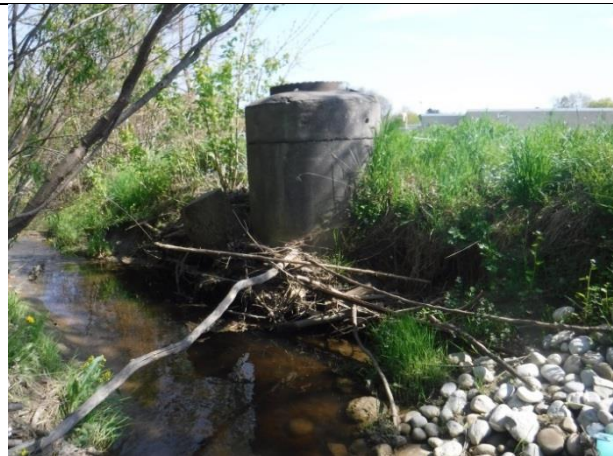
Location 1 – Scoured bank immediately upstream of MH
