CITY OF WATERLOO

Municipal Class Environmental Assessment

WATERCOURSE EROSION MASTER PLAN

Aquafor Beech Ltd.

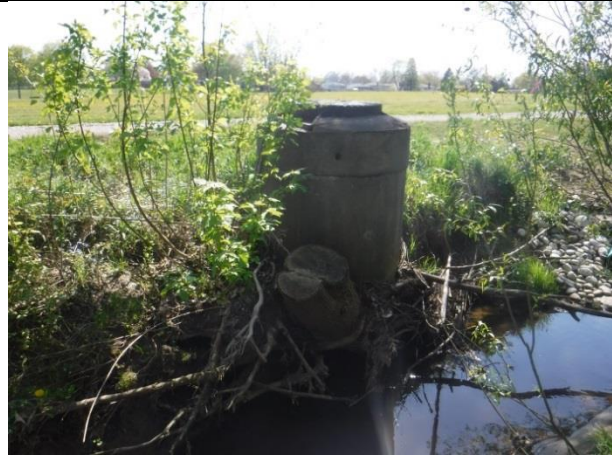
Location 1 – MH with stump of tree at base

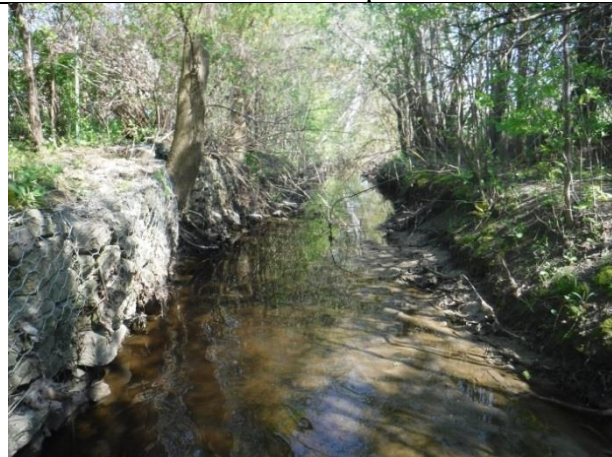
Location 2 – Failing gabion basket treatment on left bank

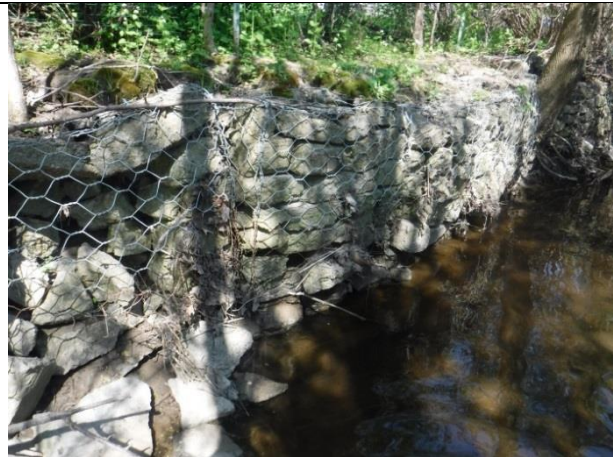
Location 2 – Emptying gabion baskets

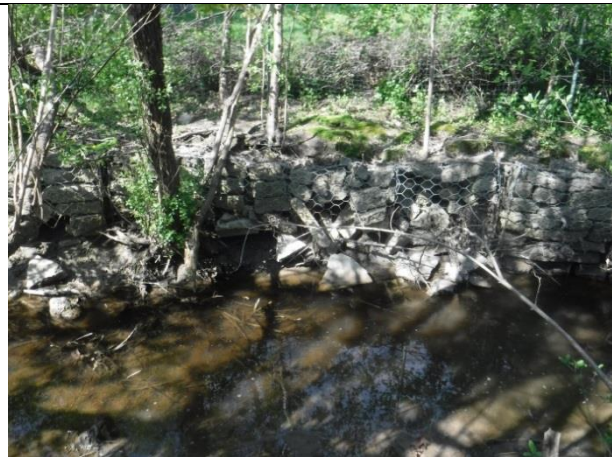
Location 2 – Failing gabion baskets on left bank

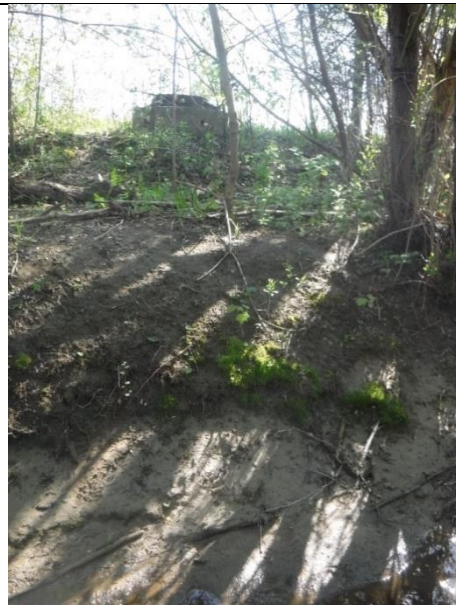
Location 2 – MH on inside of bend

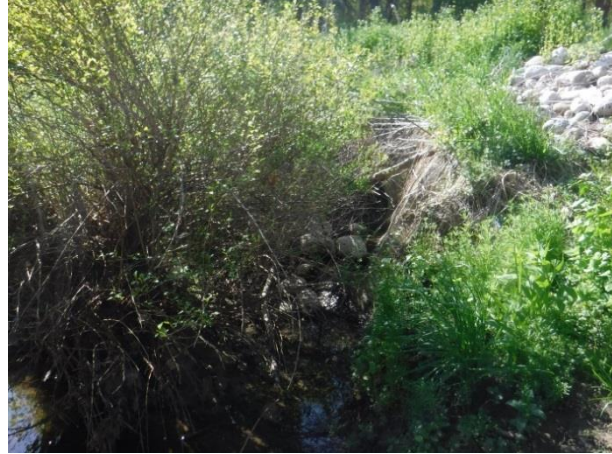
Location 3 – Shrubs blocking flows from storm sewer outfall

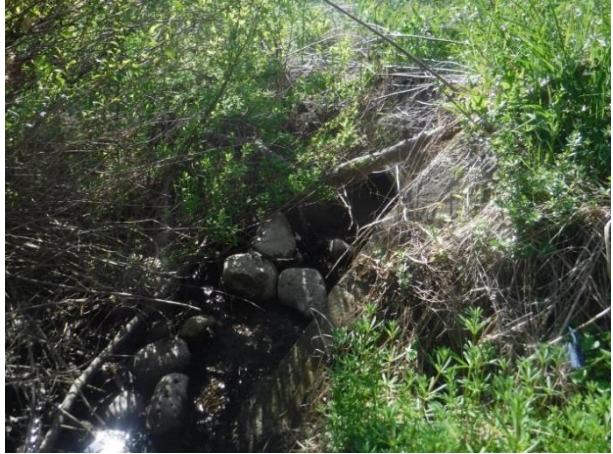
Location 3 – Storm sewer outfall

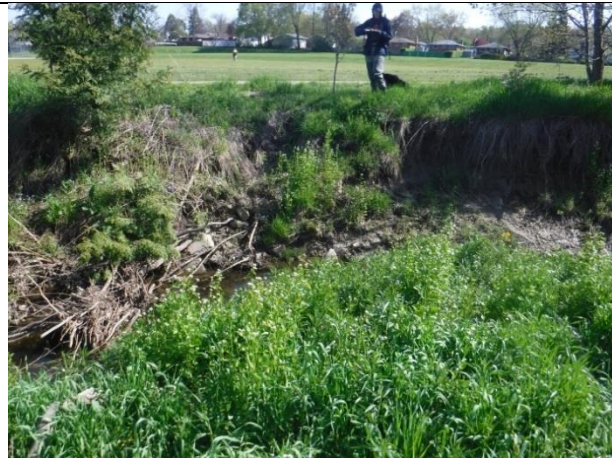
Location 3 – Bank erosion towards sanitary sewer MH

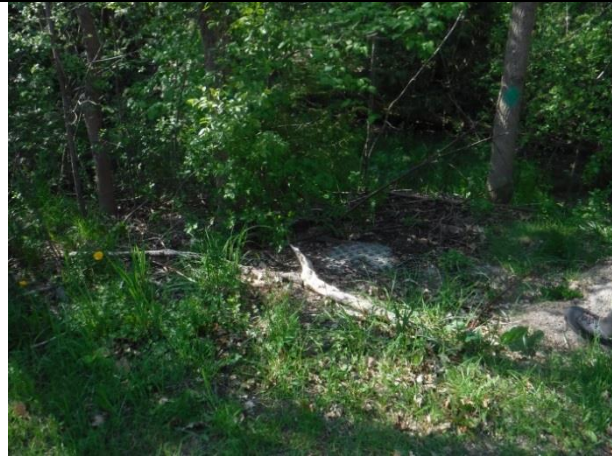
Location 4 – MH behind ash tree at top of bank

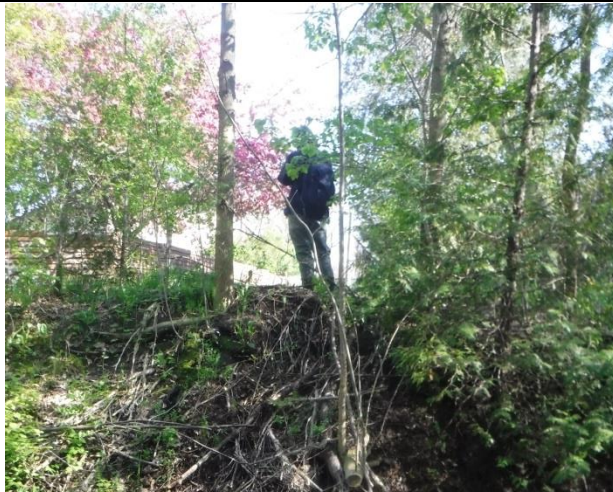
Location 4 – Channel is entrenched in this area

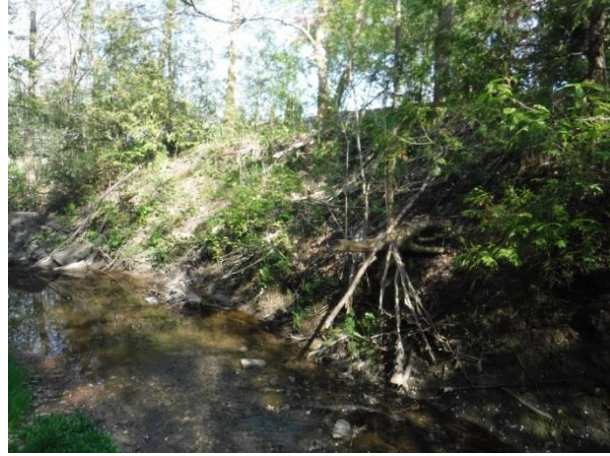
Location 4 – Eroded bank at MH. Staff standing on MH for reference with ash to left of staff.

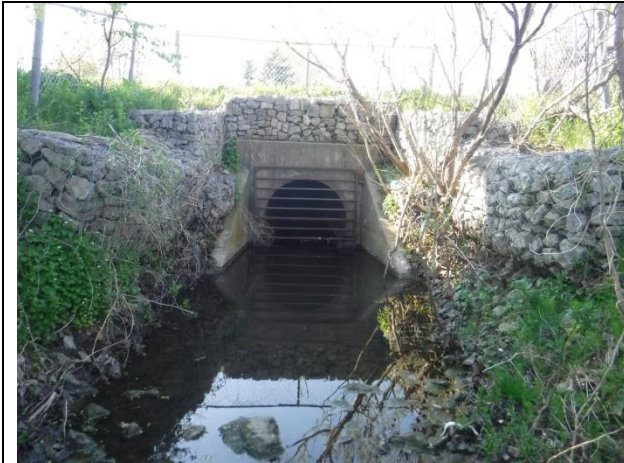
Gabion basket headwalls are slumping and emptying

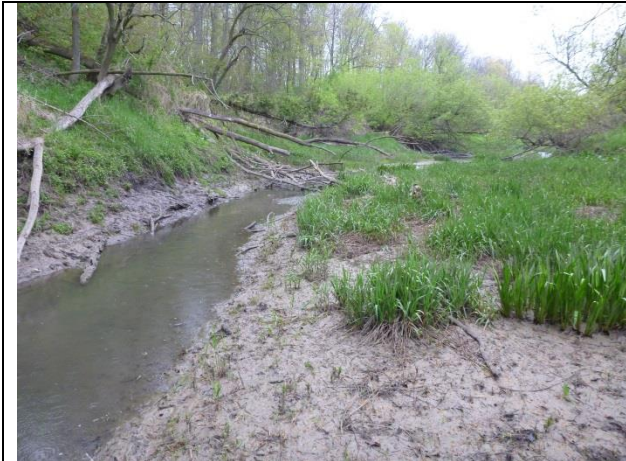
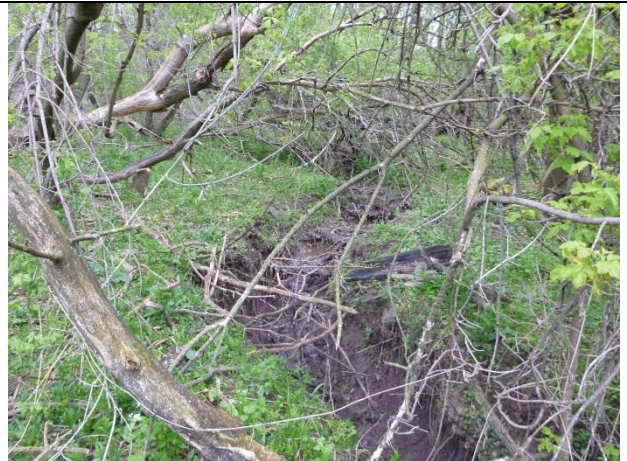
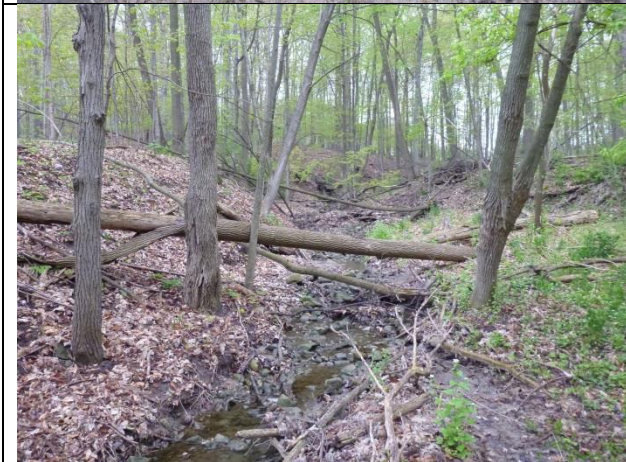
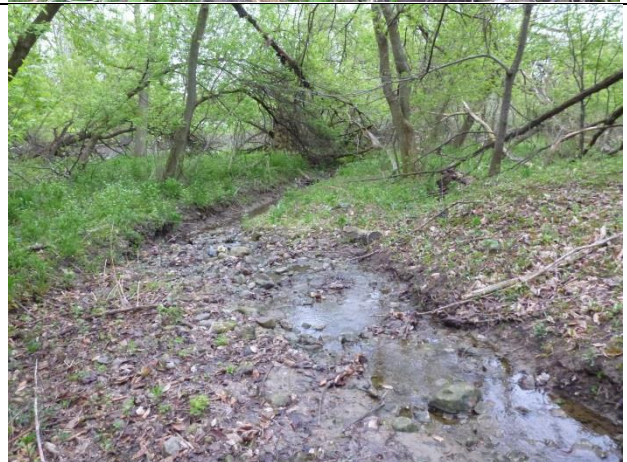
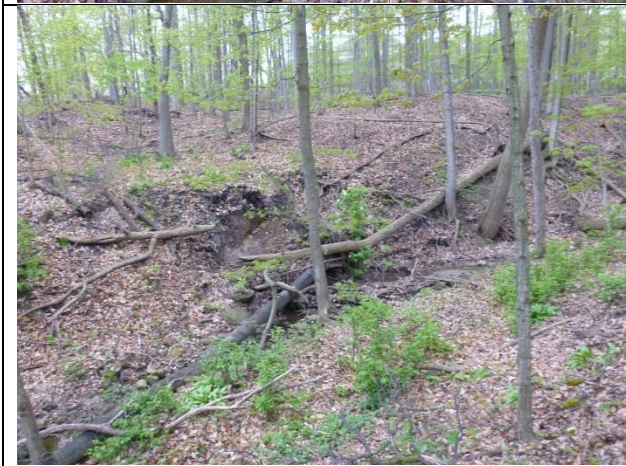
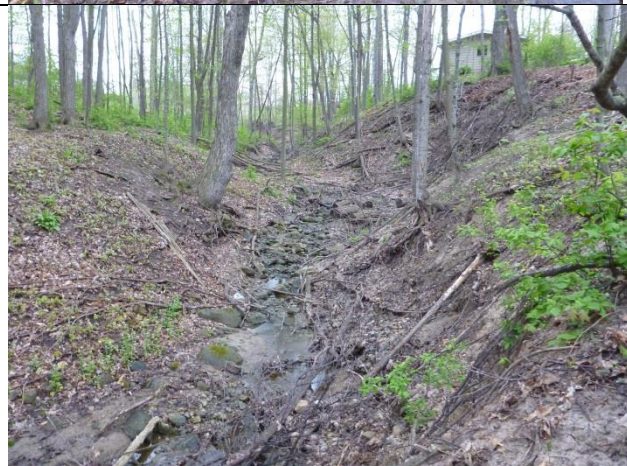
Valley wall erosion with leaning and fallen trees

Bank erosion with garage at top of slope in background

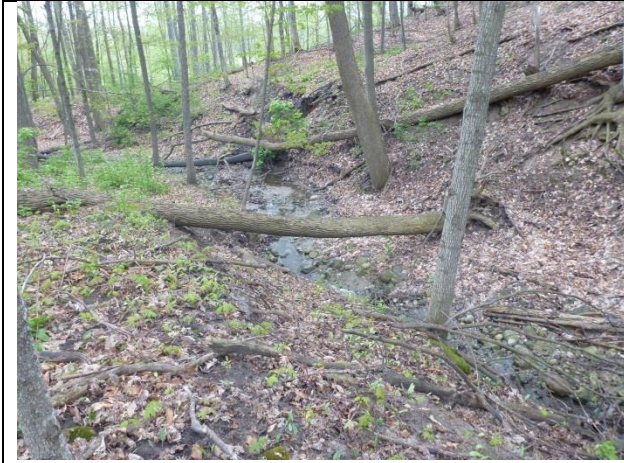
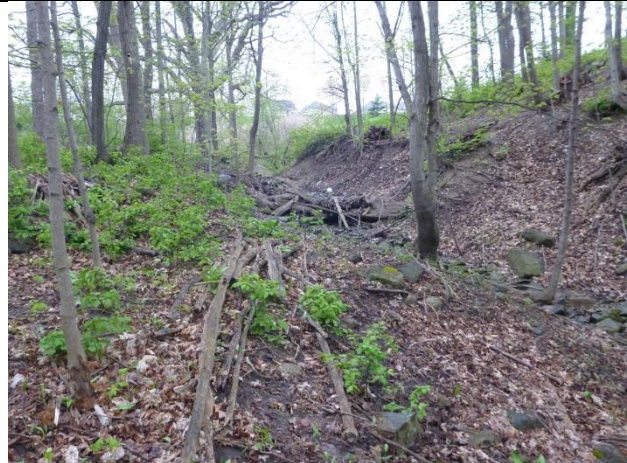
Leaning and fallen trees in the valley

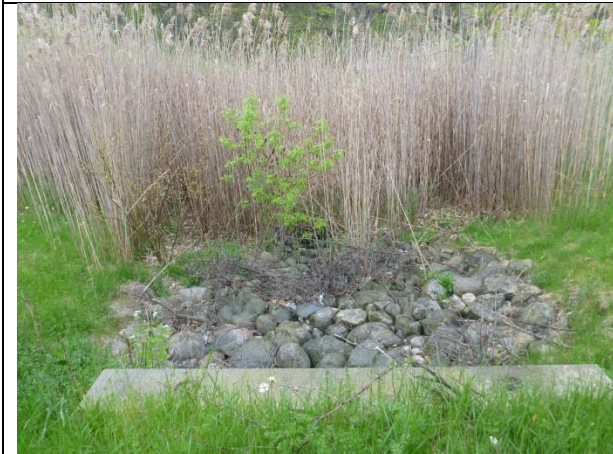
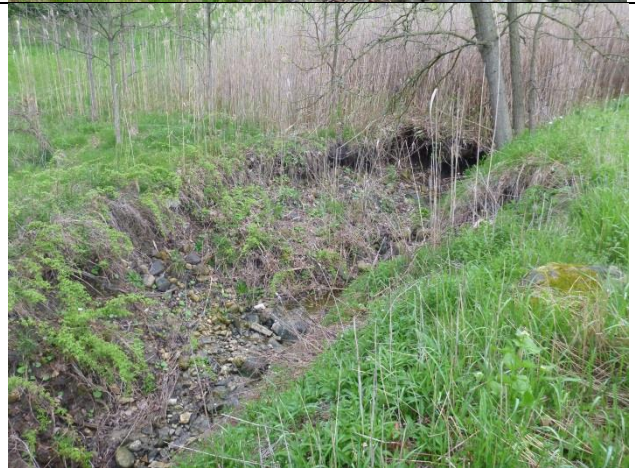
Bank erosion near storm sewer outfall

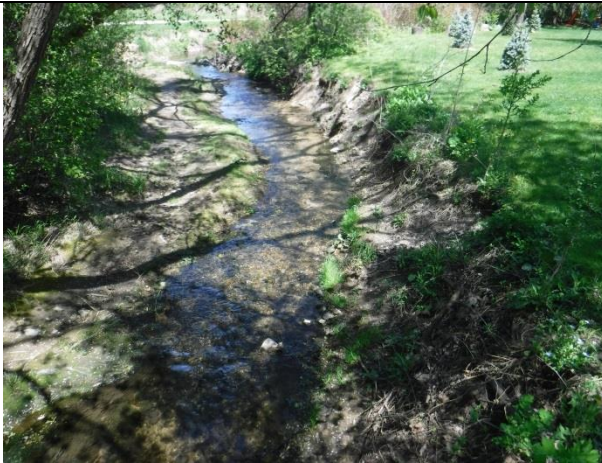
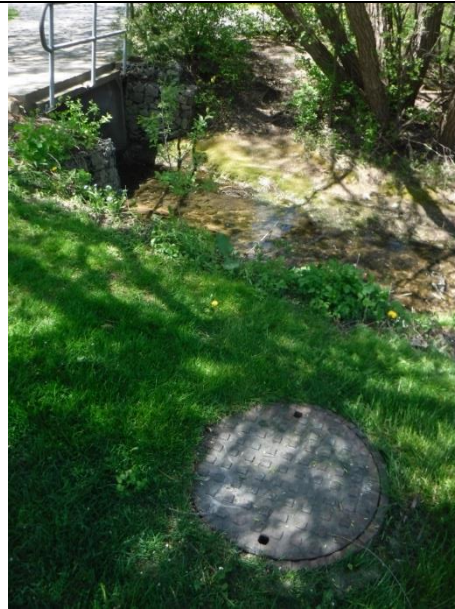
MH in bank

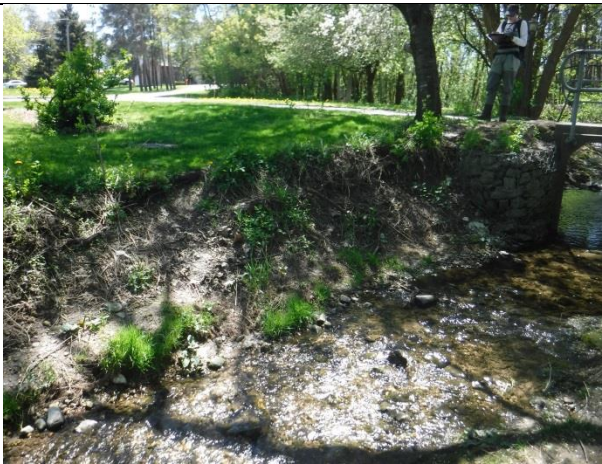
Steep, eroded bank with MH in grass at top

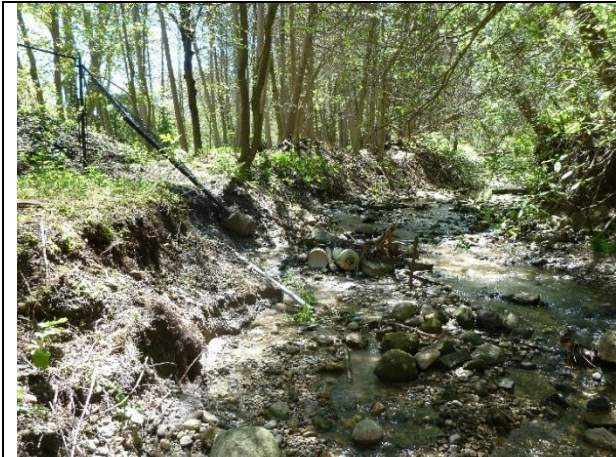
Undermined and leaning fence post

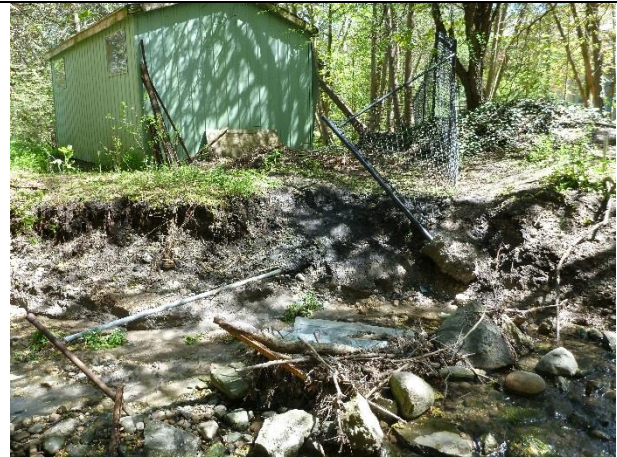
Undermined and leaning fence post

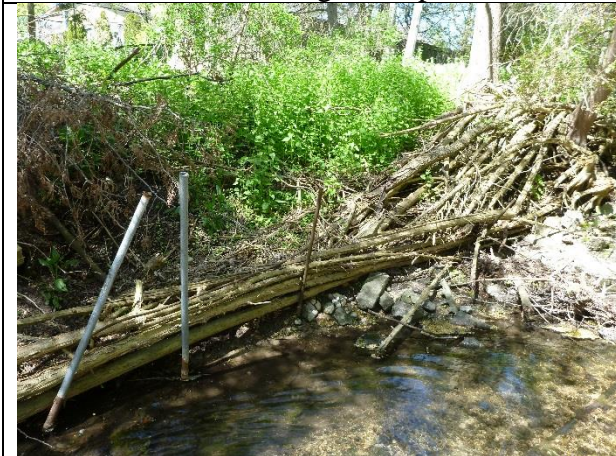
Failed private bank treatment

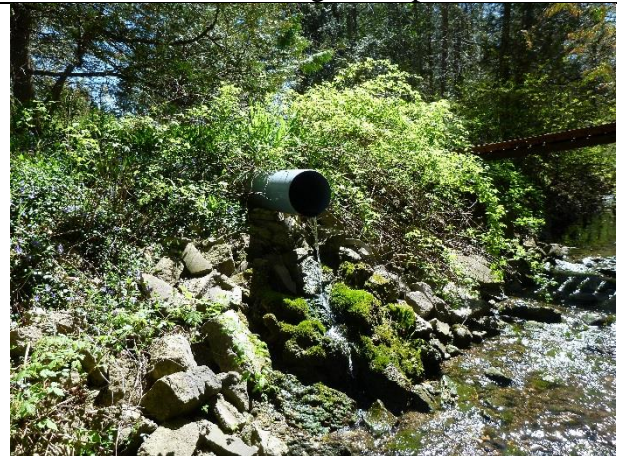
Perched storm sewer outfall

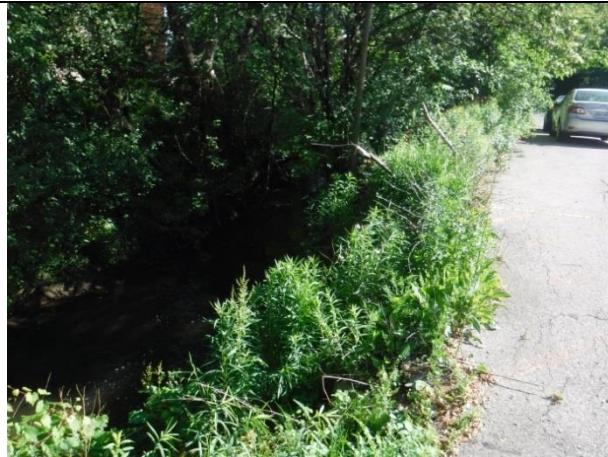
Bank erosion immediately adjacent to private parking lot

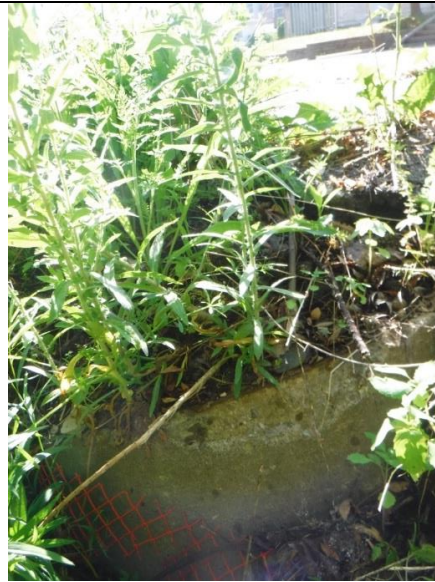
Exposed MH at top of bank with asphalt covering a portion of the lid

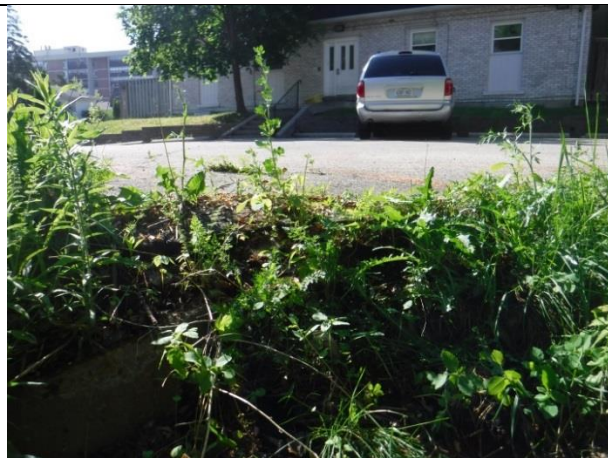
Bank erosion adjacent to parking lot with top of bank and exposed MH in foreground

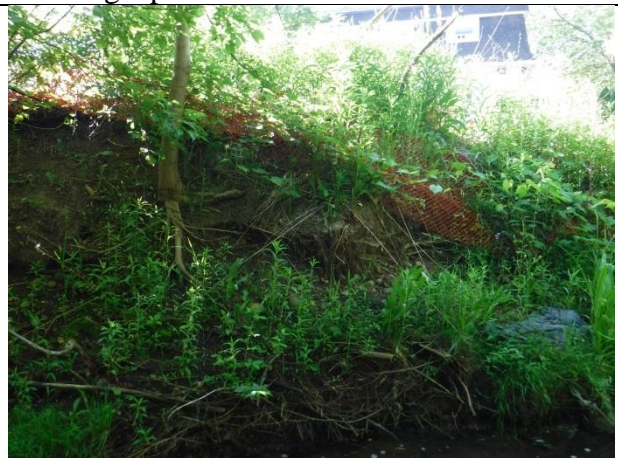
Bank erosion

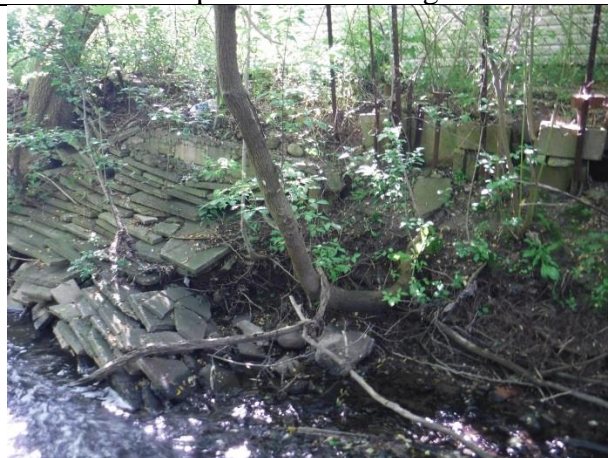
Failing privately constructed concrete slab and concrete block bank treatments

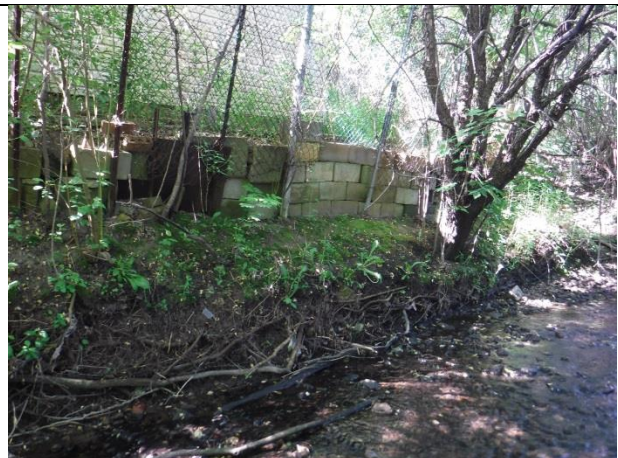
Bank toe erosion

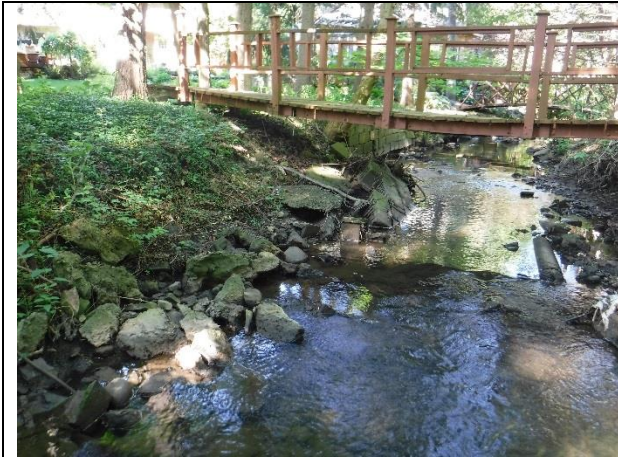
Pedestrian bridge and failing concrete block bank treatment

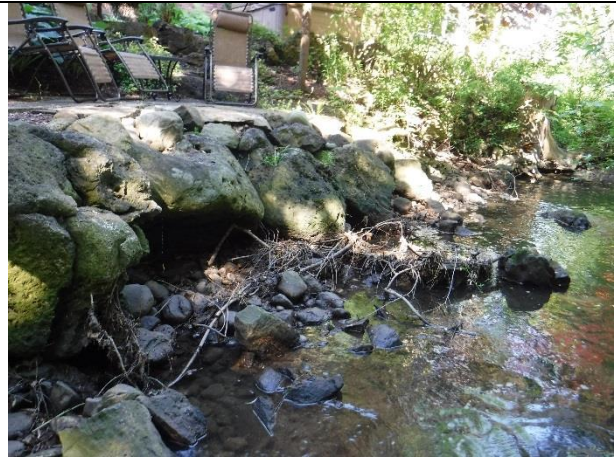
Failing boulder bank treatment

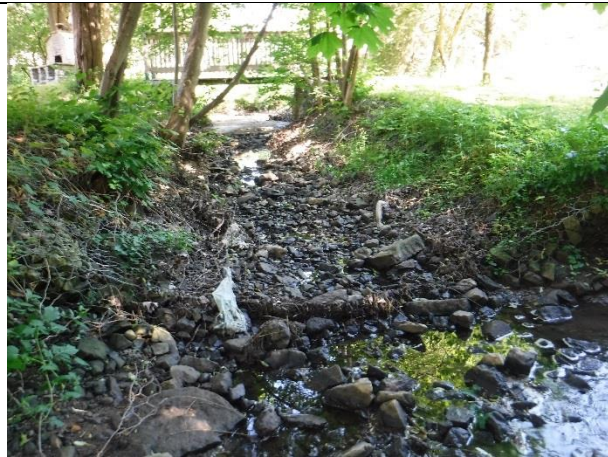
Failed gabion basket treatments

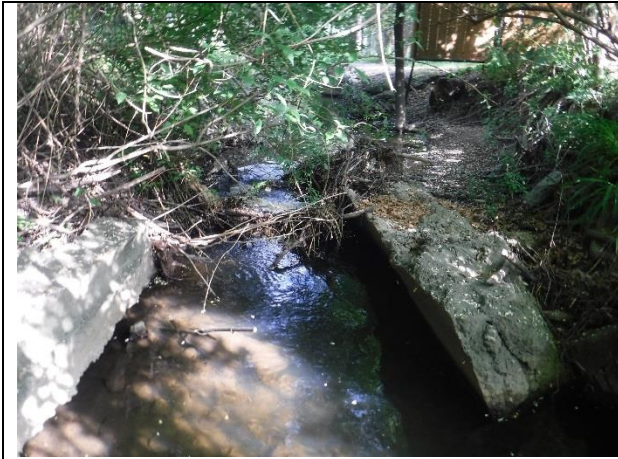
Failing concrete bank treatments may be causing conveyance issues

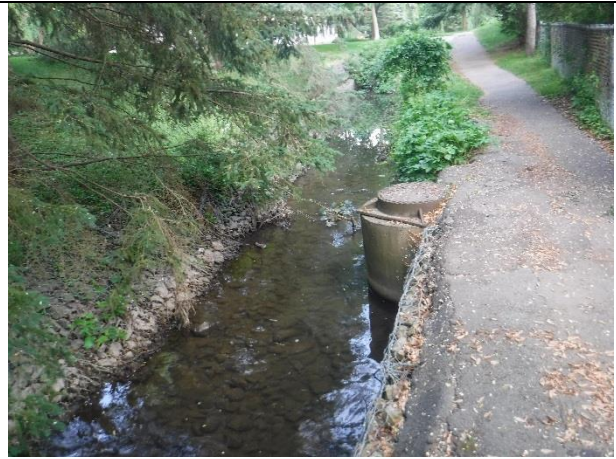
MH in creek

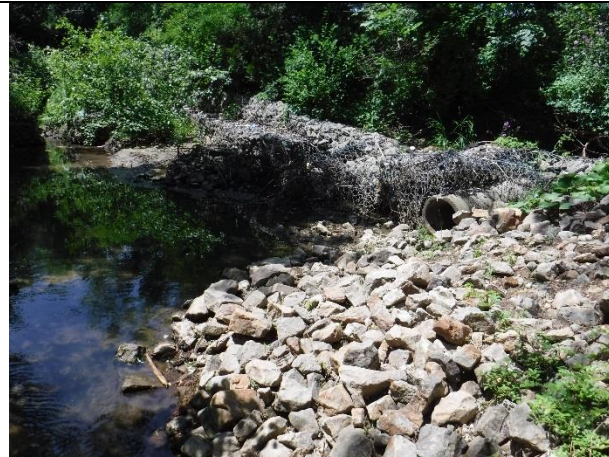
Rip rap with failed gabion baskets and storm outfall in backgrounds

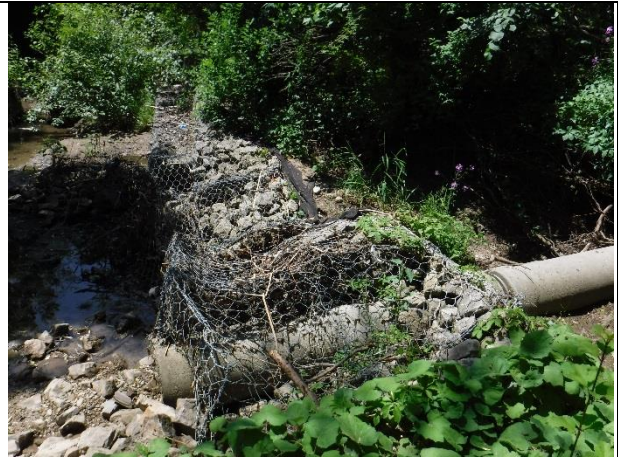
Failed gabions over storm sewer outfall

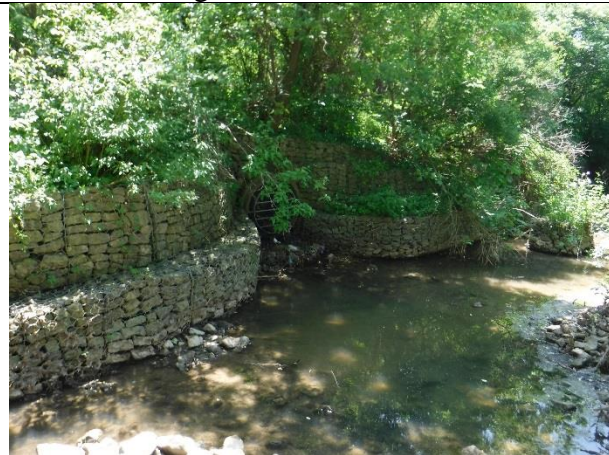
Gabions around second outfall with energy dissipater gabion block in centre of channel upstream

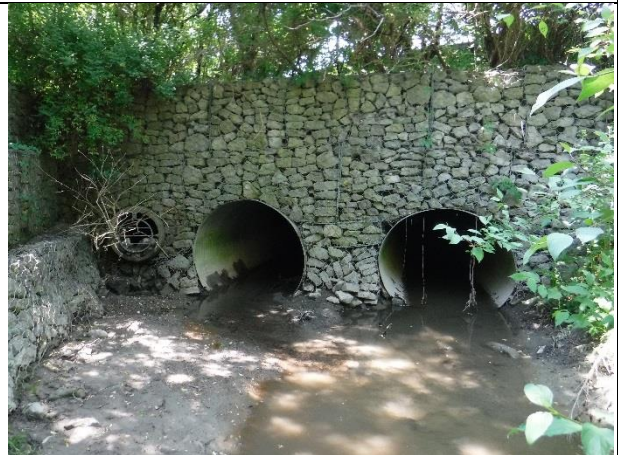
Gabion basket headwall at Columbia Street with lower baskets emptying. Note deformation of culvert on right side of photo.

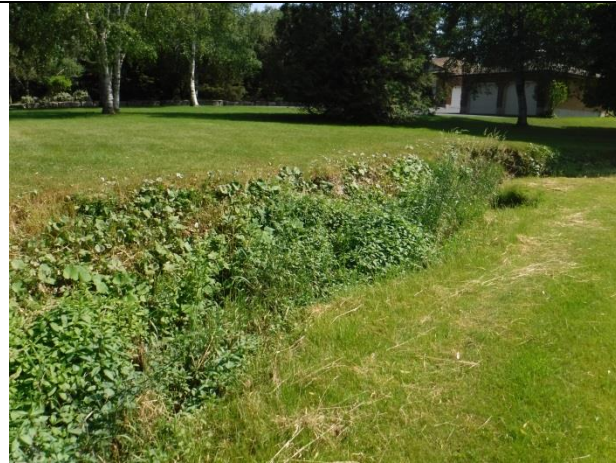
Manicured lawn to top of bank with bank erosion throughout channel

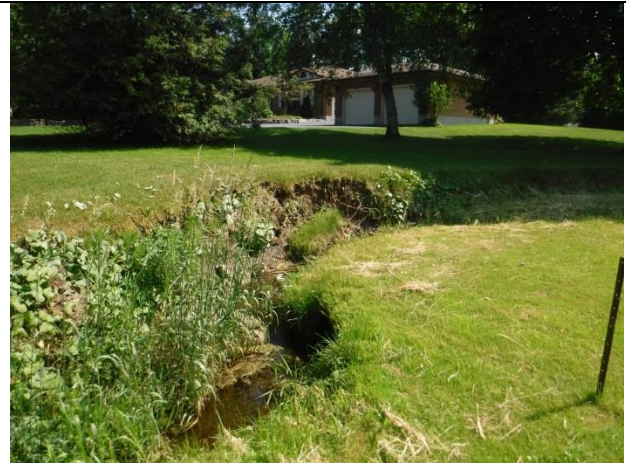
Eroded and slumping banks

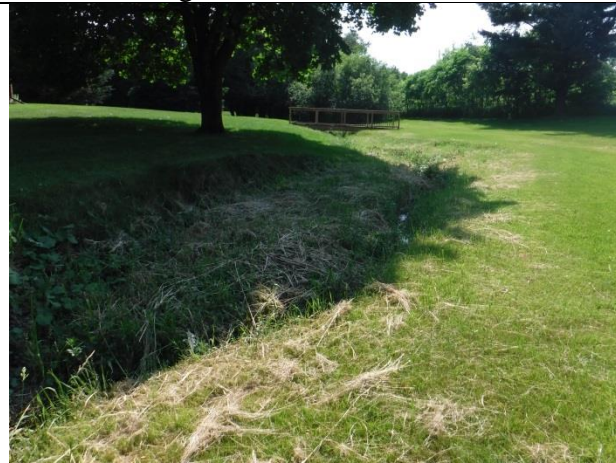
Manicured lawn to top of bank with bank slumping and eroding

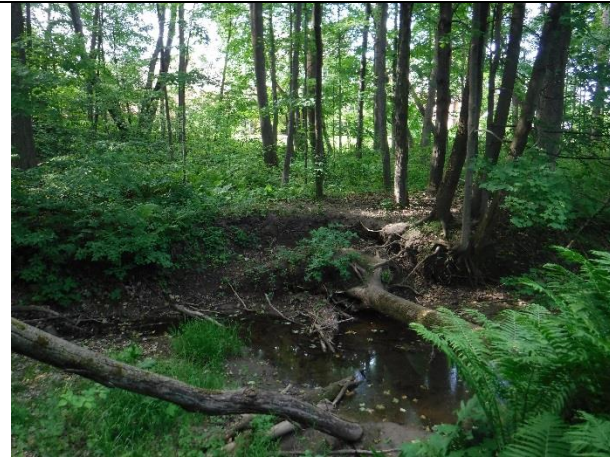
Entrenched channel with falling and leaning trees

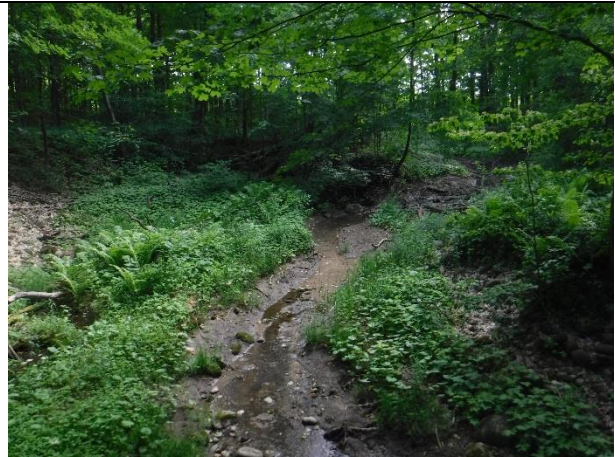
Over-widened channel

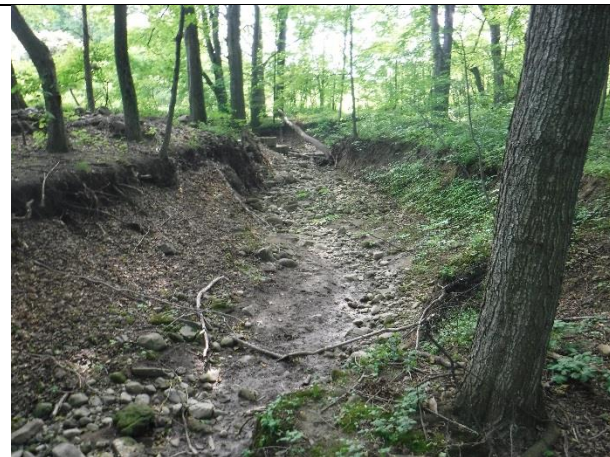
Entrenched channel with steep, eroded bank

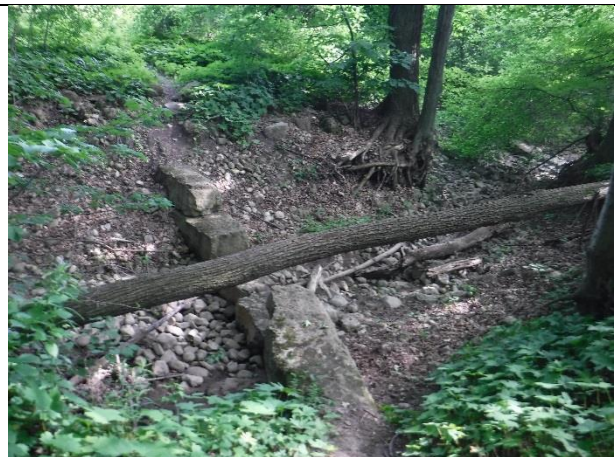
Armourstone weirs downstream of stormwater management facility outfalls

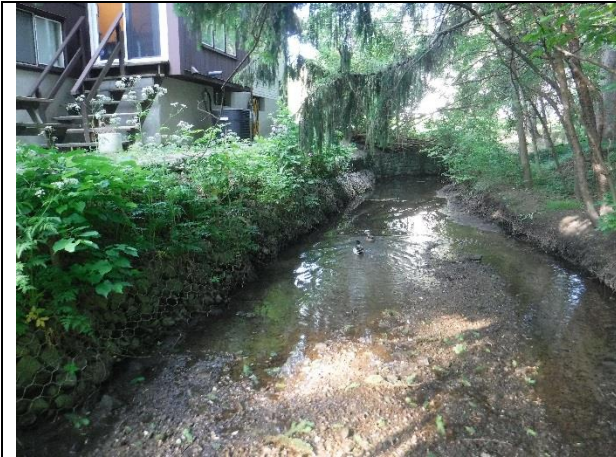
House located within 5 m of the top of bank

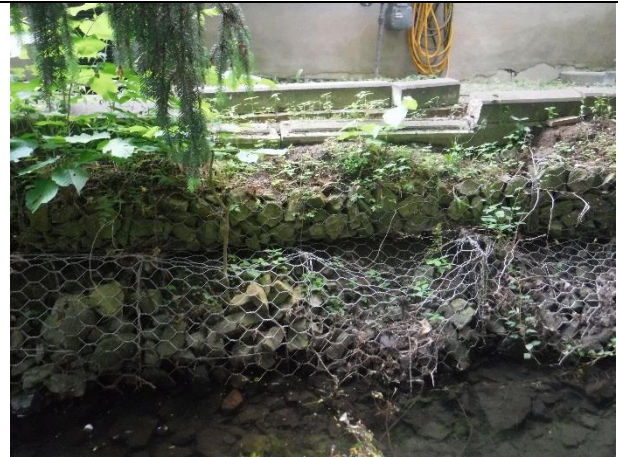
Failing gabion baskets

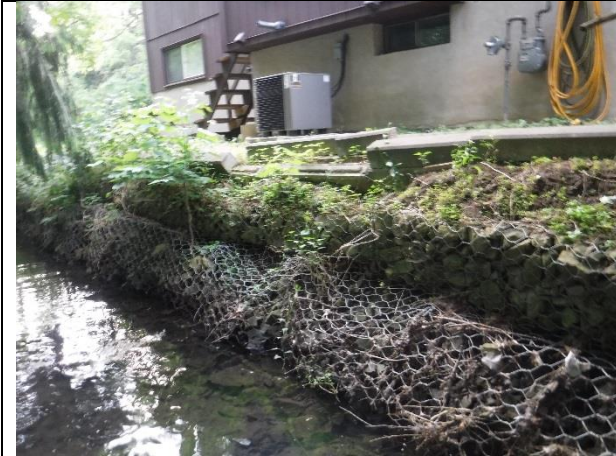
Failing gabion baskets

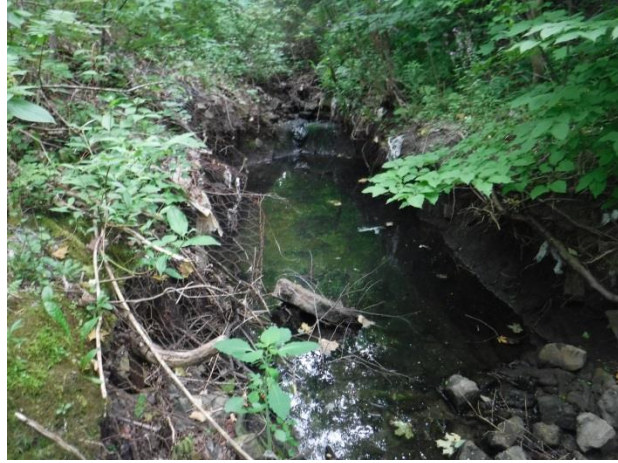
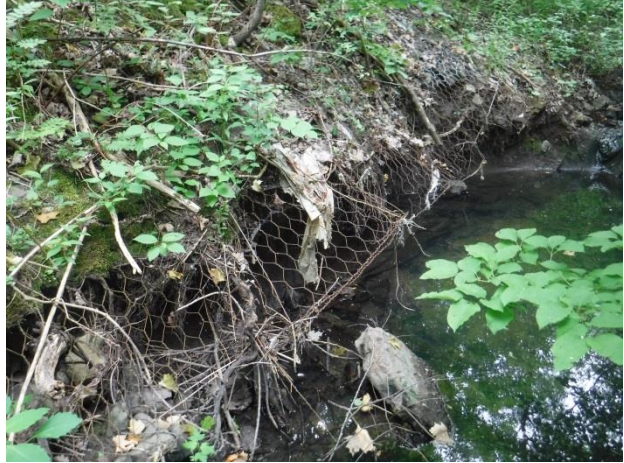
Empty gabion baskets

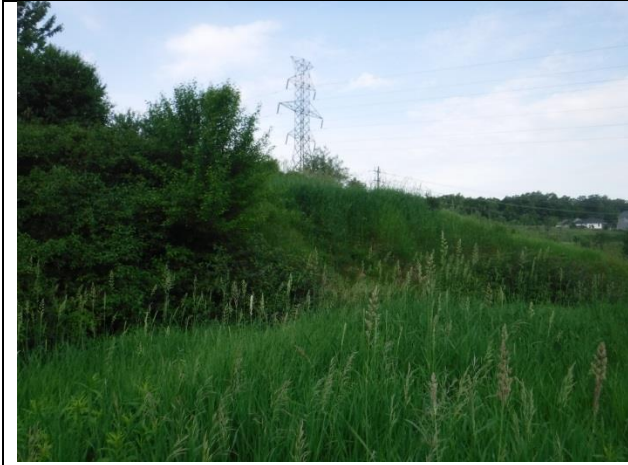
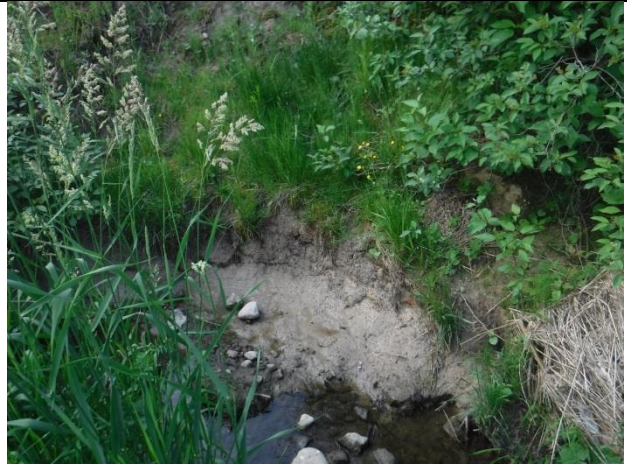
Toe erosion at creek contact with valley wall.

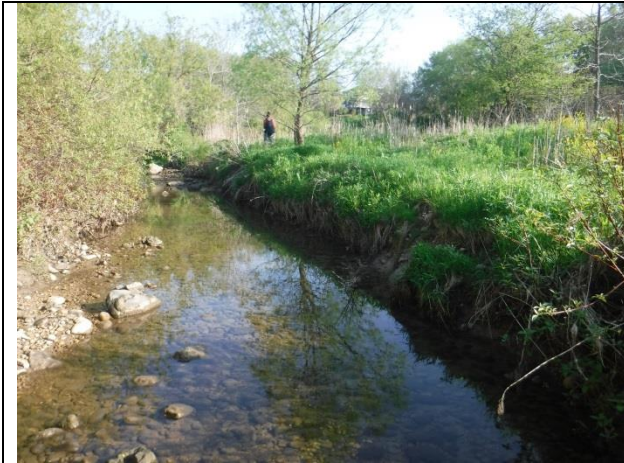
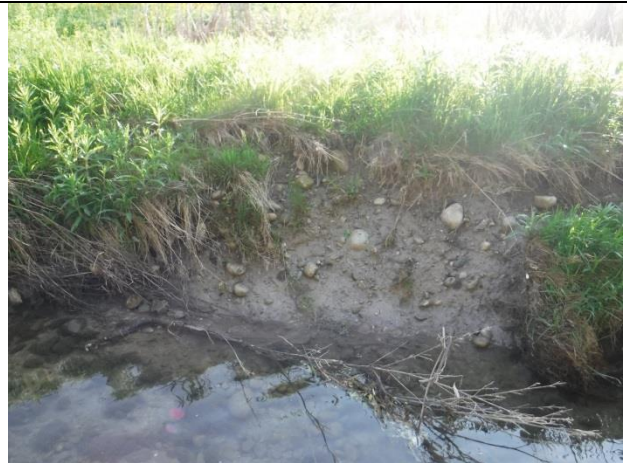
Bank erosion

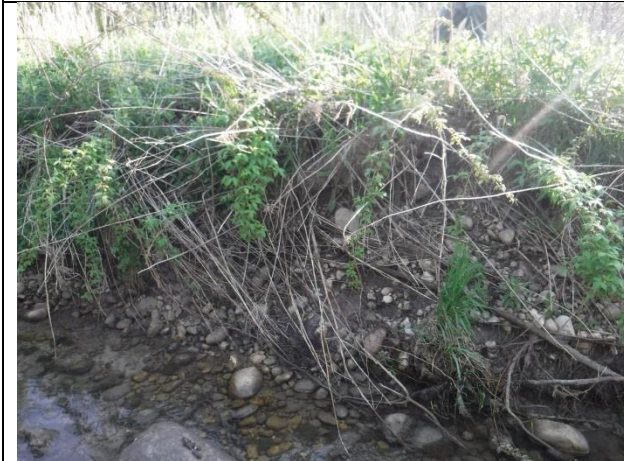
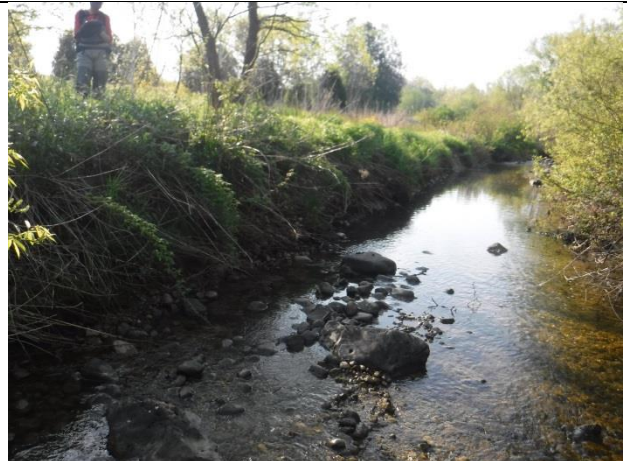
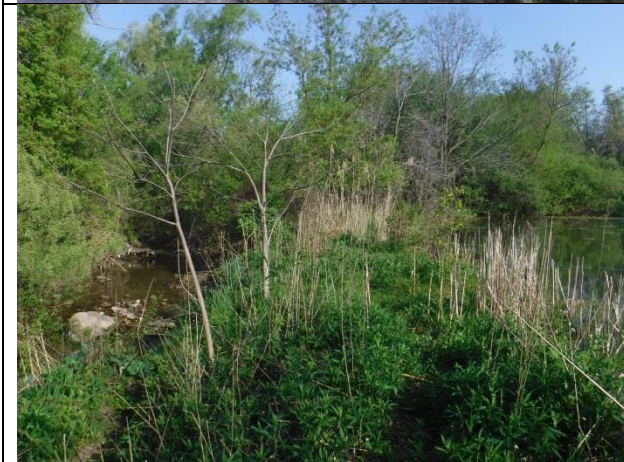
Creek on left side of photo and SWMF on right side

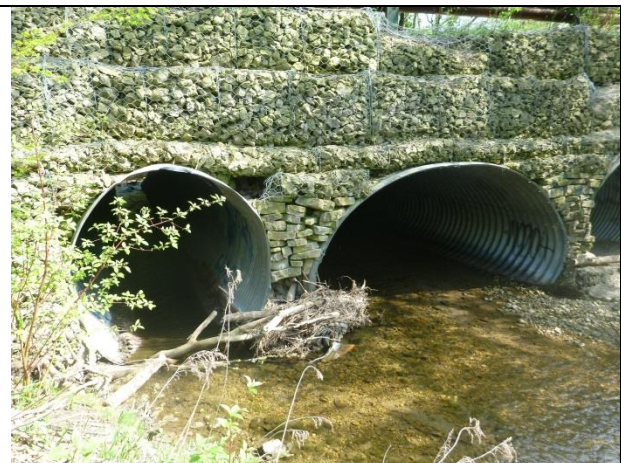
Upstream face of culverts

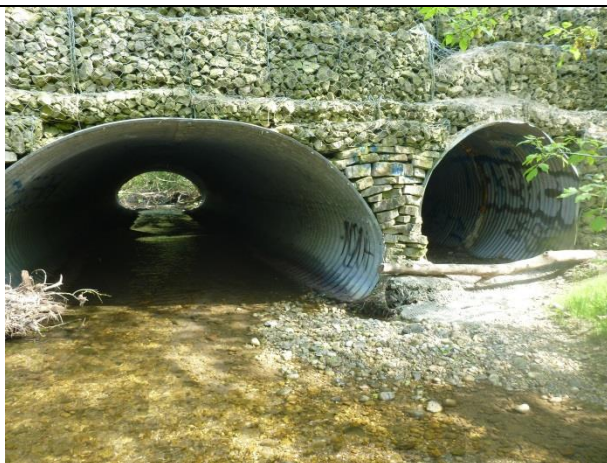
Upstream face of culverts

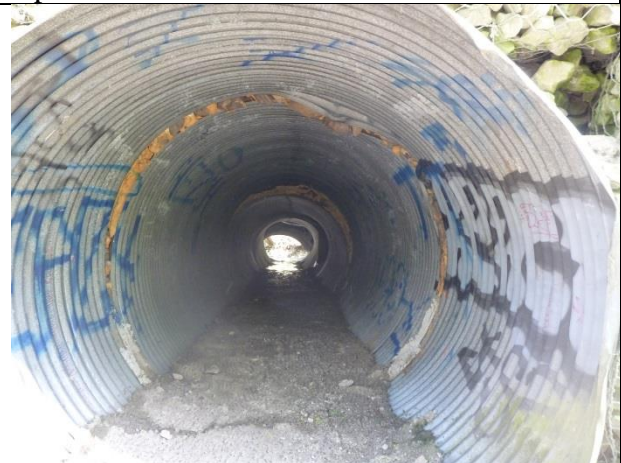
Shearing at joints in culvert

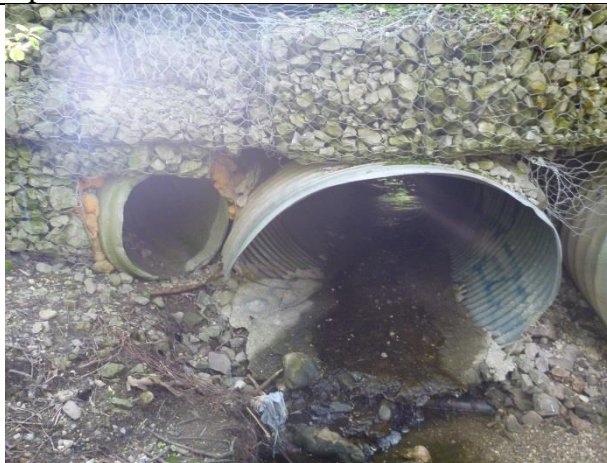
Downstream face of culverts

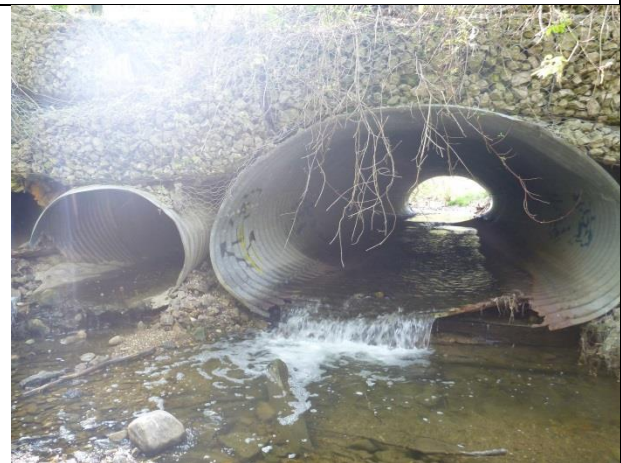
Downstream face of culverts

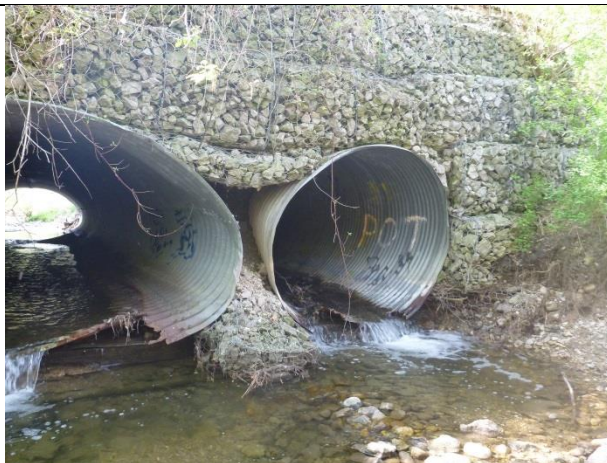
Downstream face of culverts

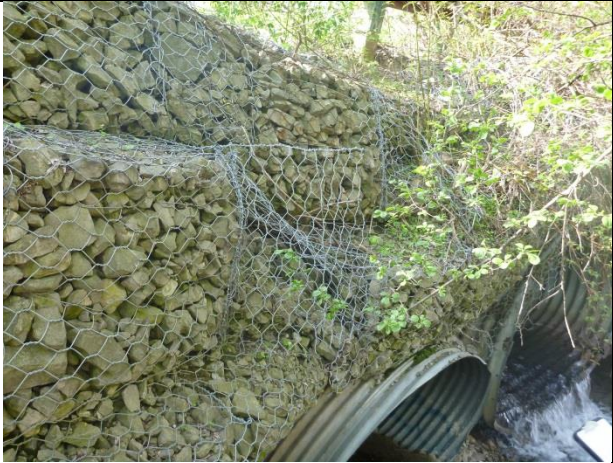
Failing gabion baskets

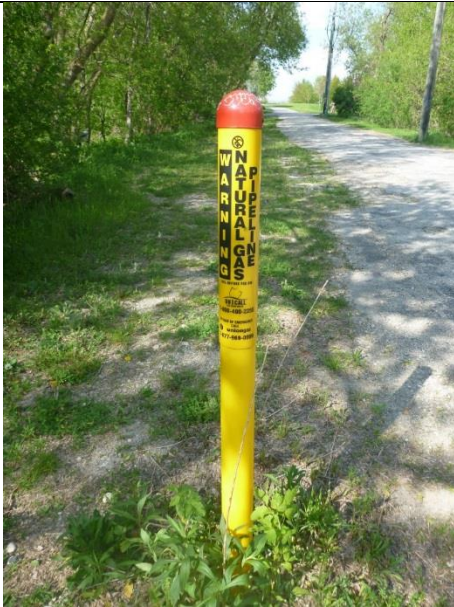
Marker for natural gas pipeline crossing creek

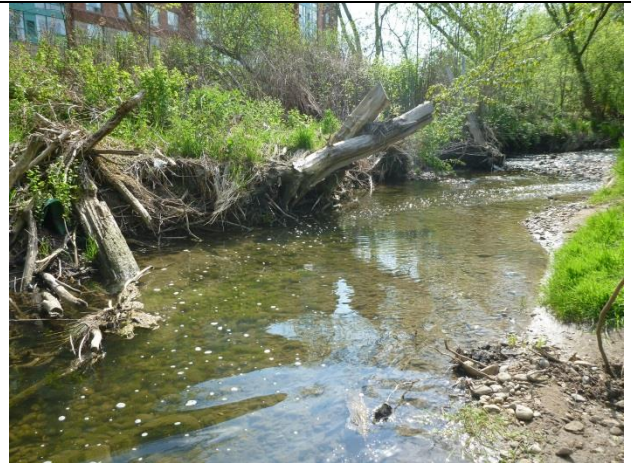
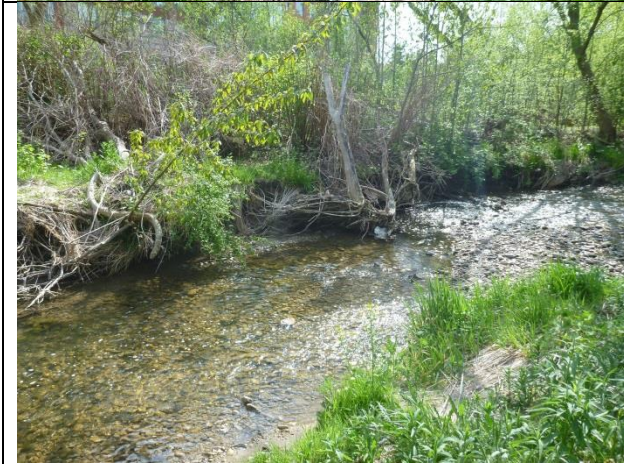
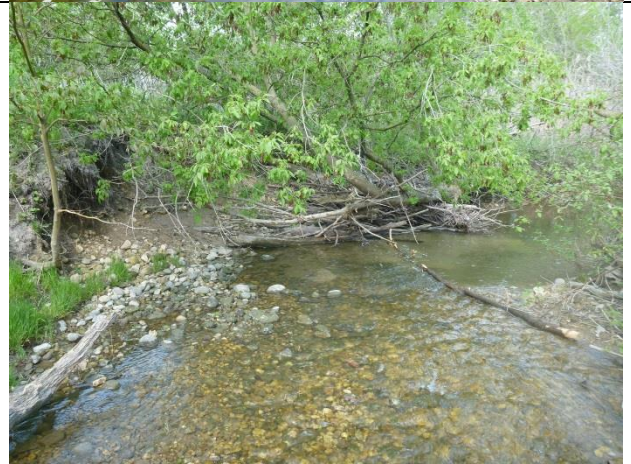
Bank erosion towards sanitary sewer

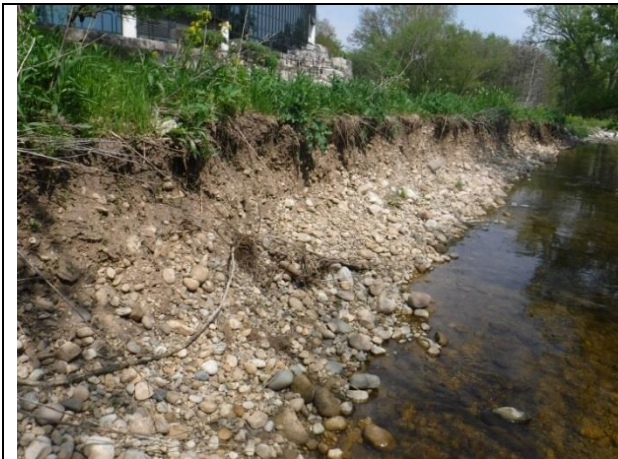
Roundstone is failing and bank is near vertical and eroding towards the path

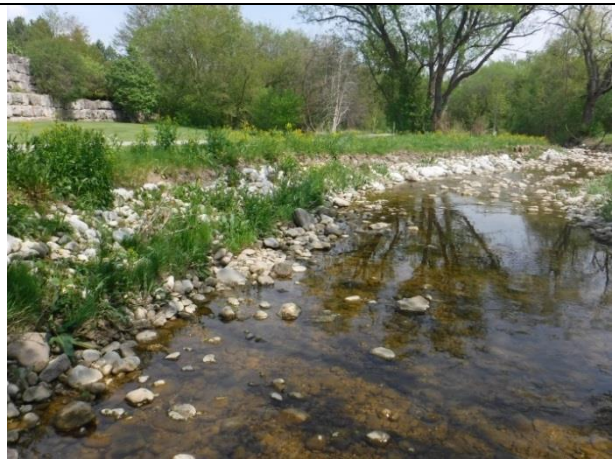
Roundstone bank treatment is slumping and vegetation on bank is primarily herbaceous

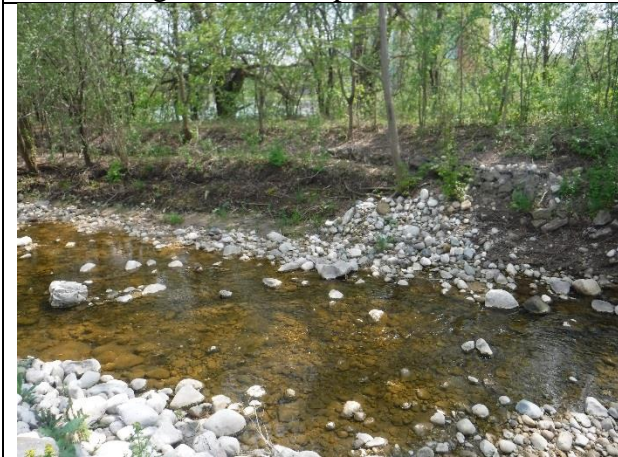
Roundstone bank treatment is failing

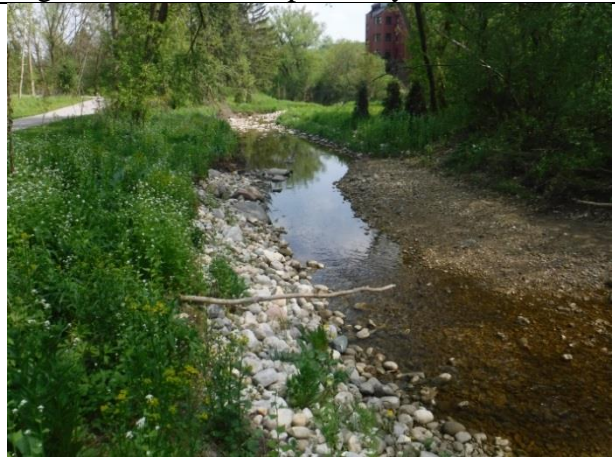
Roundstone treatment with herbaceous vegetation on bank

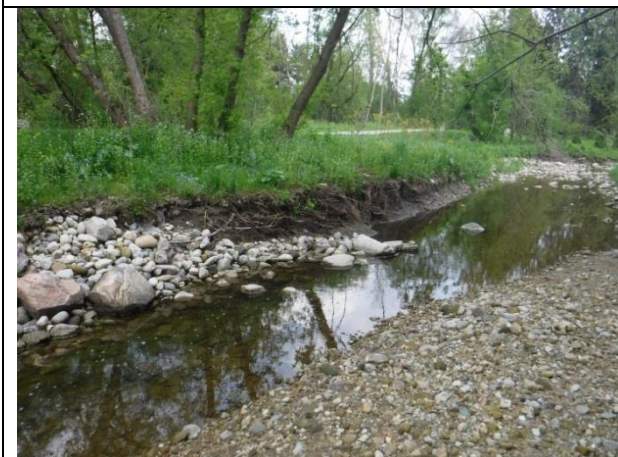
Slumping roundstone with eroding bank downstream
