CITY OF WATERLOO

Municipal Class Environmental Assessment

WATERCOURSE EROSION MASTER PLAN

Aquafor Beech Ltd.

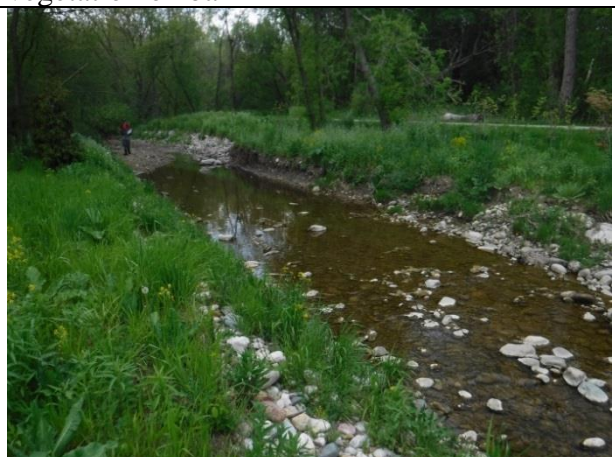
Bank erosion between roundstone treatments with trail in background

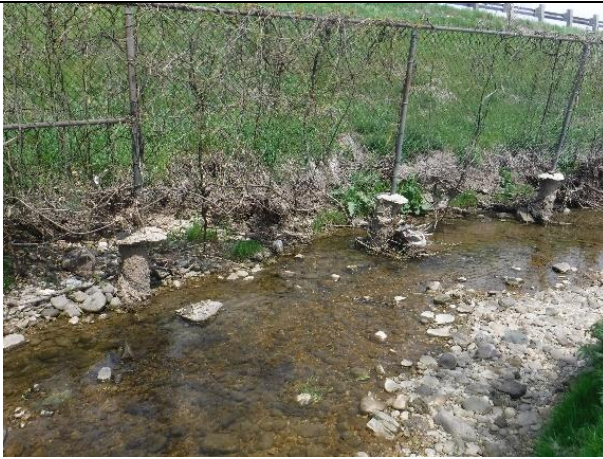
Undermining of fence posts

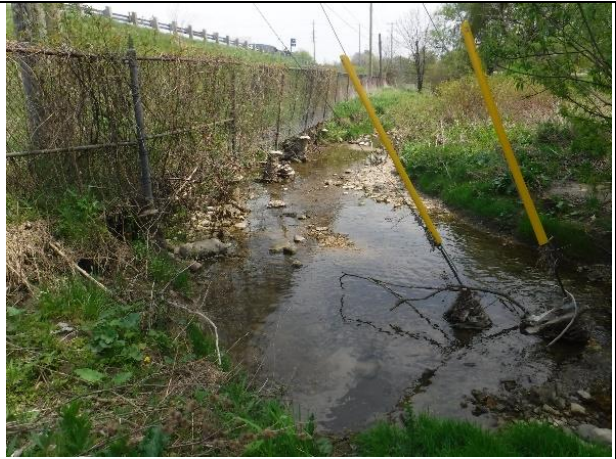
Guy wires in channel. Sanitary sewer crosses under creek.

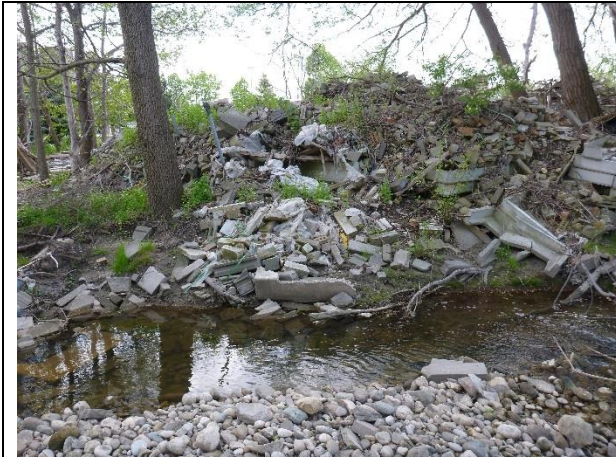
Construction debris dumping on bank

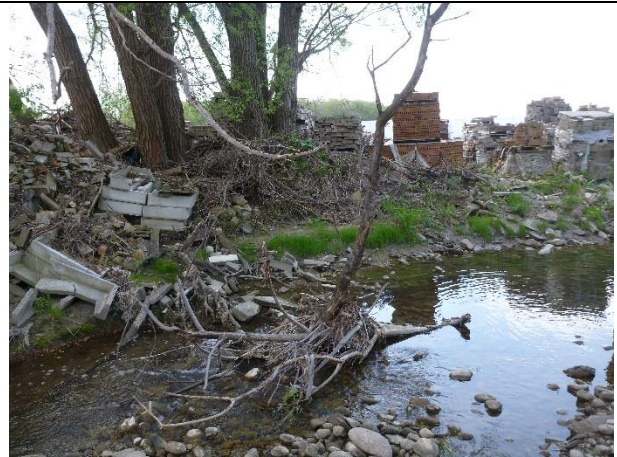
Construction debris dumping on bank

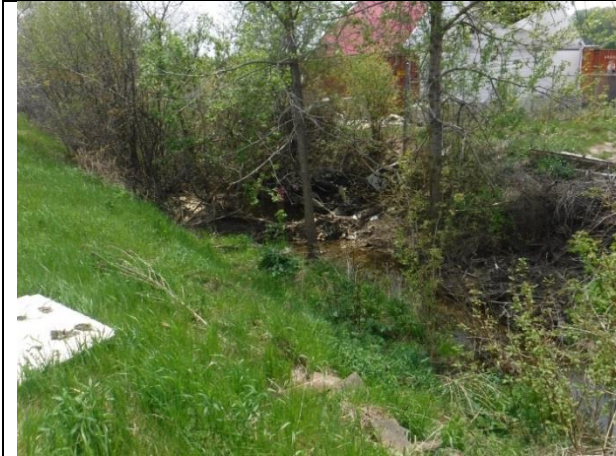
Bank erosion towards shed in background

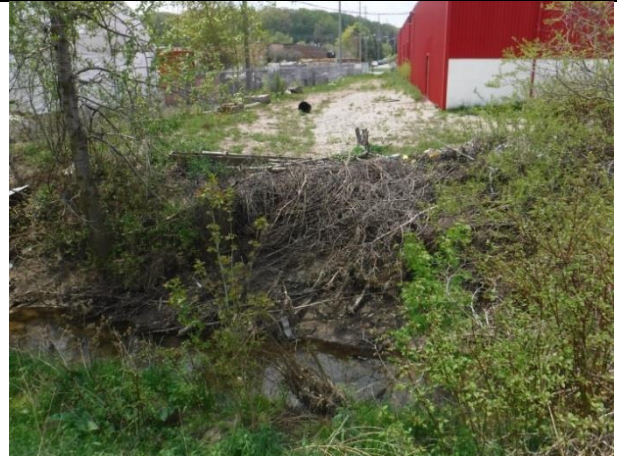
Bank erosion towards private property

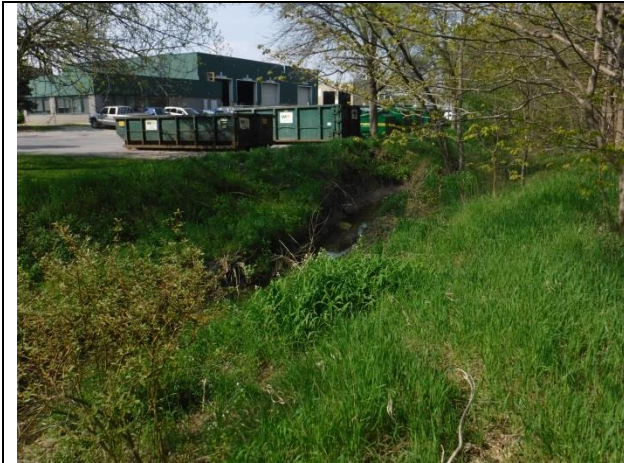
Bank erosion towards parking lot and dumpsters

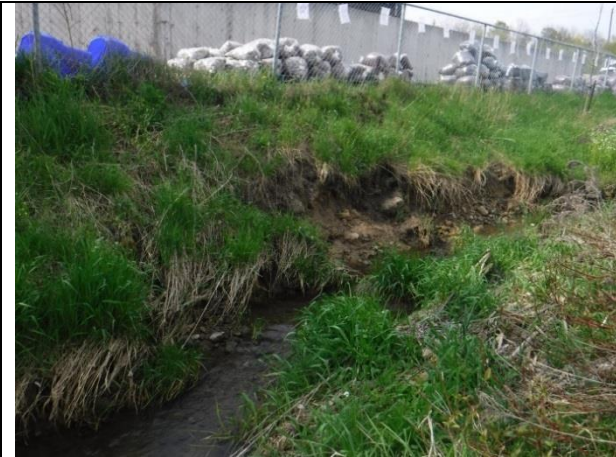
Bank erosion and slumping adjacent to garden centre lot

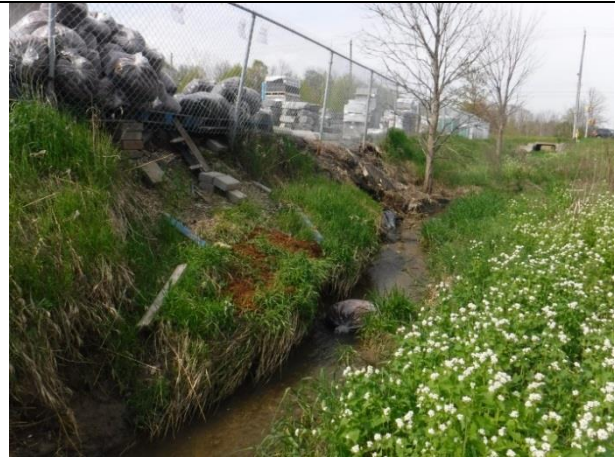
Undermining of fence

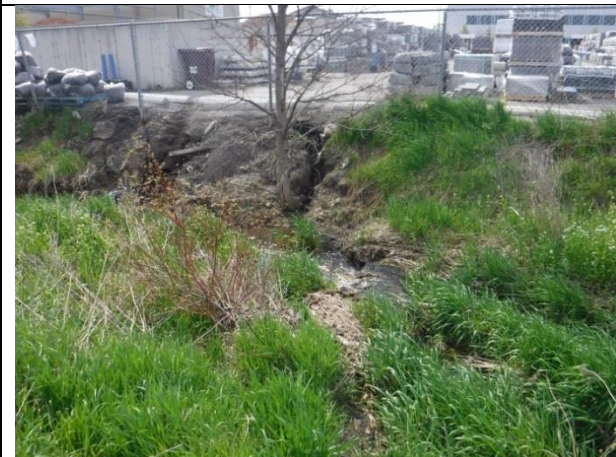
Undermining of fence where storage area runoff enters the creek

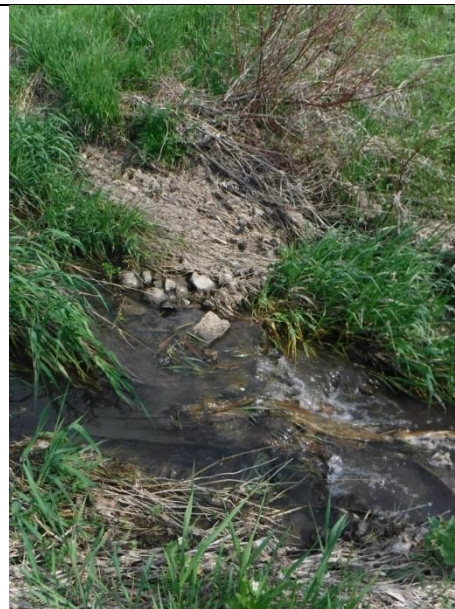
Failed gabion weir on bed

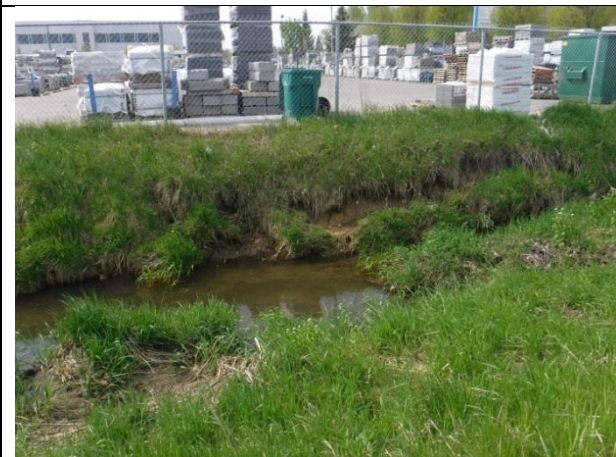
Bank slumping adjacent to garden centre lot

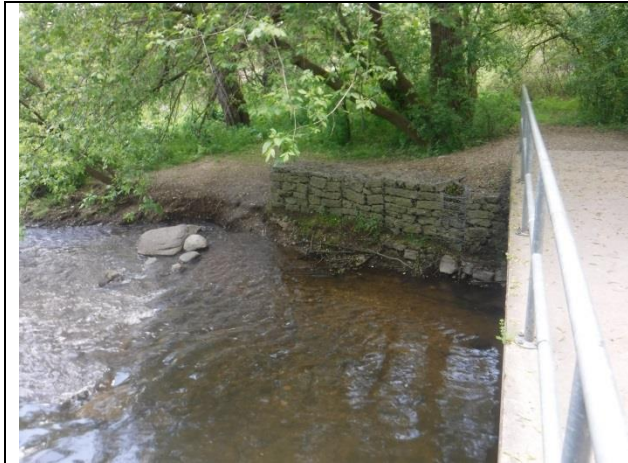
Gabions outflanked

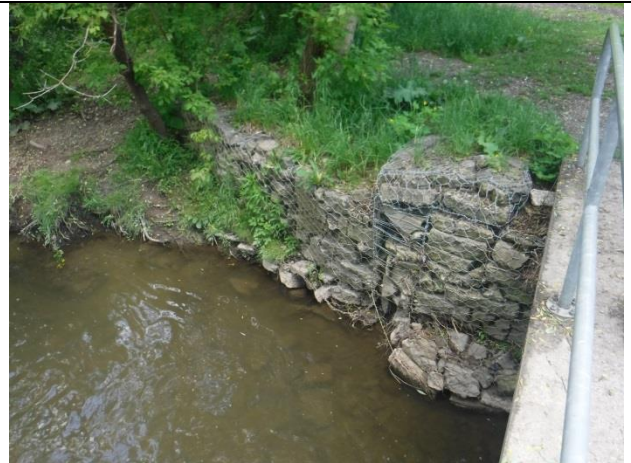
Gabions emptying at toe

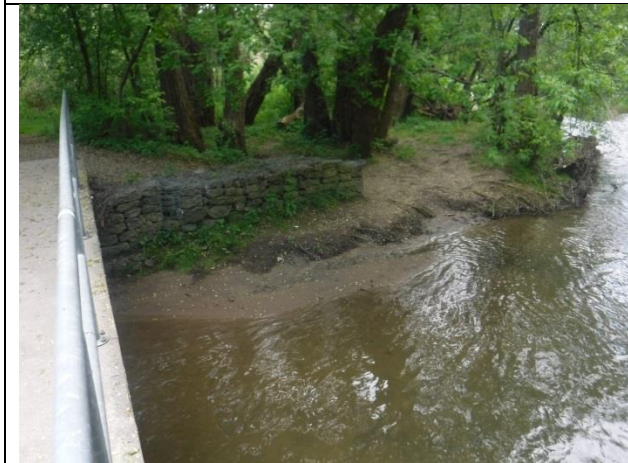
Gabions outflanked

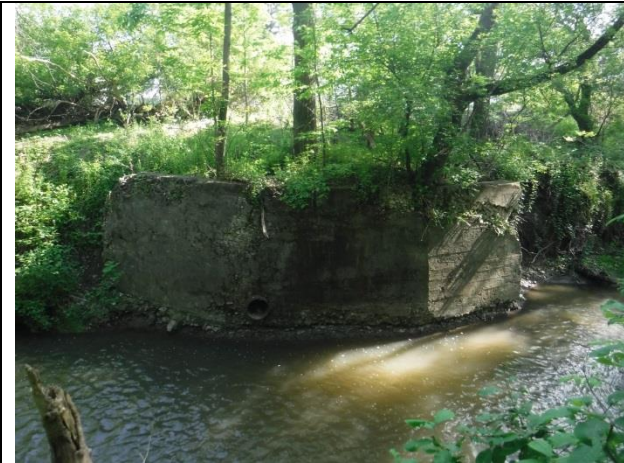
Outflanked old concrete abutment

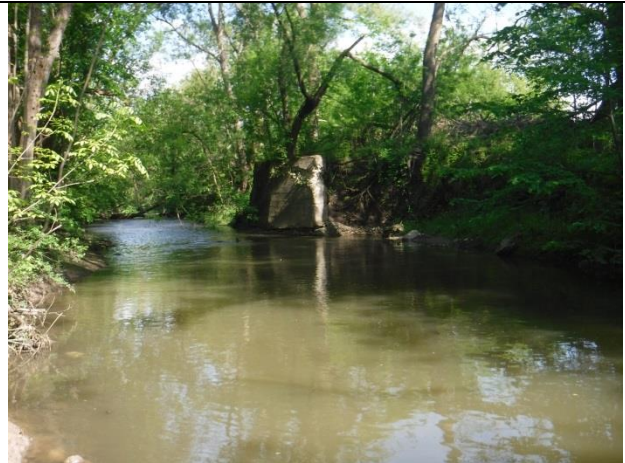
Outflanked old concrete abutment

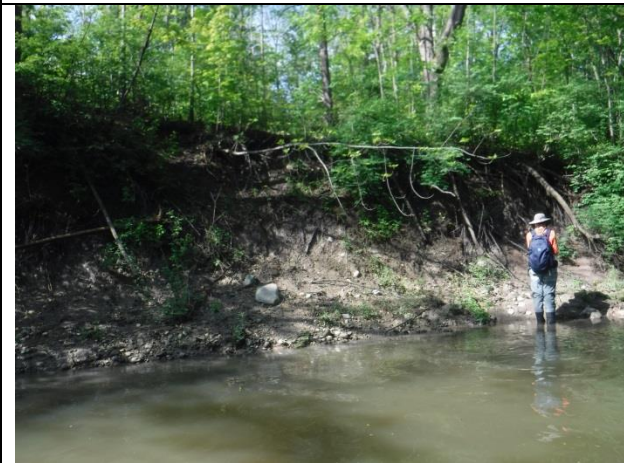
Erosion scar

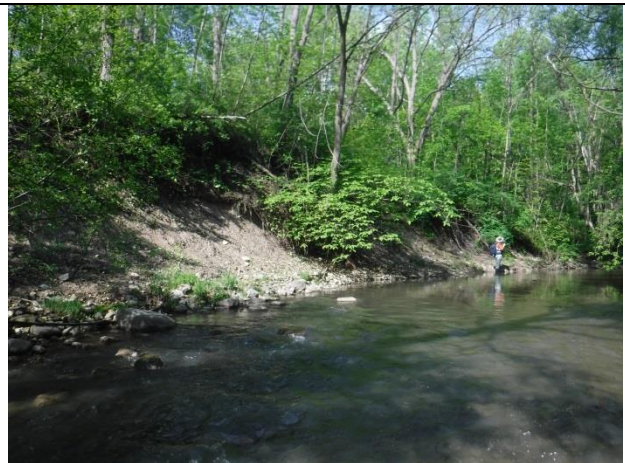
Erosion scar

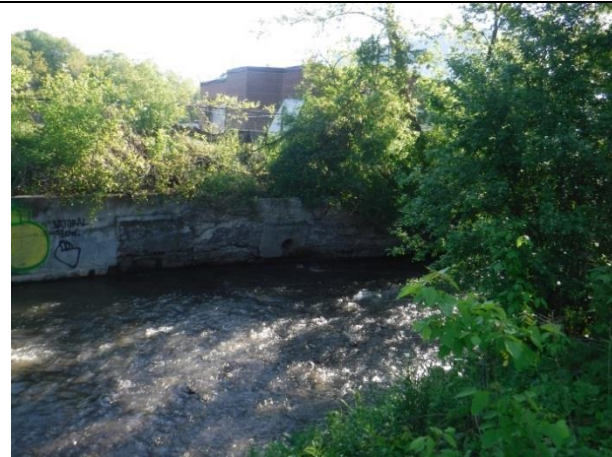
Leaning concrete wall with storm sewer outfall

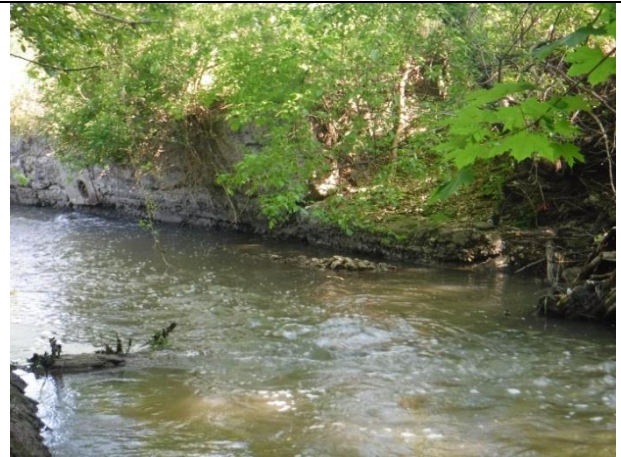
Outflanked downstream end of leaning concrete wall

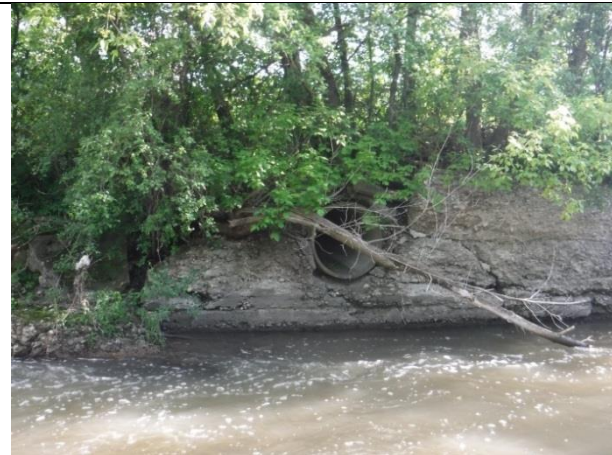
Storm sewer outfall in concrete wall

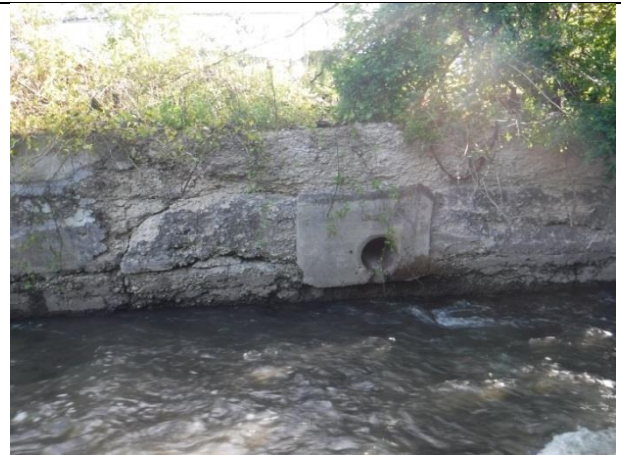
Storm sewer outfall in concrete wall

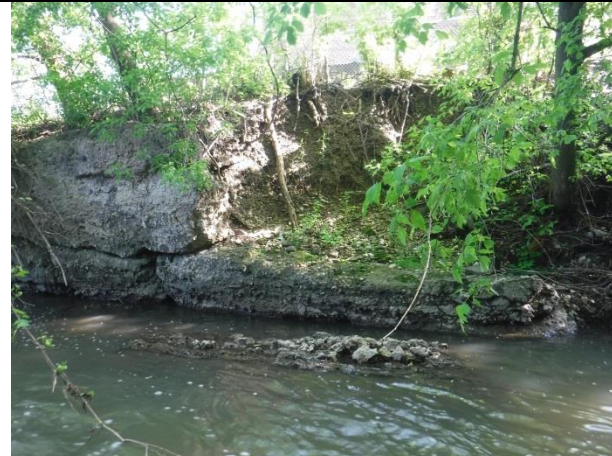
Outflanked downstream end of concrete wall

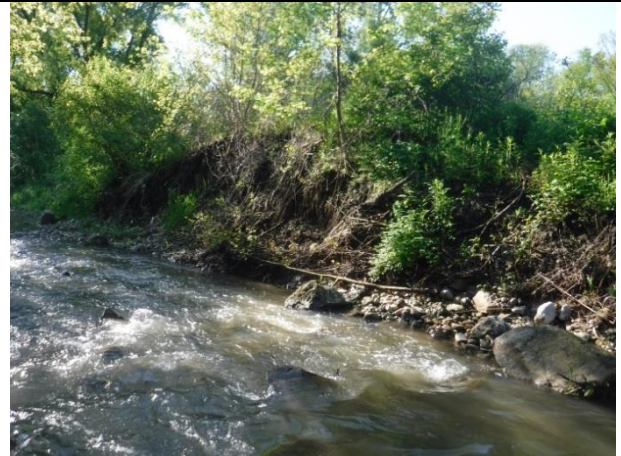
Near-vertical bank opposite concrete wall

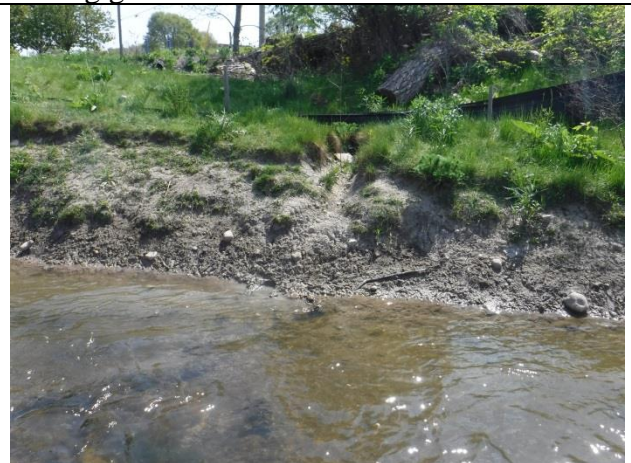
Bank erosion associated with storm sewer outfall

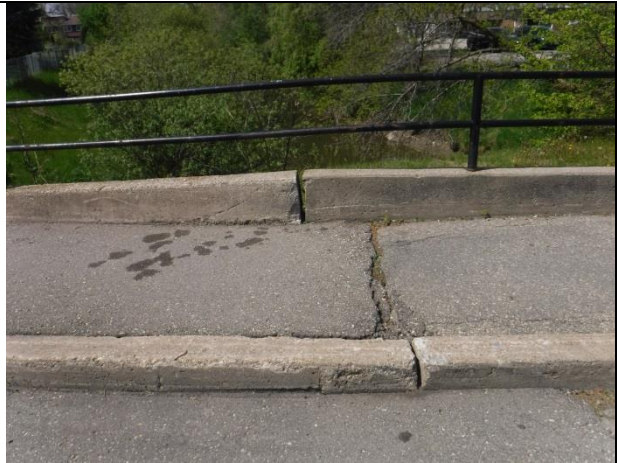
Cracks in curb and asphalt on bridge deck

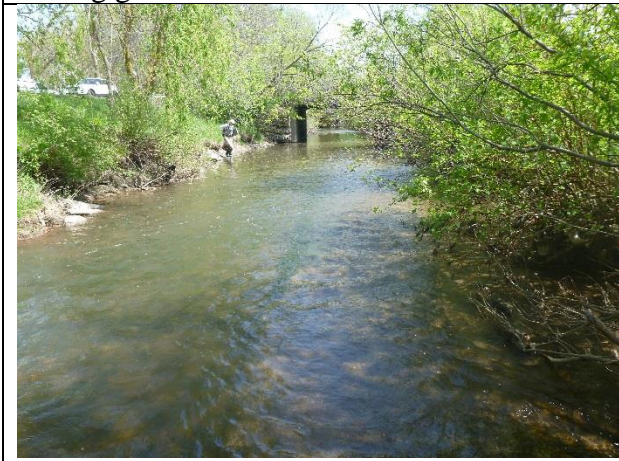
Exposed concrete on channel bed

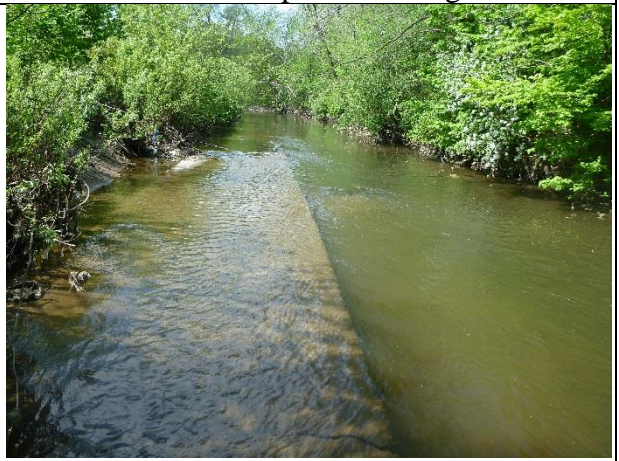
Exposed concrete on channel bed

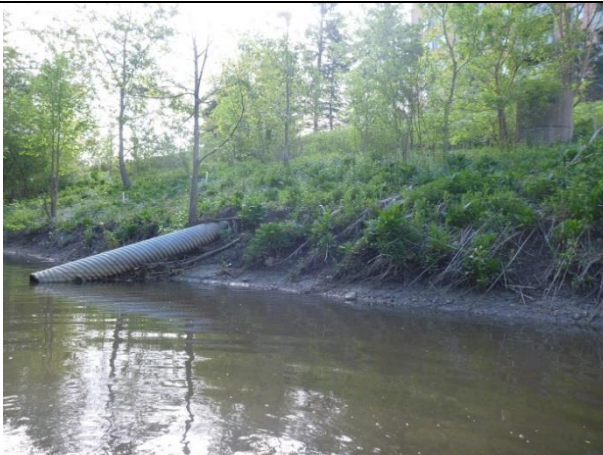
Near vertical bank erosion in front of MH.
Failing private outfall.

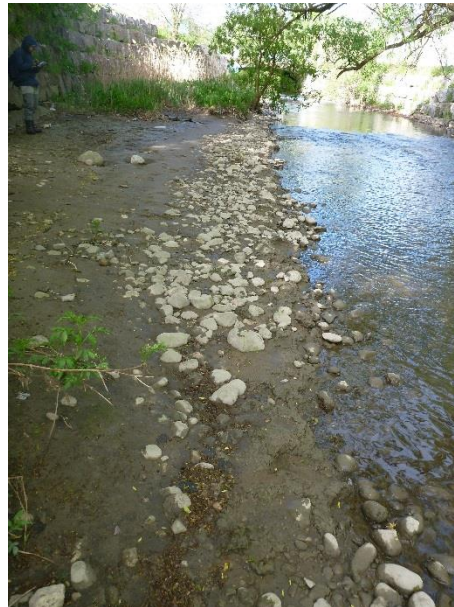
Exposed concrete on bed

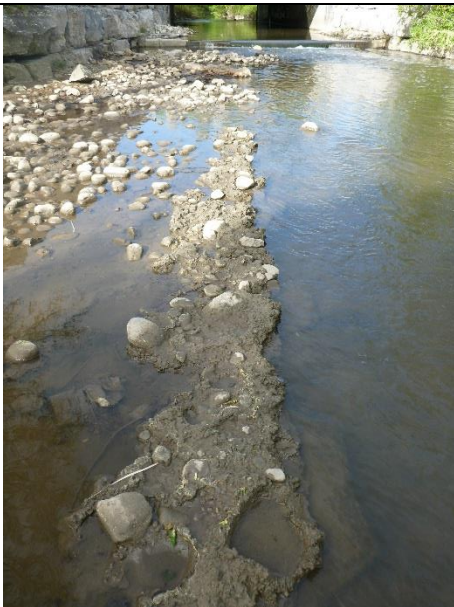
Exposed concrete on bed

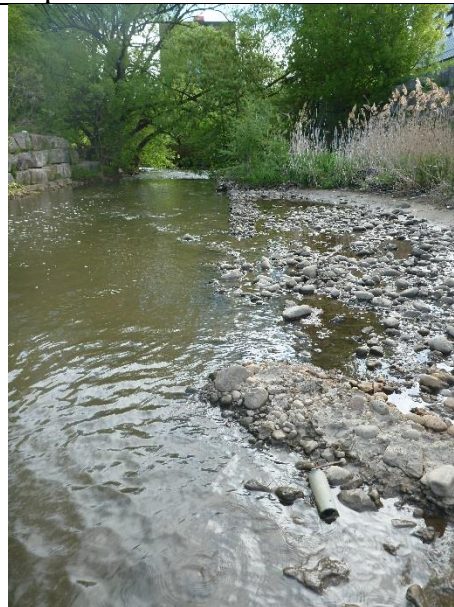
Exposed concrete on bed

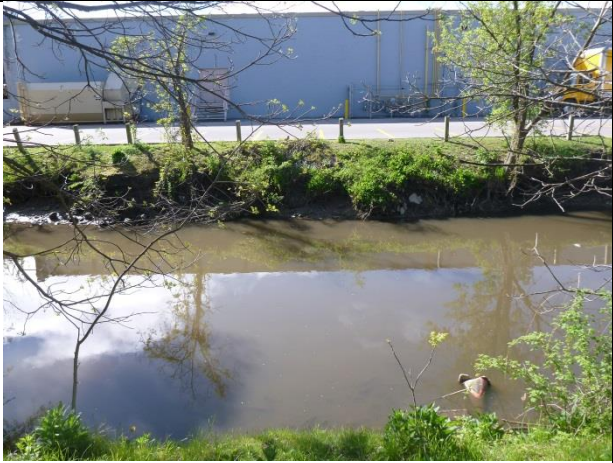
Bank erosion adjacent to paved loading area

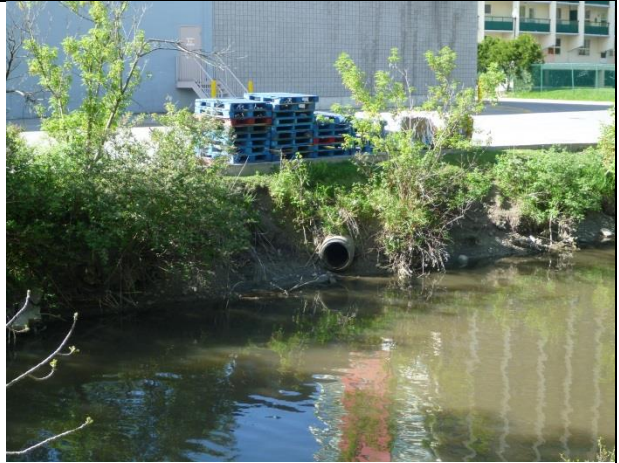
Storm outfall on eroded bank with loading area above

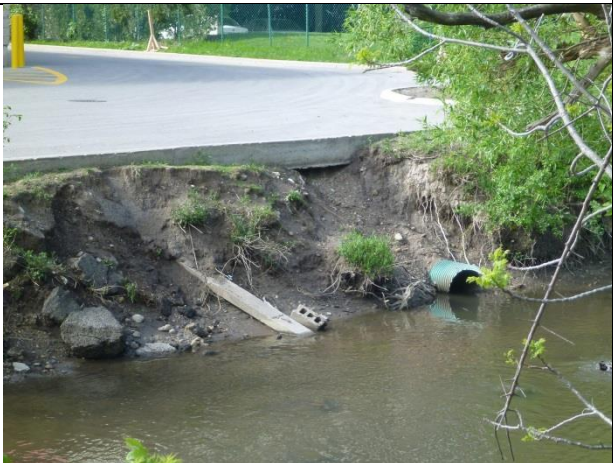
Undermining of loading area pavement

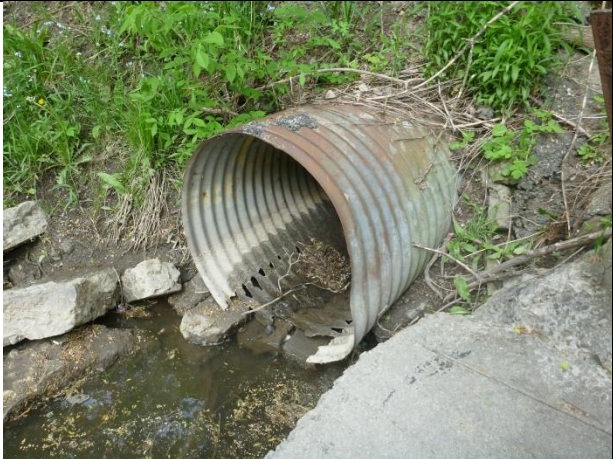
Storm sewer outfall in poor condition

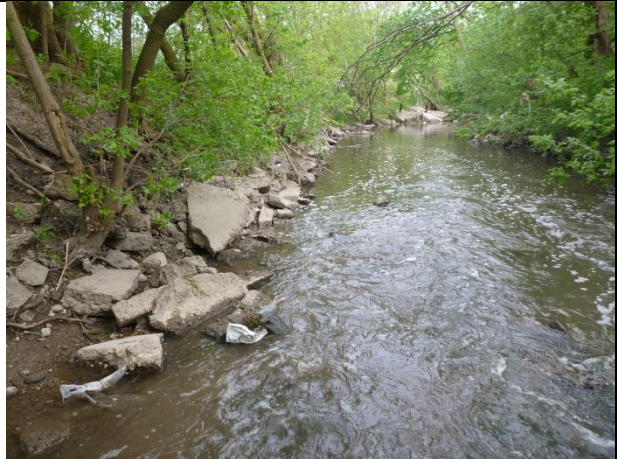
Concrete debris on toe of bank

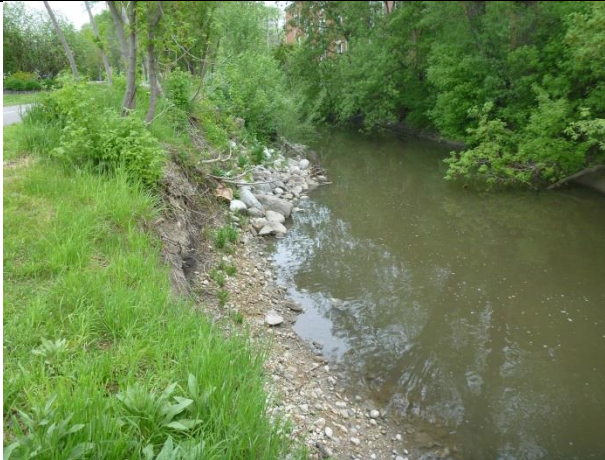
Near vertical bank erosion adjacent to trail

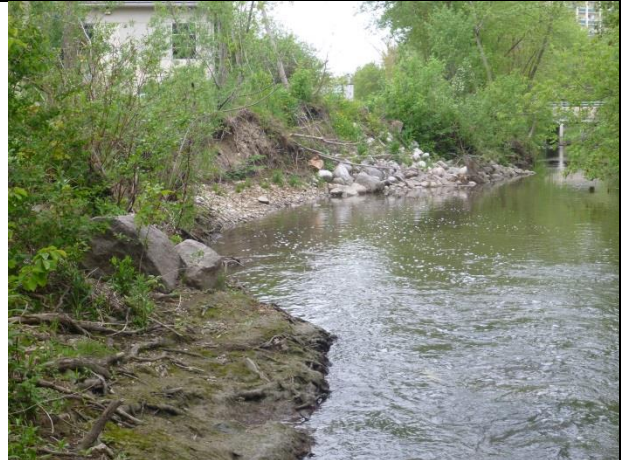
Erosion upstream of roundstone treatment

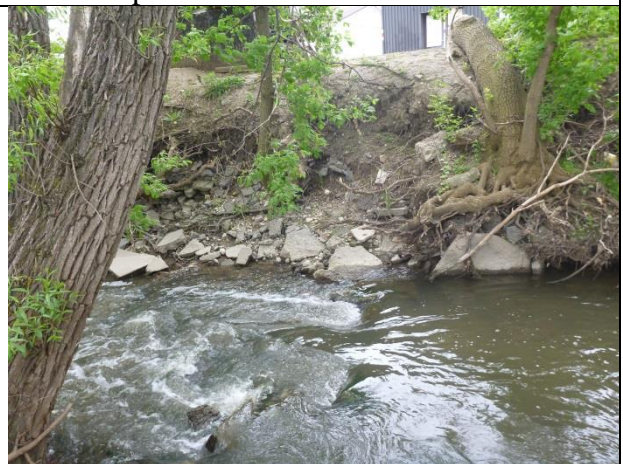
Rock riffle at upstream end of site with right bank erosion adjacent to private property

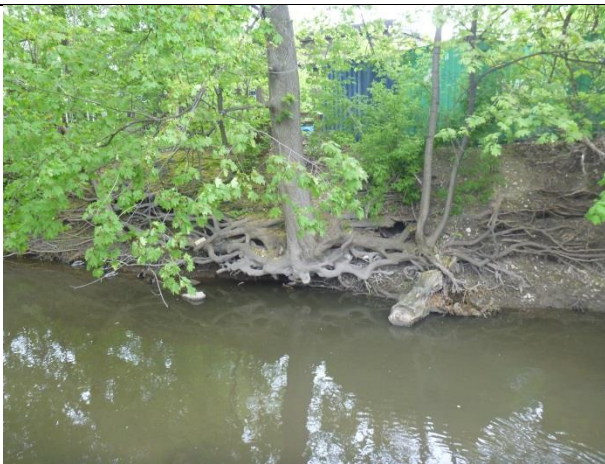
Structures on private property at top of bank

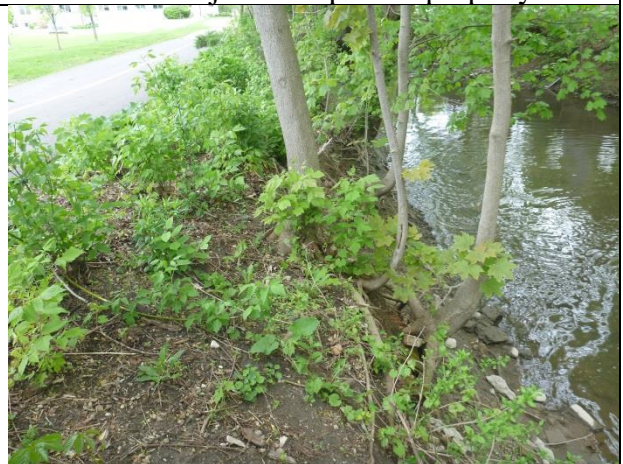
Bank erosion adjacent to trail

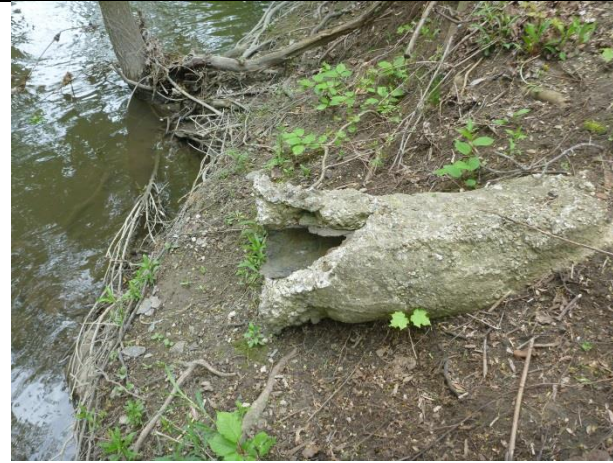
Storm outfall in poor repair

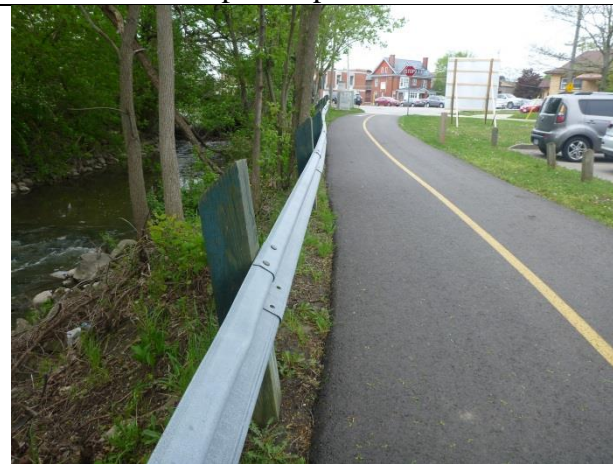
Top of eroding bank in close proximity to trail

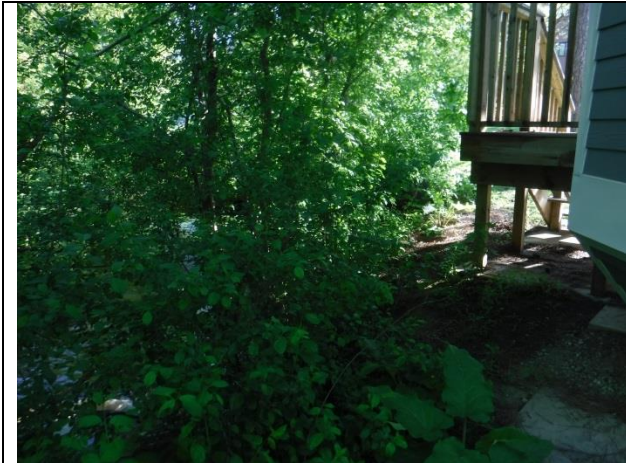
Top of bank within 1 m of structure

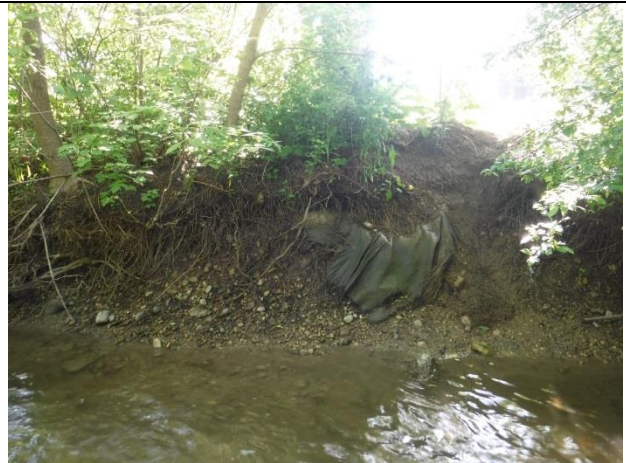
Bank erosion and undermining of vegetation

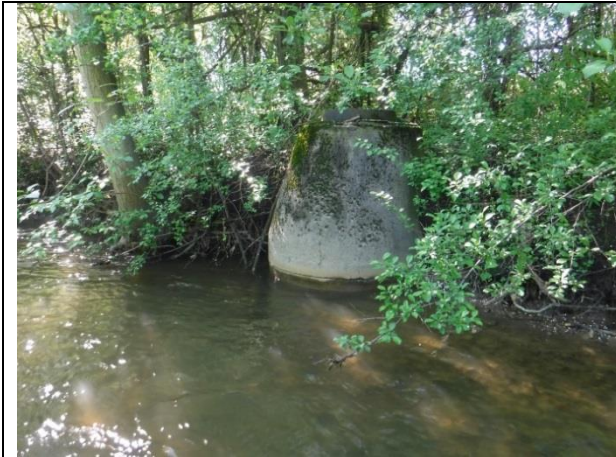
MH in bank on outside bend

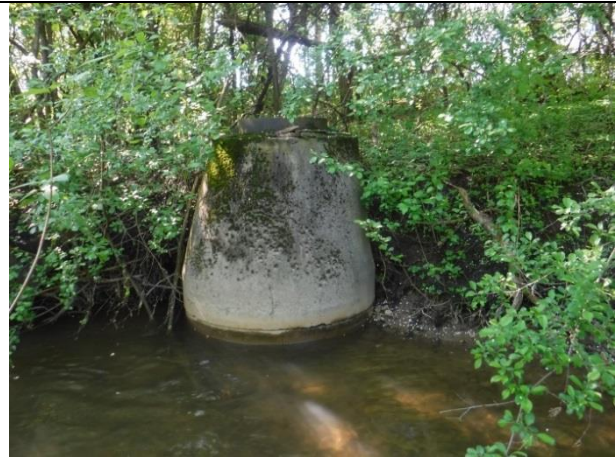
Approximately half the circumference of the MH is exposed

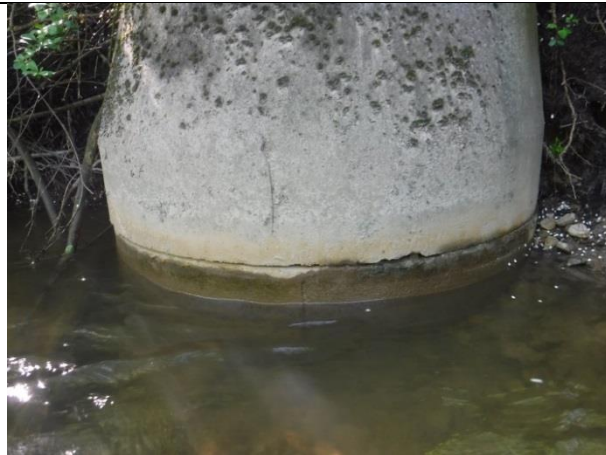
Infiltration may be occurring in joints and cracks in the concrete

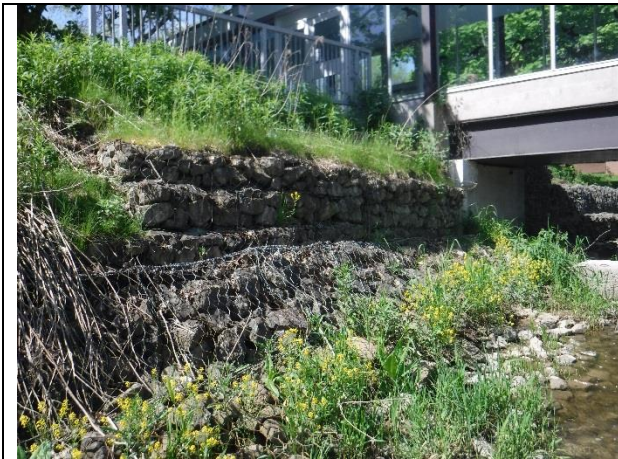
Emptying gabion baskets downstream of crossing for University of Waterloo residence (REV)

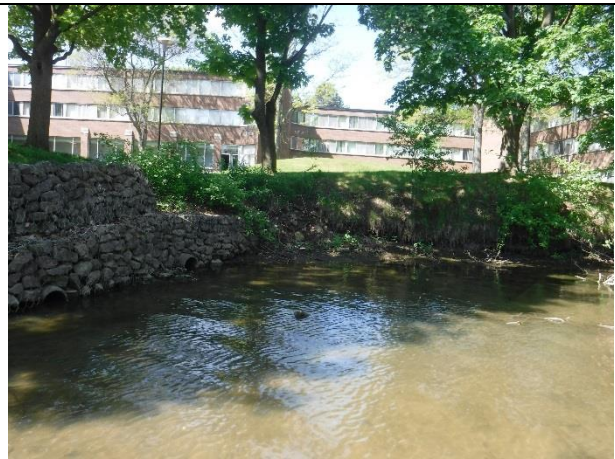
Bank erosion upstream of gabions on right bank

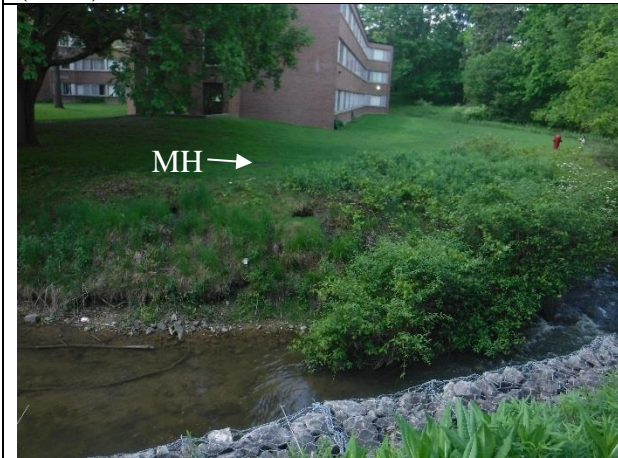
Sanitary sewer MH behind eroding bank

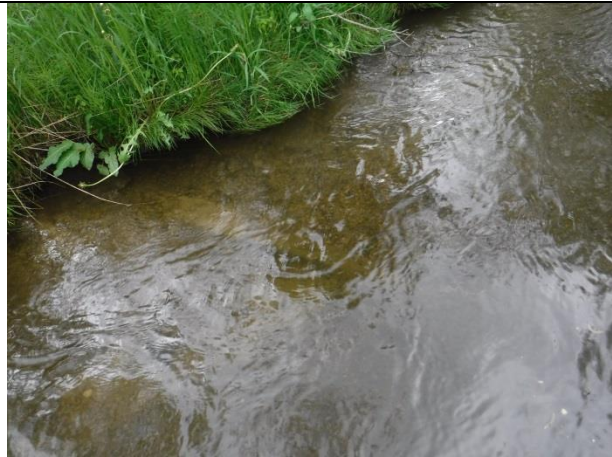
An exposed conduit was observed on the channel bed immediately downstream of Wilmot Line. A second conduit may have been exposed downstream. A sign on the bank indicated buried communications cables. The creek does not appear to be downcutting significantly in this area.

Exposed conduit on channel bed

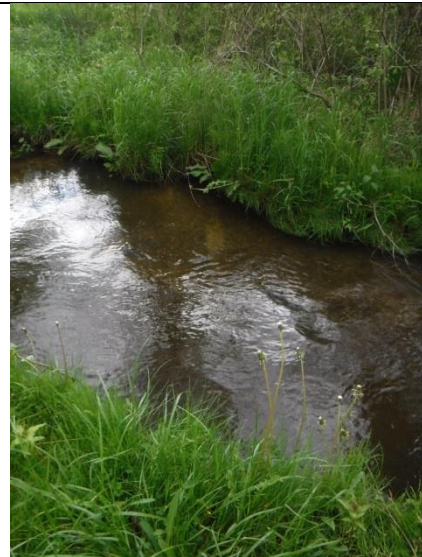
Exposed conduit on channel bed

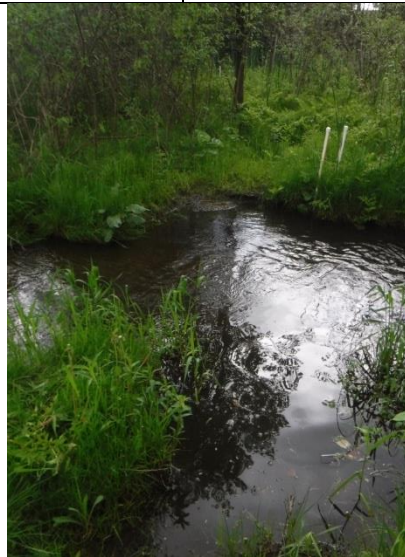
Location of second conduit

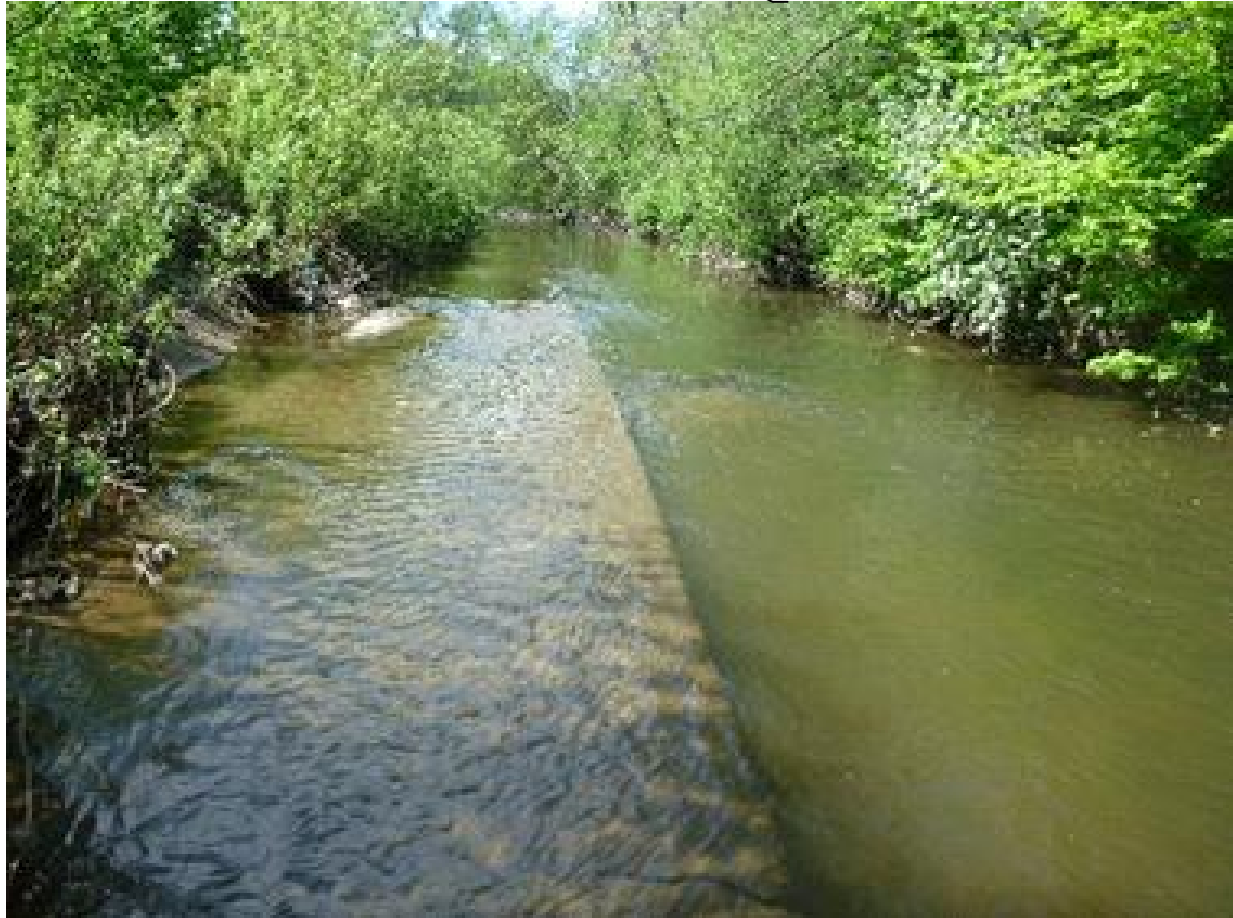
EXPOSED CONCRETE ON CHANNEL BED

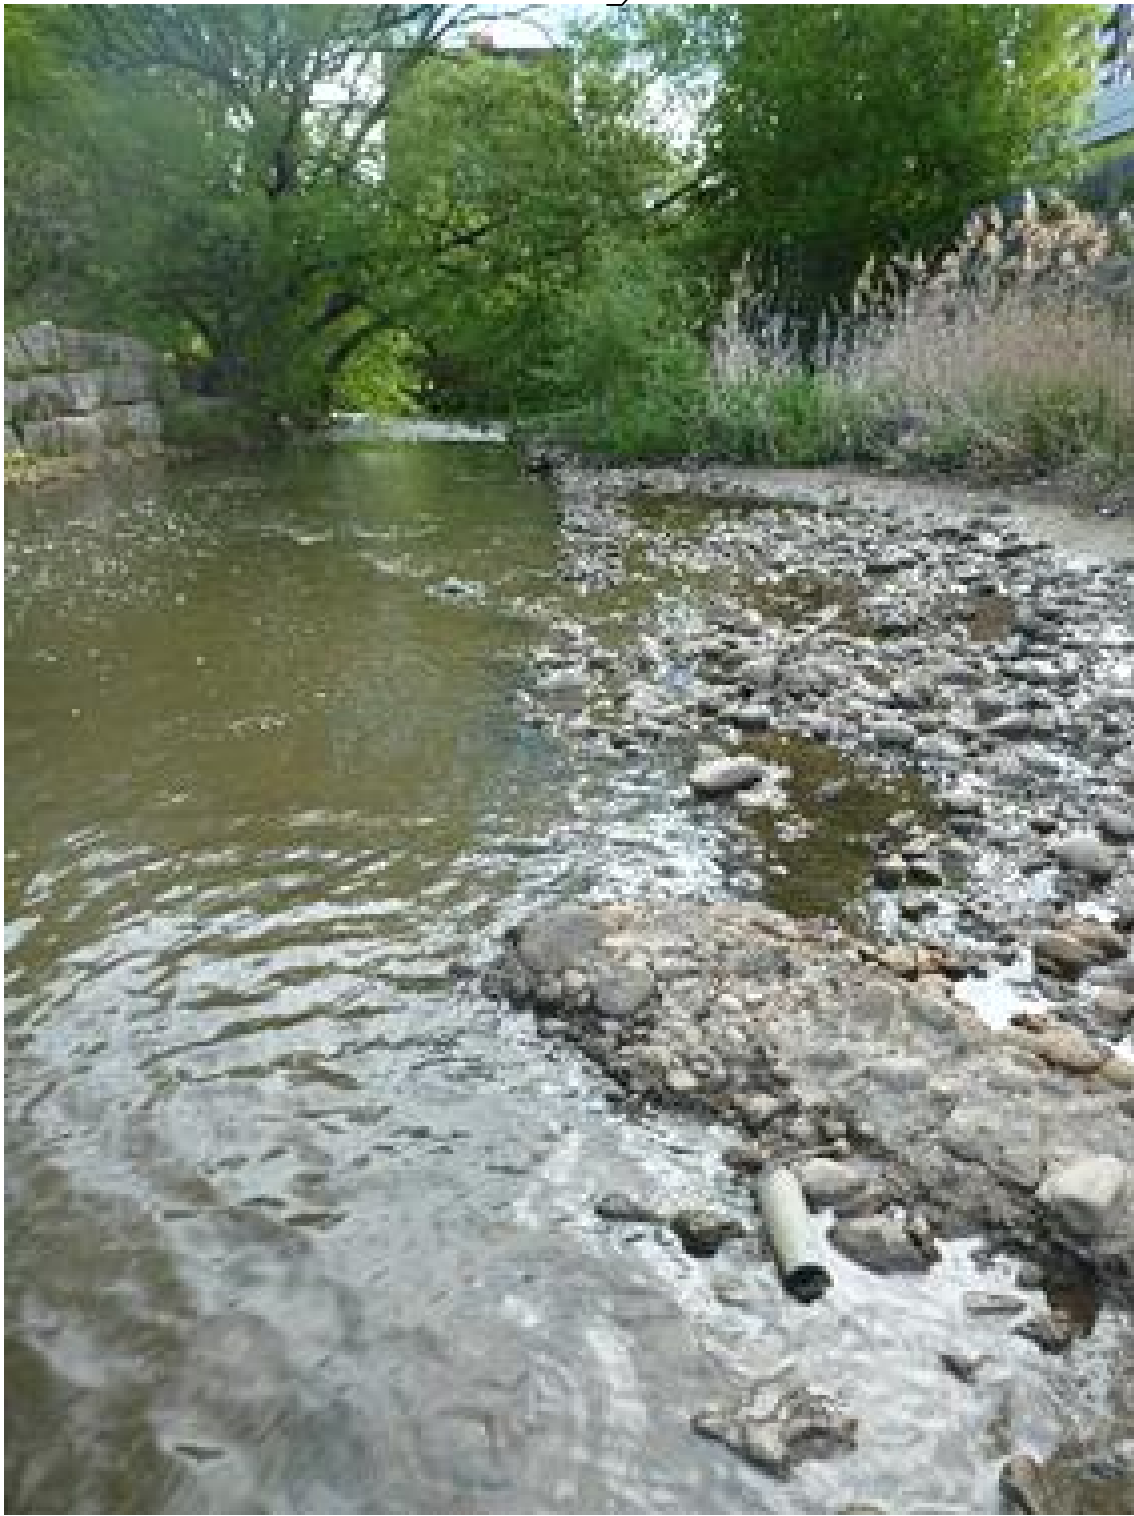
EXPOSED CONCRETE ON BED

Exposed concrete was observed on the channel bed and is likely a sanitary sewer encasement. Armourstone walls are located on either side of channel in this area.

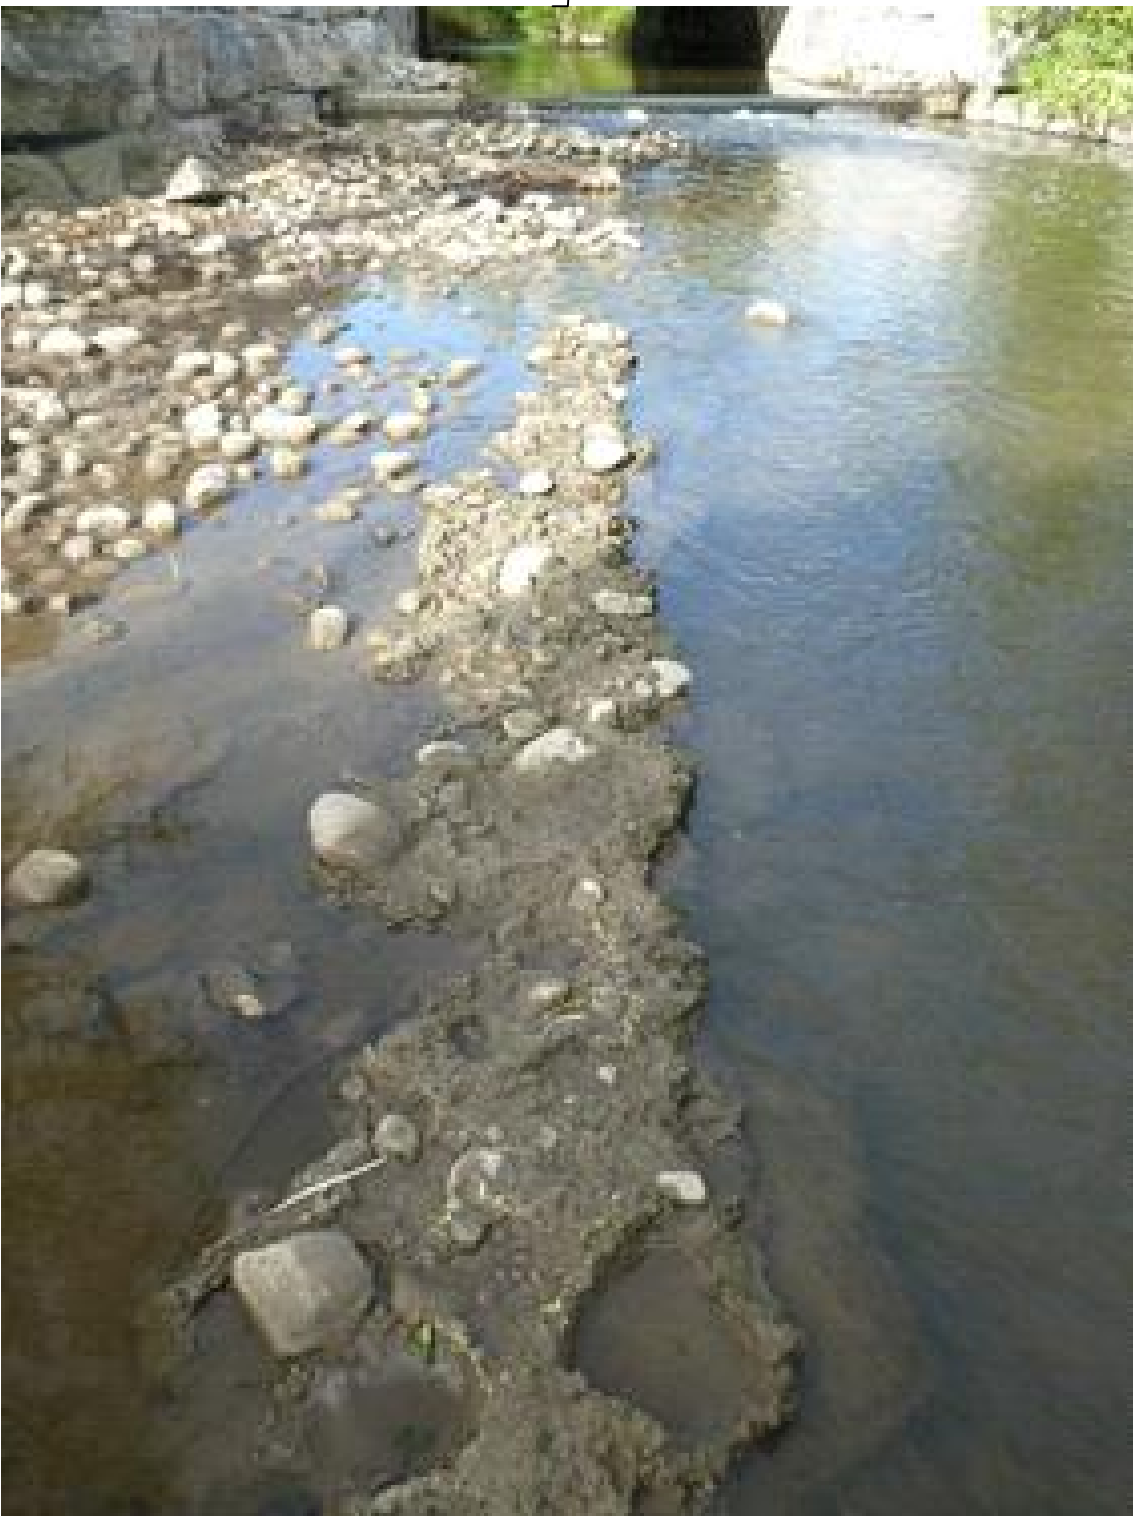
EXPOSED CONCRETE ON BED

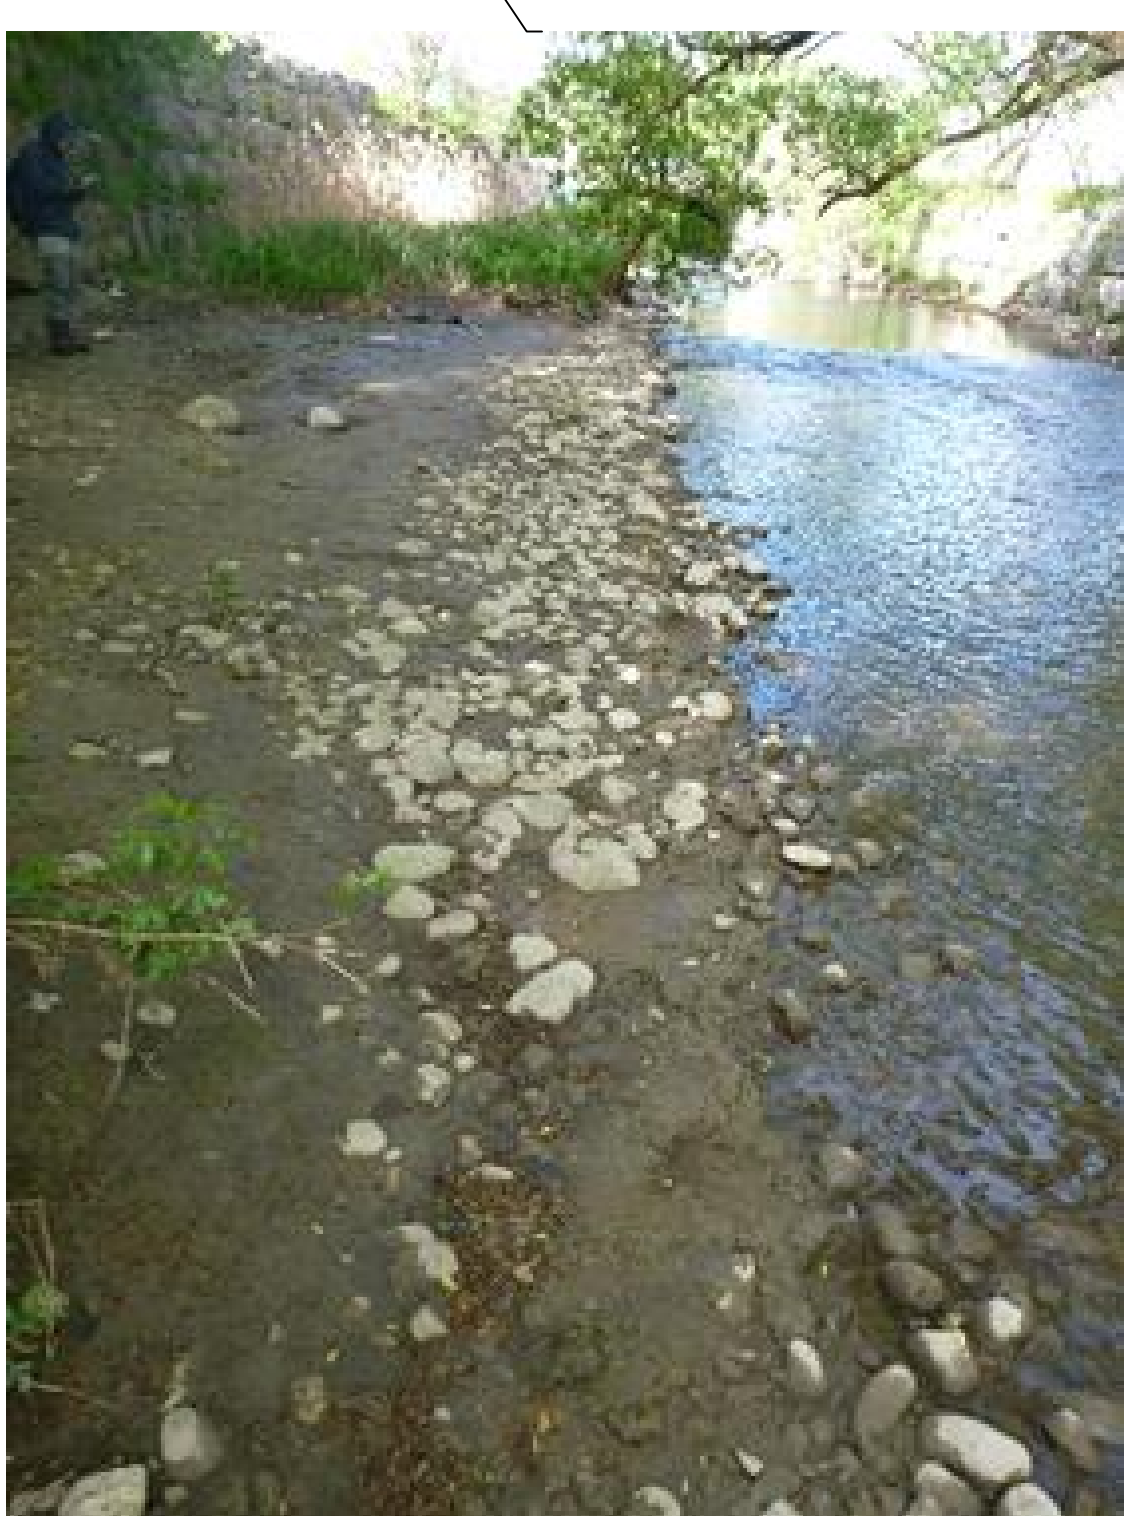
EXPOSED CONCRETE ON BED
