CITY OF WATERLOO

Municipal Class Environmental Assessment

WATERCOURSE EROSION MASTER PLAN

Aquafor Beech Ltd.

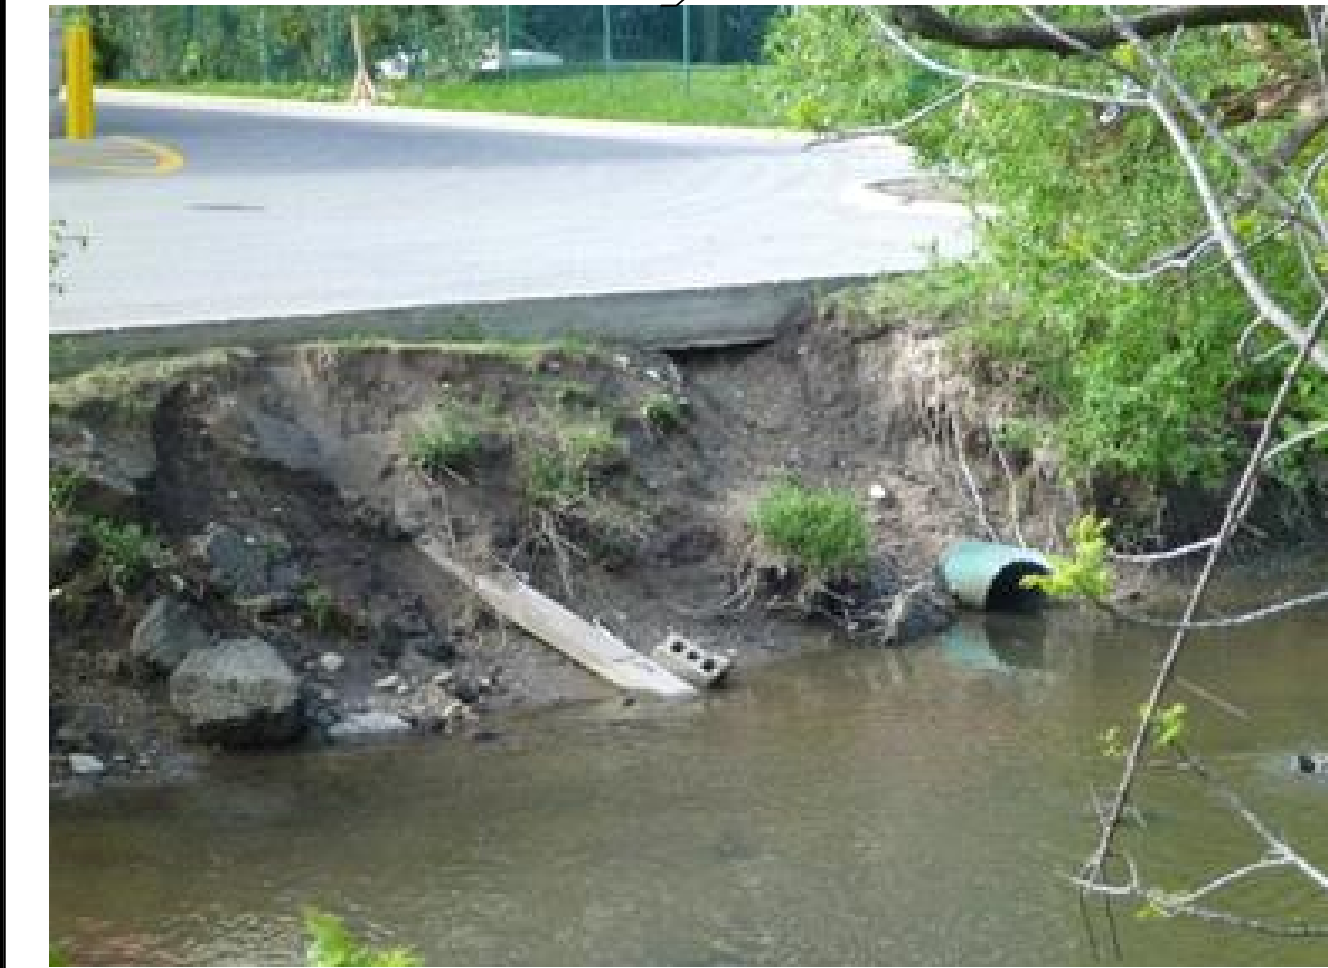
UNDERMINING OF LOADING AREA PAVEMENT

Near-vertical bank erosion is occurring on both sides of channel. A recreation trail and sanitary sewer run along the left bank. The eroding bank is within 1 m of the trail in some areas. Private property is located on the top of the right bank with erosion posing a risk to a fire hydrant, parking lot, loading area, and structures.

The preferred alternative at this site is full channel restoration. Due to the confined nature of the channel at this site, it is expected that armourstone walls will be required. Grade control on the channel bed will be included at the sanitary sewer crossing and elsewhere, as required, to protect the base of the armourstone wall from undermining. Vegetation plantings at the top of the armourstone wall should be included where space permits.

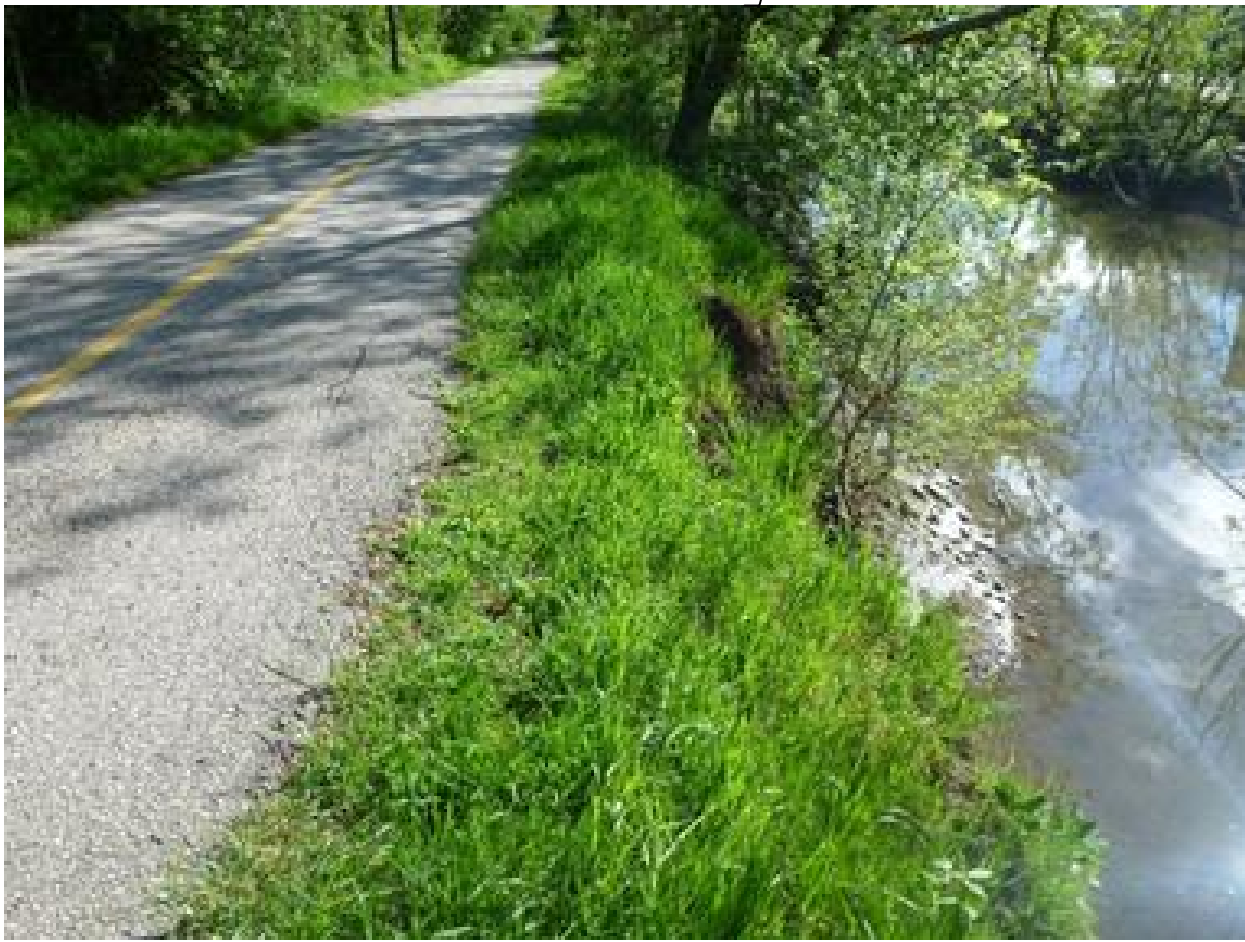
NEAR VERTICAL BANK EROSION PUTTING TRAIL AT RISK

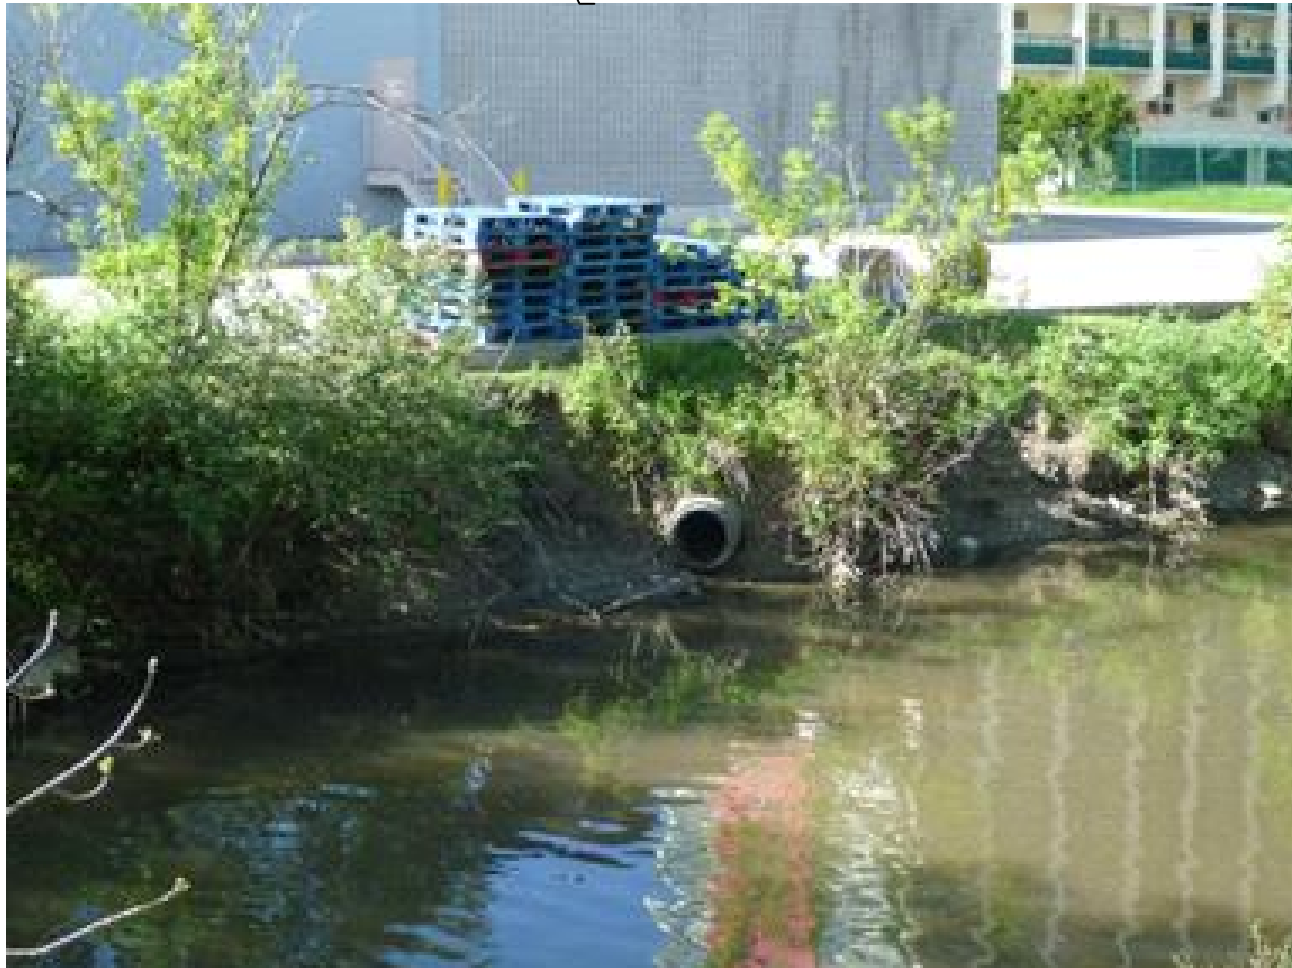
STORM OUTFALL ON ERODED BANK WITH LOADING AREA ABOVE

Numerous storm outfalls are in poor repair. Concrete rubble and yard waste dumping on the bank was noted at the upstream end of the site.

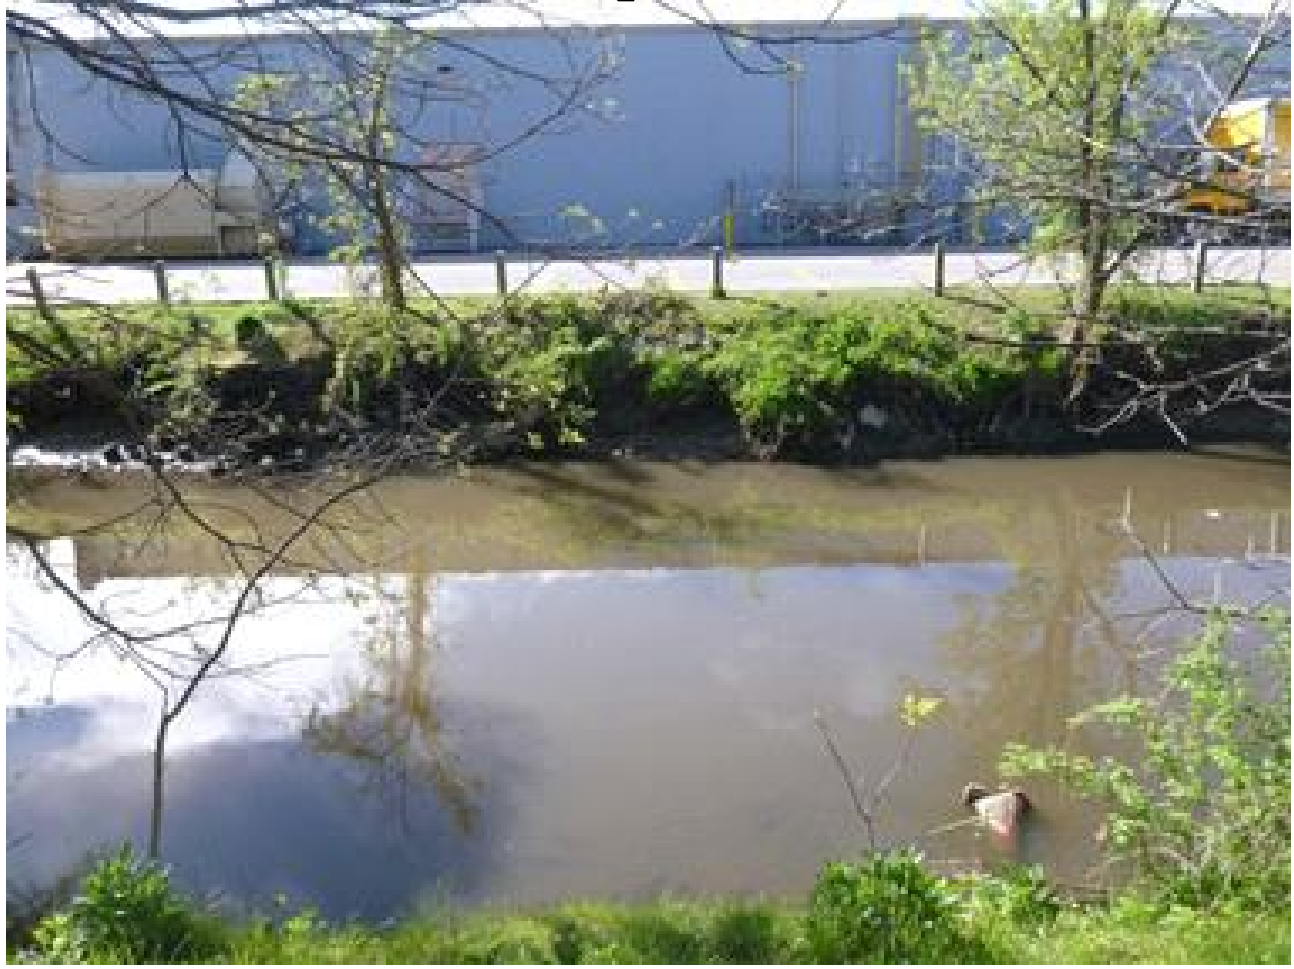
BANK EROSION ADJACENT TO PAVED LOADING AREA

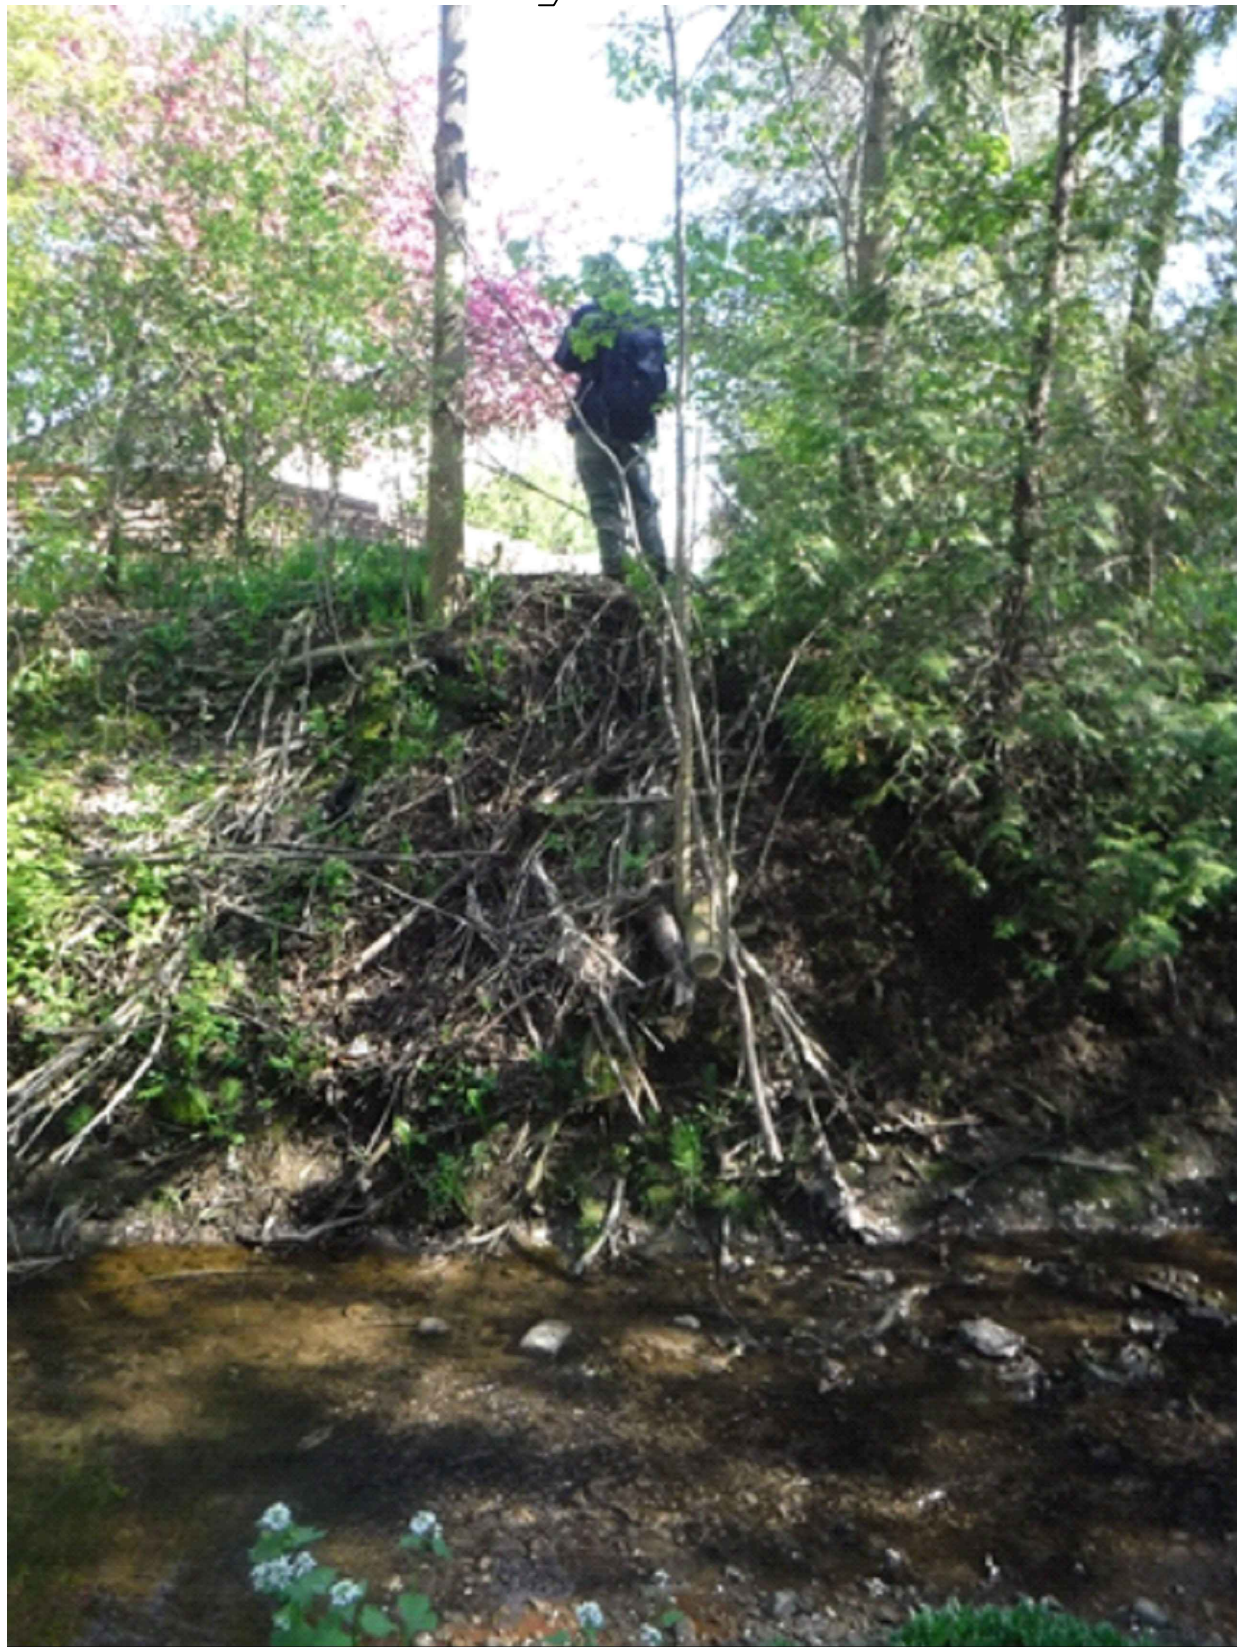
Location 4: A sanitary sewer MH is located within 1 m of the top of bank. Roots from a dead ash tree are holding the bank at present. The creek is entrenched in this area and bank erosion is likely once the ash tree is lost. There may be an opportunity to realign the creek away from the MH.

LOCATION 4 - ERODED BANK AT MH.

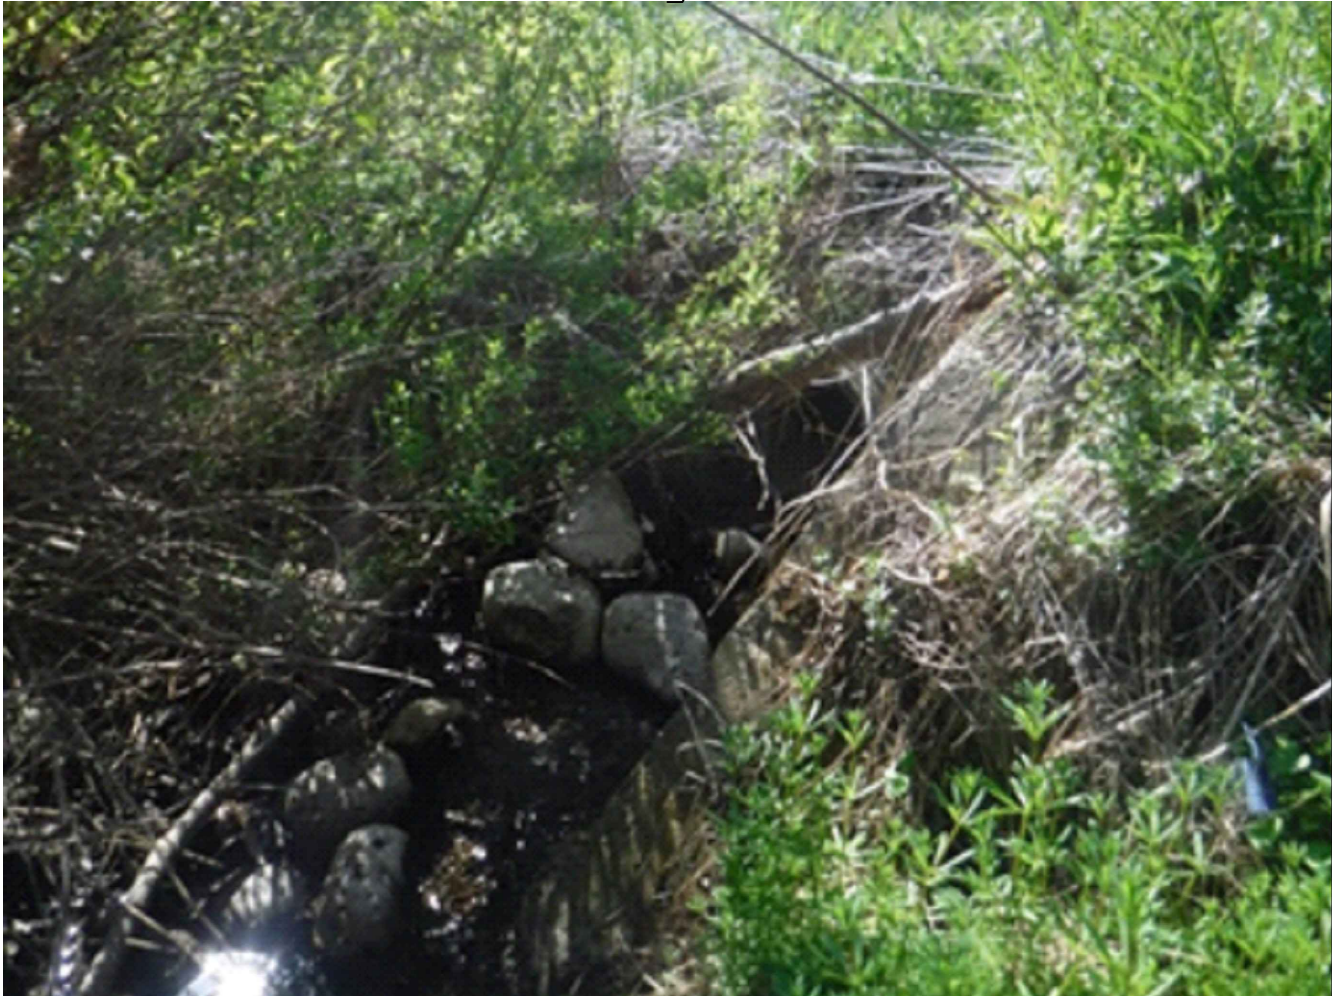
Location 3: The right bank is eroding towards a sanitary sewer MH. The bank material appears to be sandy and a large slump has developed. A rill has also developed from surface runoff towards the MH. On the opposite bank, shrubs in front of a storm sewer appear to be blocking flows. Upstream, banks were steep and trees were observed to be leaning over the creek.

LOCATION 3 - STORM SEWER OUTFALL

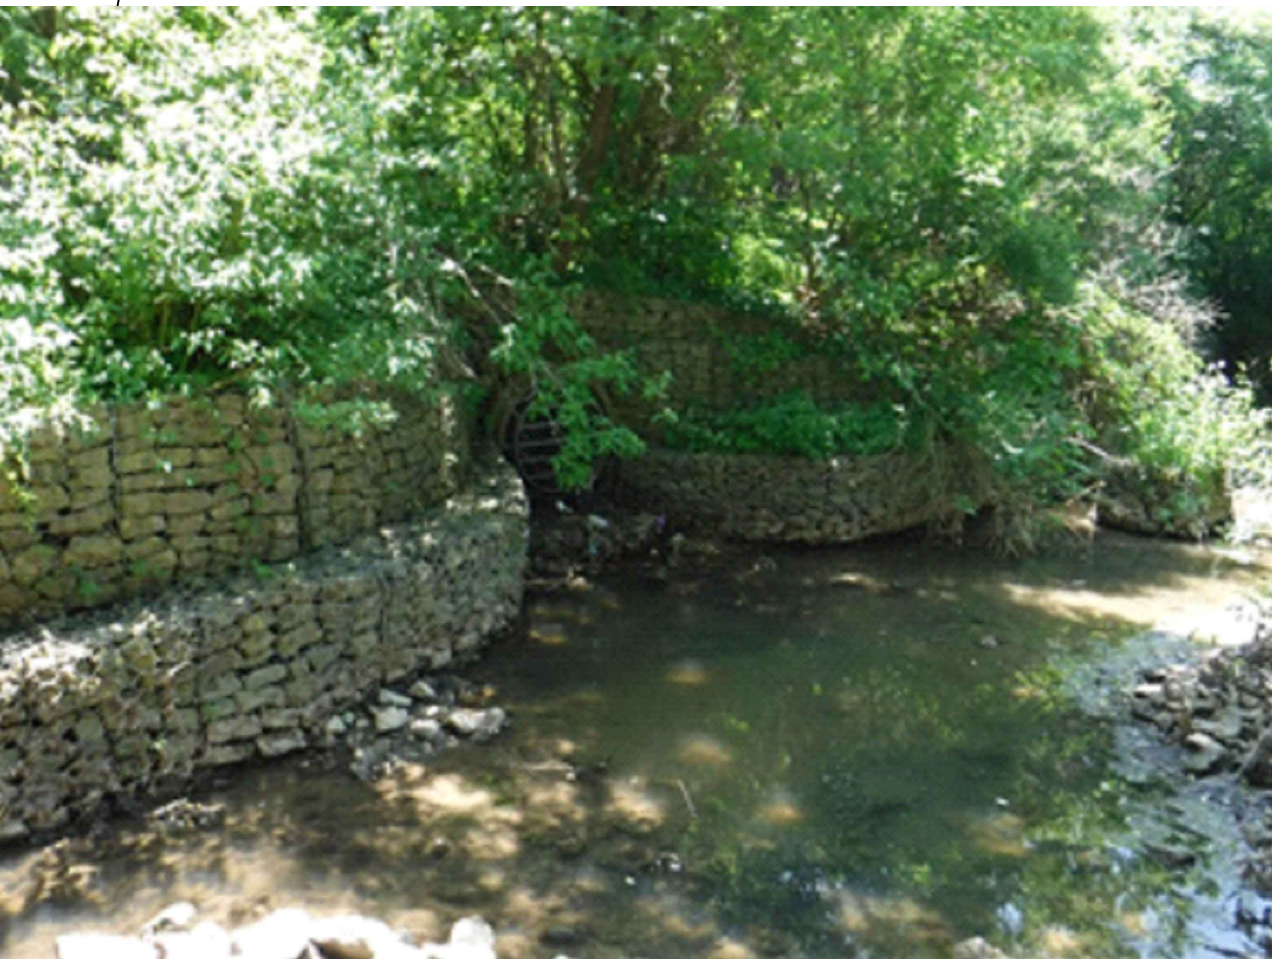
Gabion basket bank treatments are in varying states of failure extending from Columbia Street downstream to 2 storm sewer outfalls. A pile of rip rap has developed in this area. A sanitary sewer crosses under the creek in the vicinity of the storm sewer outfalls. At Columbia Street, 2 CSPs convey flows under the road. The CSP on the east appears to be deformed.

GABION BASKET HEADWALL AT COLUMBIA STREET WITH LOWER BASKETS EMPTYING

The preferred alternative at this site is full channel restoration. The existing gabion baskets would be removed and replaced with armourstone walls and/or vegetated buttresses depending on the space available. The storm sewer headwalls will be restored and grade control will be required on the channel bed to protect the sanitary sewer crossing. The culvert condition at Columbia Street West should be assessed and replaced if required.
